Historic Building Assessment

Town Hall and Courthouse

Newport, New Hampshire

Prepared by: Scully Architects 17 Elm Street,
Keene, New Hampshire 03431 603-357-4544

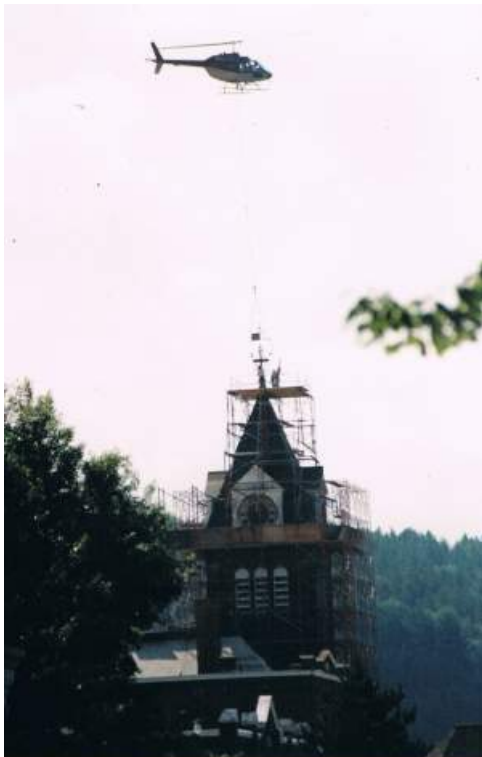
Photo 10 – Clock tower being renovated in 1996. Helicopter removing weathervane

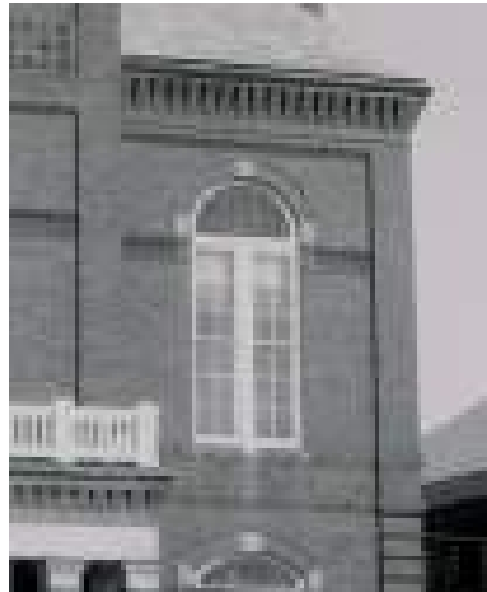
Photo 13 – Enlargement of Photo 12 showing half-round sash and satin glass prior to removal.

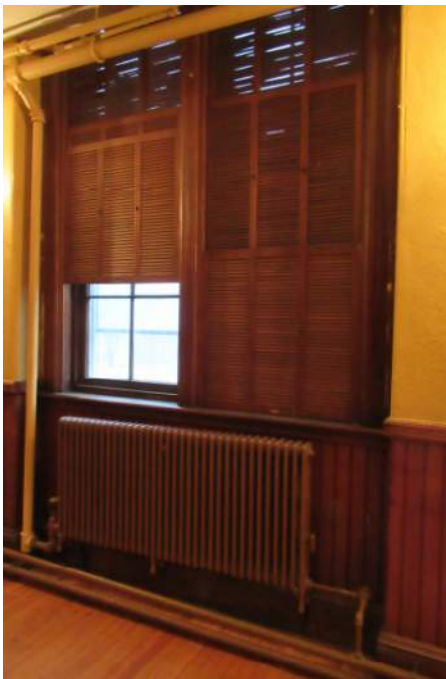
Photo 16— Window shutters at
south wall of Opera House
Photo take November 2018

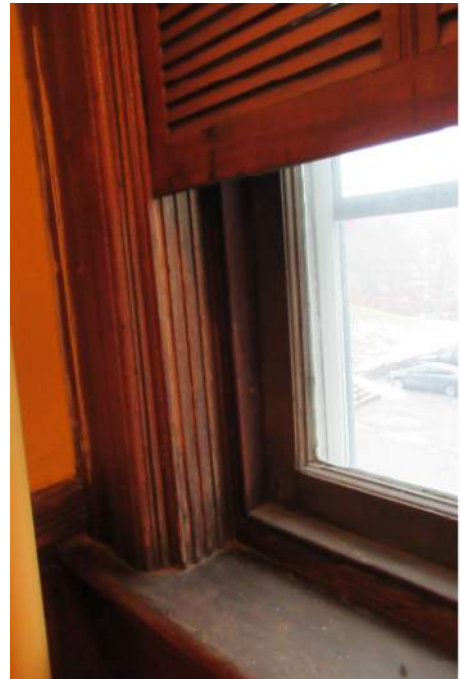
Photo 17— Wood track for
vertically sliding window
shutters. November 2018

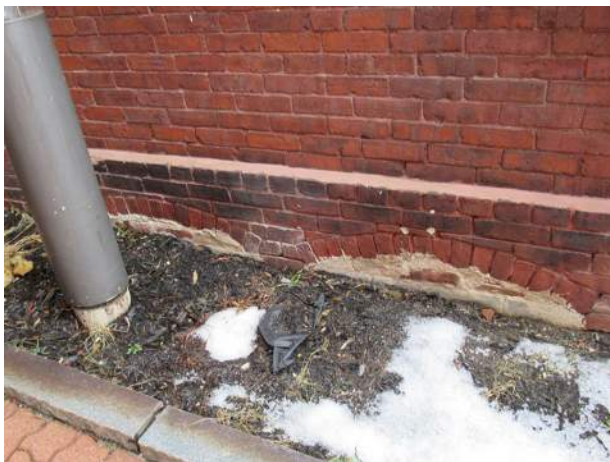
There were originally a series of small window sash at the base of the building that opened to the basement. All of these sashes have either been removed or covered over with plywood. What remains of the original window sash and frames, as well as the plywood coverings are in poor condition. In many locations the pavement is in contact with the wood. There are pathways for water to enter the building.

Photo 48—Pervious location of basement windows at west end of north exterior wall

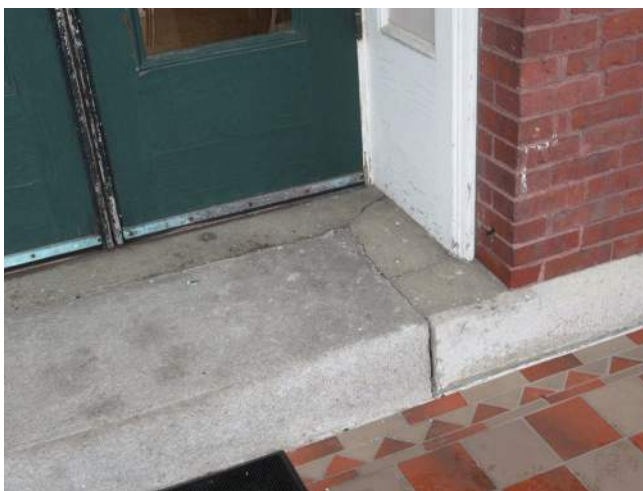
There are two pair of wood doors with glass vision panels at the main entrance to the first floor on the west side of the building (see photo 32). These doors and frames are in fair condition they need some minor repairs, painting, replacement of weather-stripping and adjustments to the remaining hardware. There is evidence that this doorway was modified sometime in the past (see photo 48). There were modifications made to the door sill and exterior jamb

Photo 51 — Southernmost door at first floor main entrance at west side of building. Evidence that this entrance was altered in the past.

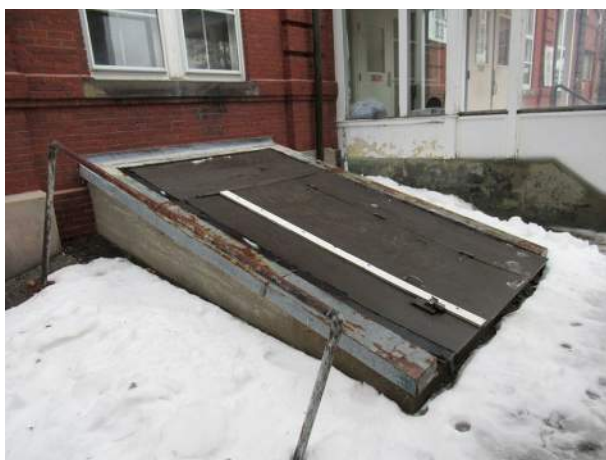
On the south side of the building there is a bulkhead and doors that provide access to the basement. These doors and adjacent trim are in poor condition. They need significant repair or replacement.

Photo 52 — Bulkhead entrance to basement located on south side of the building

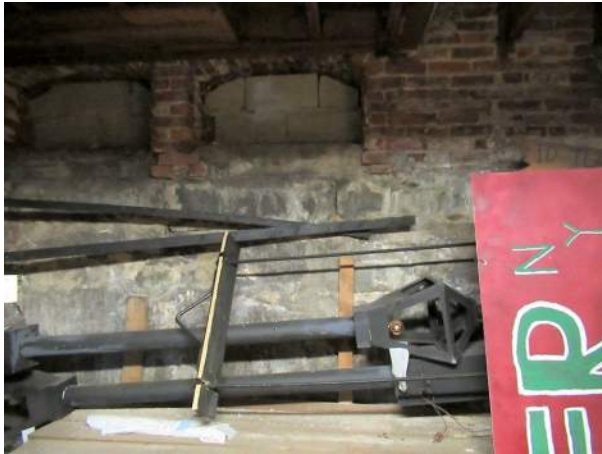
Photo 59 — North exterior foundation wall in basement, original basement windows in-filled with concrete masonry units, most likely when 1986 Courthouse Annex was constructed.

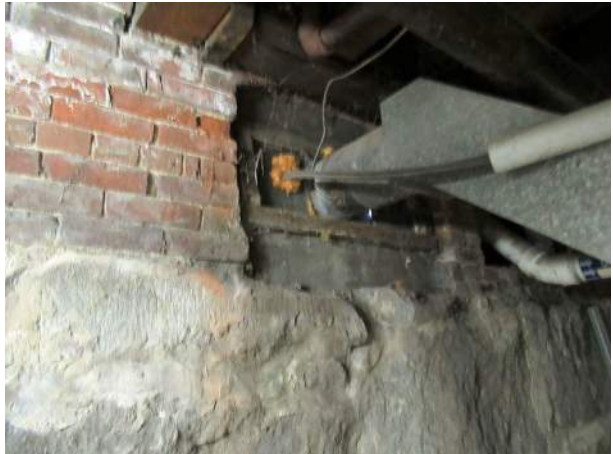
Photo 60 — South exterior foundation wall. The previous basement window openings seen here corresponds to exterior photo 50.

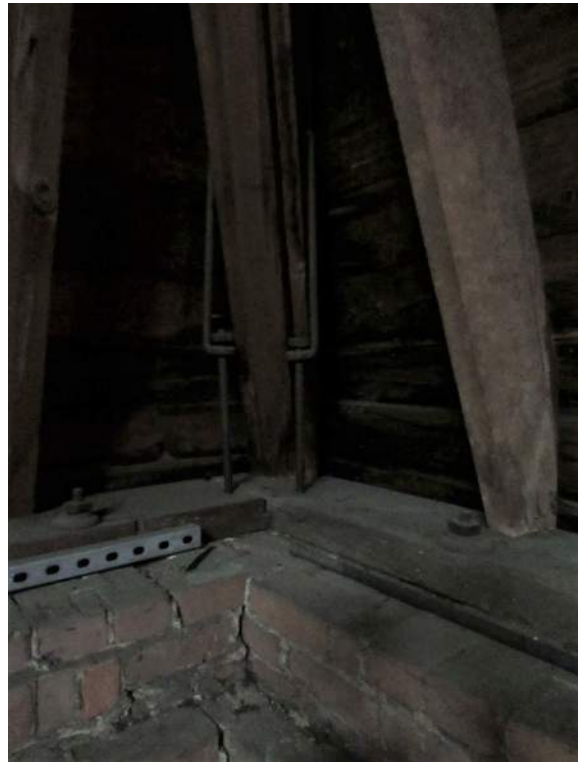
Photo 74—Close up of north east corner, note open brick joints

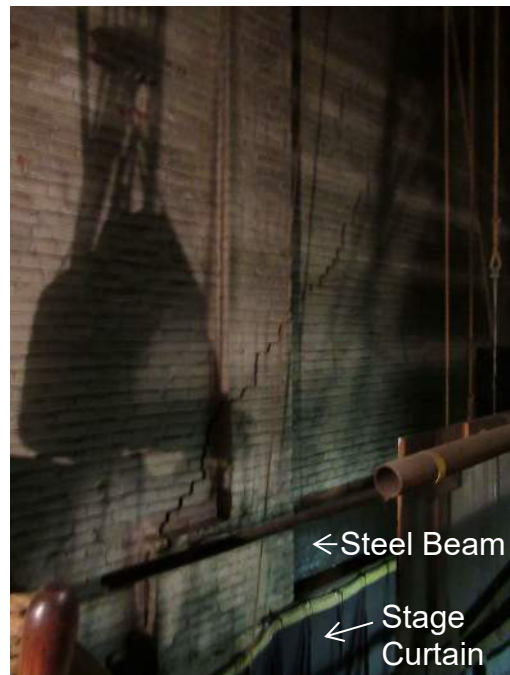
There is a crack in what was the original brick east exterior wall. This can be seen in the attic at the south end of the wall and also seen on the elevated platform leading to the fly loft. The crack starts at the south end of the steel beam that supports the proscenium arch of the stage below and continues upward in a northerly direction. The crack is widest at the bottom and decreases in size as it goes up. There is a slight offset with the brick below the crack about ¼' east of the wall above the crack. This offset also decreases as the crack gets smaller. Given the layers of dirt within the crack it is likely this condition has existed for a long time. There does not appear to be a similar crack at the north end of the proscenium arch. This crack was most likely caused by settlement or a slight deflection of the beam installed above the court room in 1904.

Photo 76—Open joint in masonry wall. Looking west at original exterior east wall.

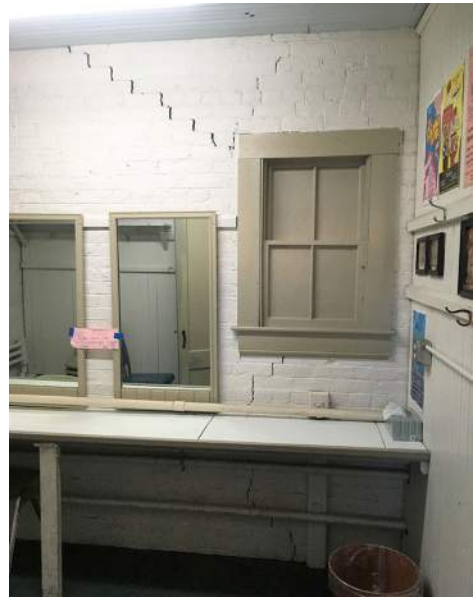
Photo 77 —Open mortar joints in west wall of dressing room in south west corner of mezzanine level.

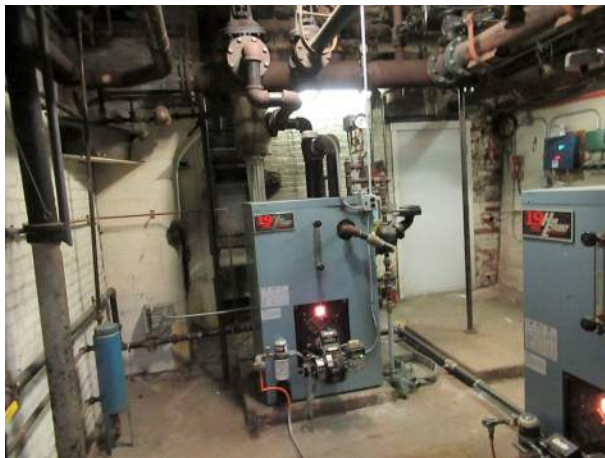
In the north east corner of the first floor there is a mechanical room which contains the boilers for the heating system for the building. This space has a concrete floor exposed brick walls which seem adequate for the use. The ceiling is plaster over metal lath, which is attached directly to the first floor wood joists. The ceiling is in poor condition with some missing plaster. This floor structure supporting the ceiling is the same area previously noted under the Structure section of this report, that is sagging. It is likely that portions of this ceiling will need to be removed to repair the floor structure.

Photo 91 —First floor mechanical room looking north.

The brick at the north wall of the first floor mechanical room should be repointed where needed to replace soft or missing mortar (see photos 91 & 92).

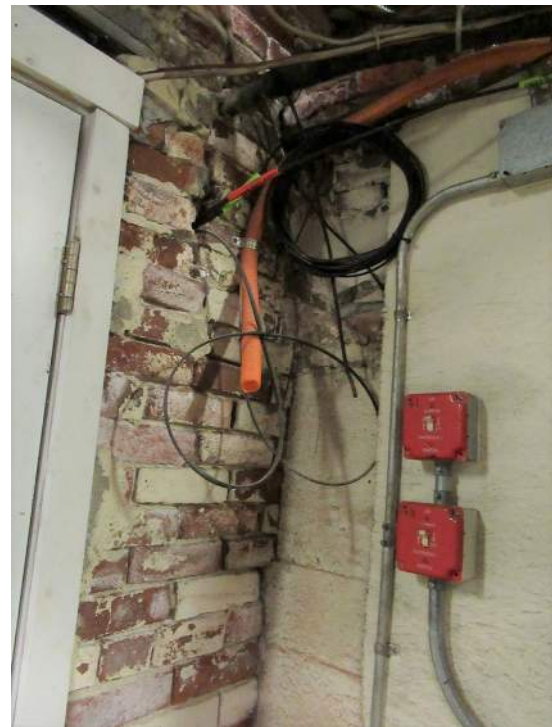
Photo 92 —North east corner of mechanical room showing deteriorated mortar joints.

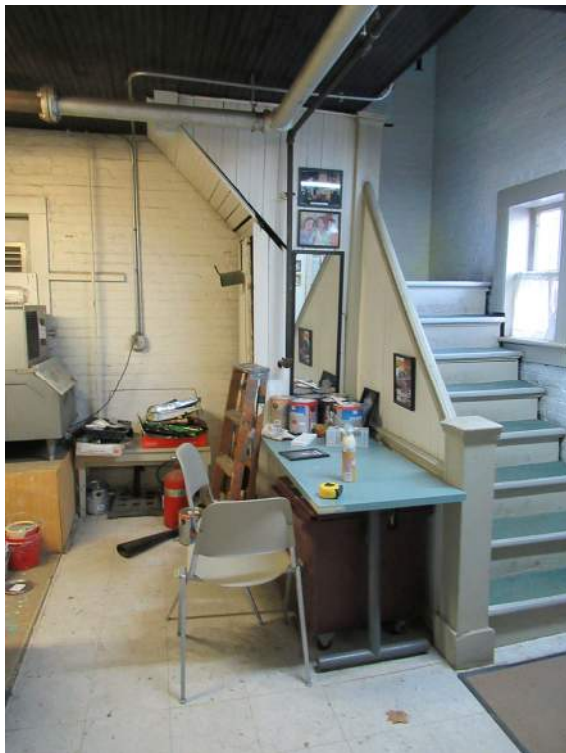
The finishes are generally in fair condition. The floor is generally level except an area about 10' by 10' in the north east corner dips down about 3" towards the north east corner.

Photo 101—North east corner of mezzanine level, looking north

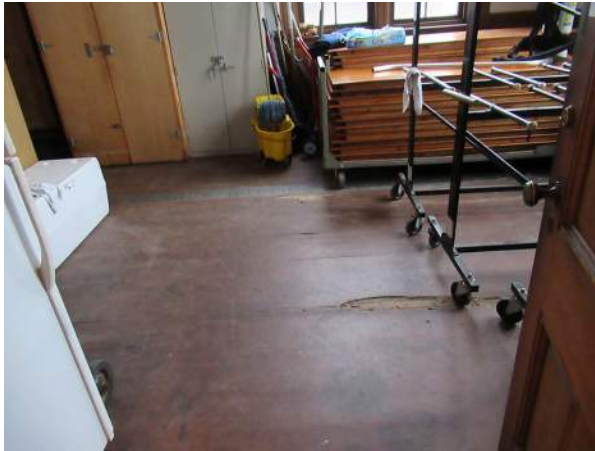
The workroom in the south east corner of the second floor was not renovated as part of the other renovations in the early 2000's. The plaster walls, plaster ceiling and resilient floor covering are in poor condition.

Photo 107—Second floor workroom & storage area looking south.

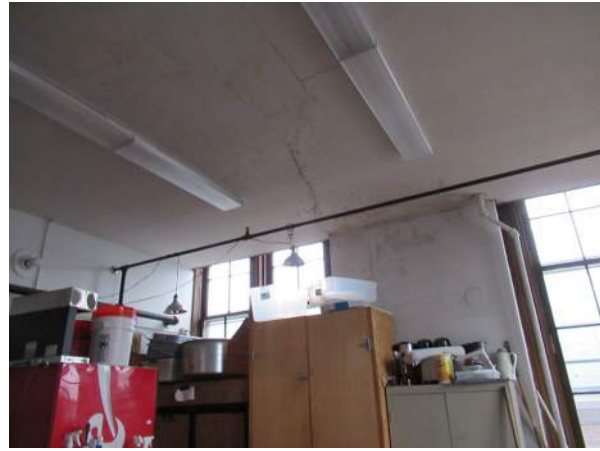
Photo 108—Second floor workroom looking south.

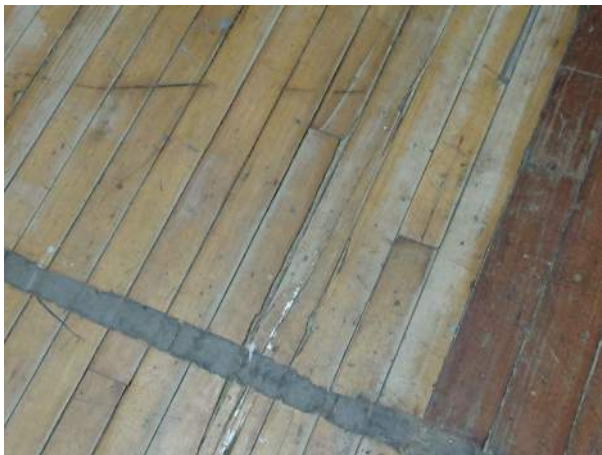
Photo 131— Example of split & cracked floor boards at stage.
