Parlin Field Runway Assessment and Improvement Plan

Assessment of Current Runway Condition

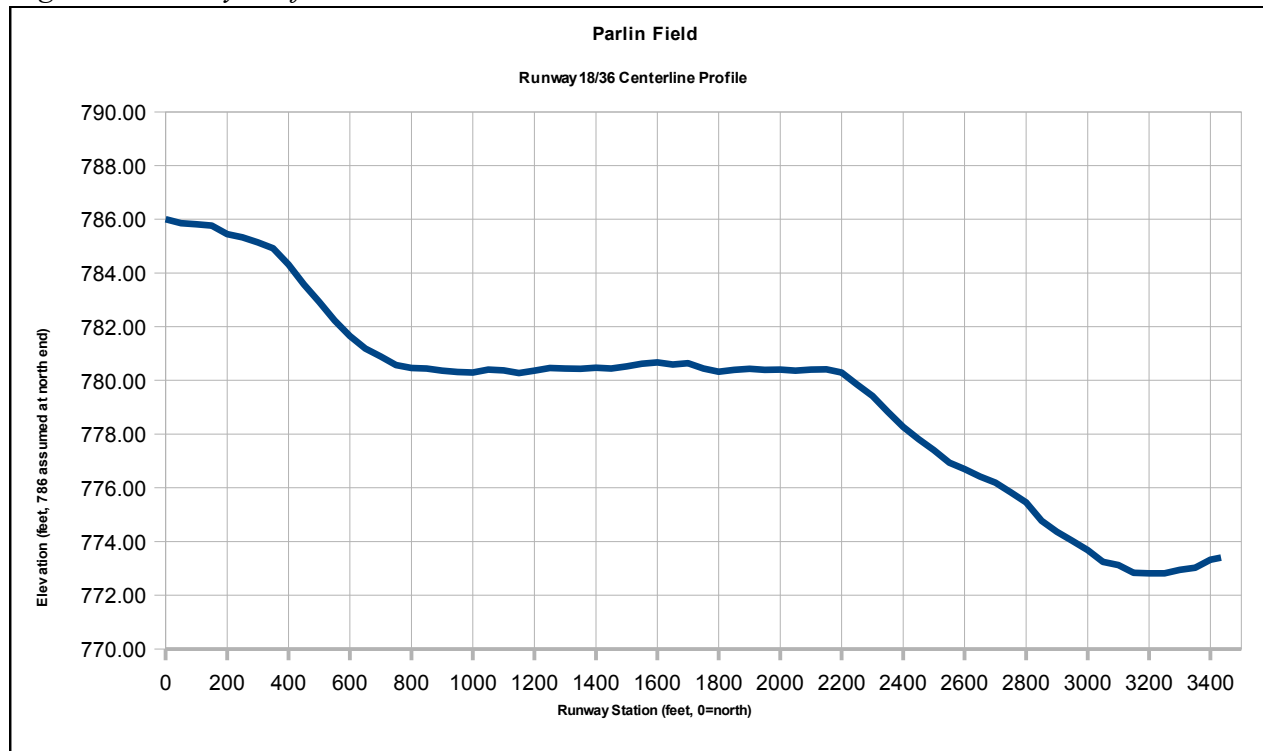
Figure 1. Runway Profile

While it is not a characteristic of the of the runway surface (and therefore is not addressed by the PASER manual), the runway profile – or the change in elevation along the runway from north the south – is a feature of the runway that we did investigate and quantify. The fact the the runway slopes from the north to the south is well known by local pilots and does play a role in determining how to best use the runway under some circumstances. There is also a known issue in landing from the south (Runway 36) whereby landing in a certain area can result in a bounce. This area is termed the "ski jump" (station 2200 in the centerline profile). As a part of the runway assessment, the runway profile was surveyed and the results are shown in *Figure 1*, below. The survey showed that the overall slope of the runway was approximately 0.4% – a low figure with no operational implications and well within FAA specifications. However, the "ski jump" has a vertical curvature that is too short to meet FAA standards and does have operational implications.

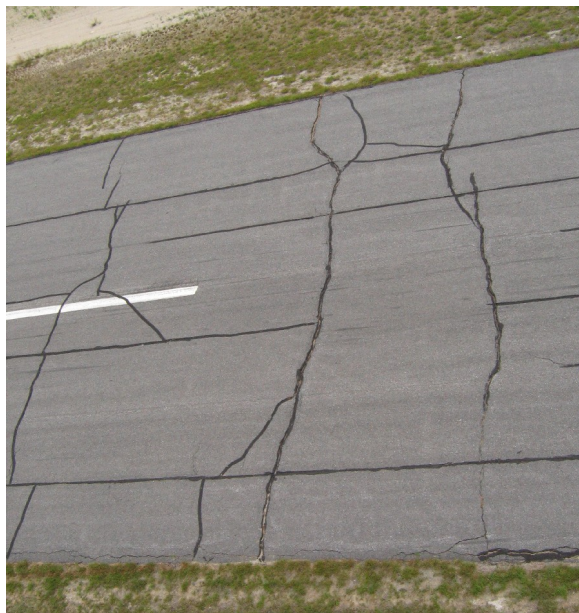
Illustration 1: Pavement rating FAIR. Thermal cracks less than 50 feet apart with minor deterioration along cracks. Block cracks 6 to 10 feet apart.

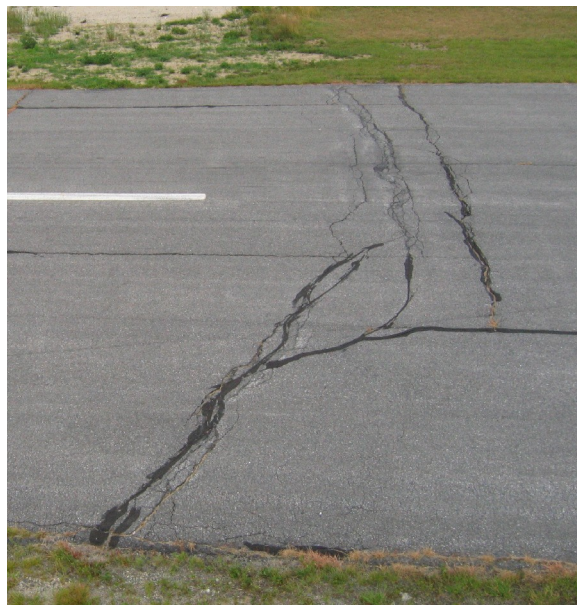
Illustration 2: Pavement rating POOR, wide cracks less than 50 feet apart with significant deterioration, settling, and deformation along crack edges.

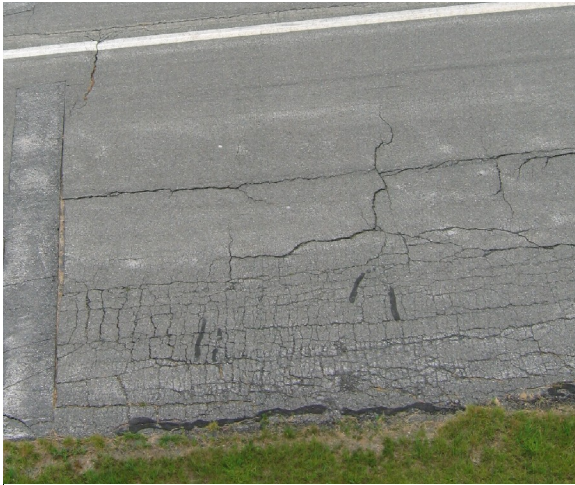
*Illustration 3: Pavement rating POOR.
Extensive alligator cracking over less than
20% of area, settling of 1 to 2 inches, and
deformation.*

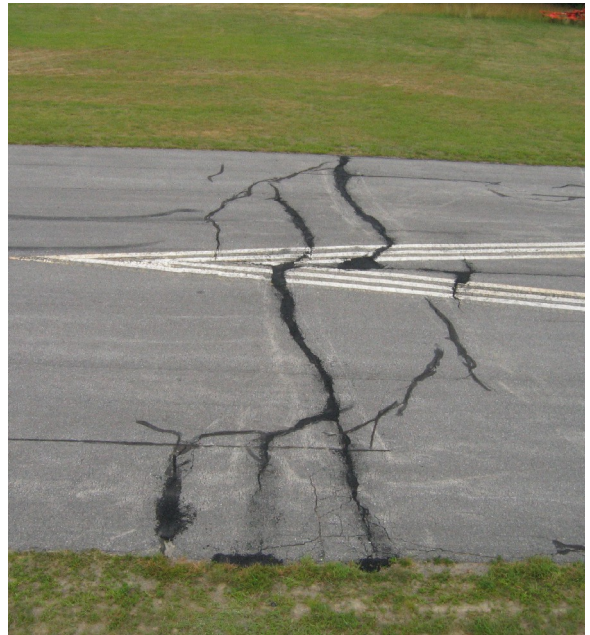
*Illustration 4: Pavement rating POOR.
Wide cracks with deterioration along crack
edges and minor settling.*
