Building: Ambulance Building
 15 – 17 Meadow Road
 Newport, New Hampshire

Town of Newport, New Hampshire

Building Assessment | June 30, 2017

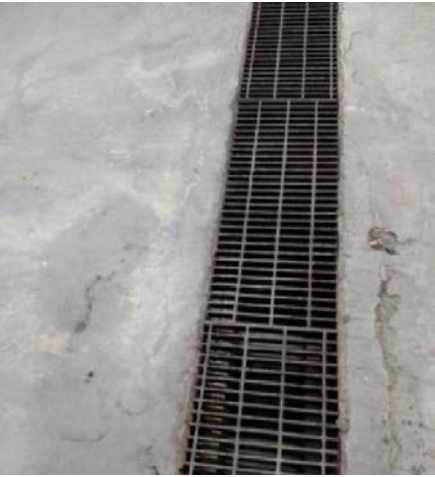
Architectural							
	This building has had multiple uses in the past and needs some work just to prevent deterioration. It barely provides adequate space for their needs and is missing many code items such as vehicle exhaust as well as ADA issues.						
	Equipment	Condition	Est. Remaining Service Life	Priority	Cost Estimate	Remarks & Recommendations	Photos
	696, Garage Floor	deteriorating		5	\$4,600	Bare concrete floor that is chipping, repair chipping and seal floor.

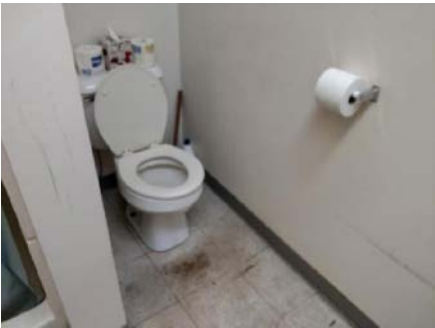
694 ADA					Building and bathroom are not ADA Accessible.

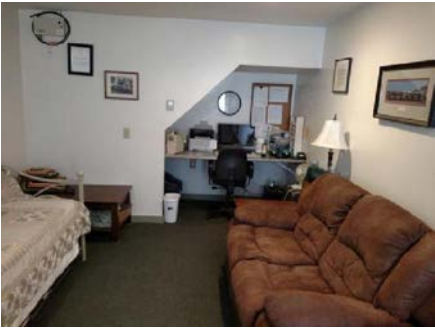
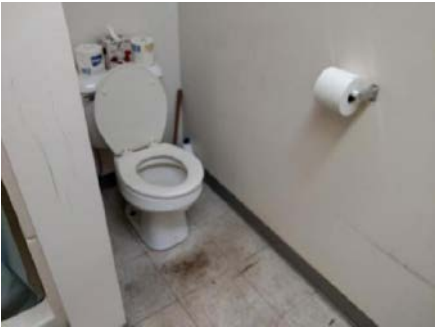
693,Floor Finishes	deteriorating	5 years	3	VCT \$5.00 per sq.ft. Carpet \$3.50 per sq.ft.	Carpet and VCT that is cracking should be put on schedule for replacement.

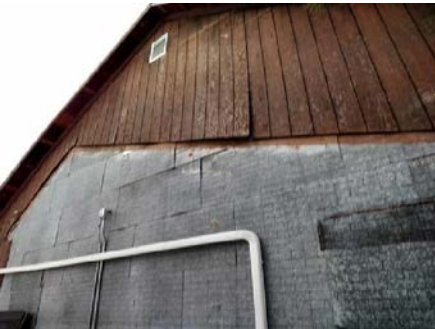
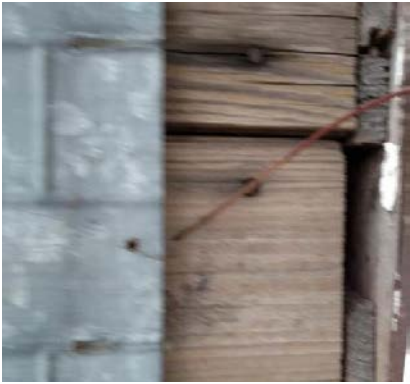
692,Siding	deteriorating		10	Carpentry repair \$400 Pressure wash \$.40 /sq.ft. Vinyl Siding \$5.0 sq.ft.	Nail existing t-111 siding, power wash and stain, suggest adding t-111 or vinyl over metal siding, need to close to the weather open sheathing.

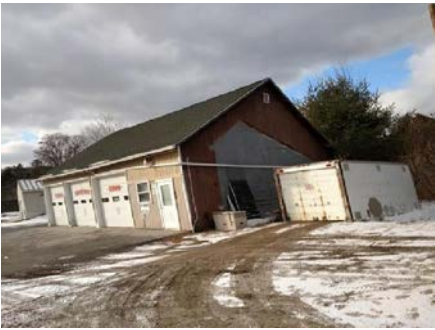
691,EN					Freezer body used for salt/sand storage.

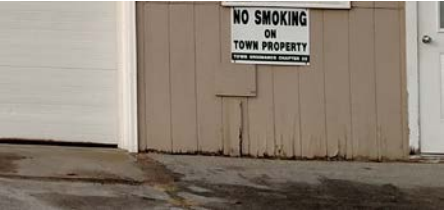
690, Siding	5	4	9	Cut siding And install new synthetic trim \$7.50 per lineal foot	Siding is rotted at bottom, suggest cutting back one foot and adding a synthetic material with flashing.

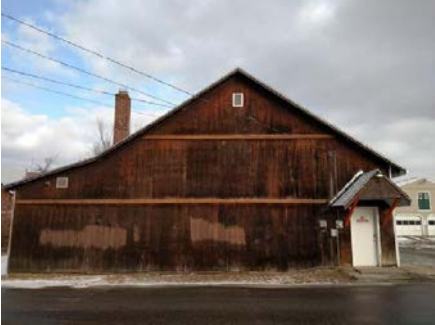
689, Stain	5	4	8	Pressure wash \$.40 /sq.ft Stain \$1.50 /sq.ft	Deteriorating Power wash and stain this siding typical.

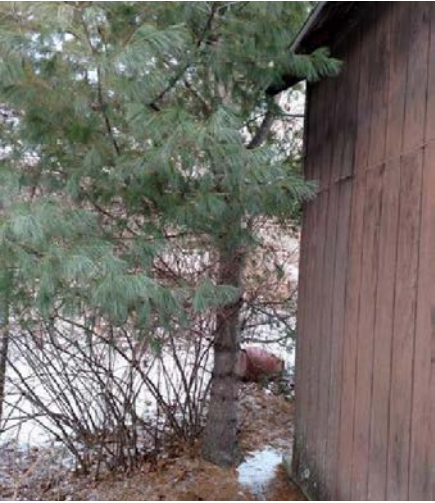
153,General Comment:	4	4-6y	4	Tree removal \$300	Remove tree, has created environment that rotted siding and will accelerate aging of roofing.

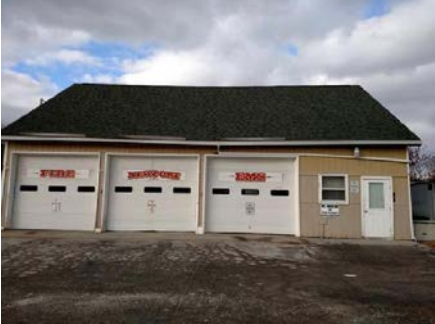
151,Roof	2	20	10	In future remove and replace \$7.00 sq.ft.	Asphalt shingle relatively new arch type.

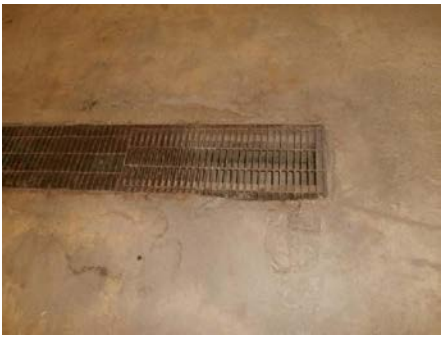
Structural							
	Considering this is an emergency facility and given the conditions noted below the Town should consider replacing this facility.						
	Equipment	Condition	Est. Remaining Service Life	Priority	Cost Estimate	Remarks & Recommendations	Photos
	222, floor			2		Grade-supported floor slab is cracked, also spalled around center trench drain. See arch section

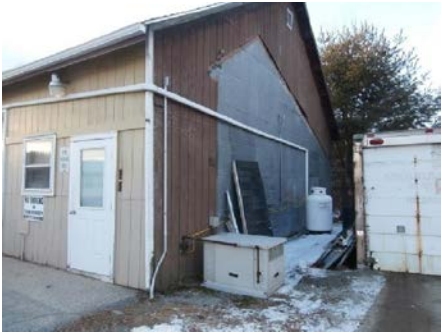
221, Wall				See arch	Previously existing building addition on the east side has been demolished, but the siding has not been repaired properly - now covered with roofing materials.

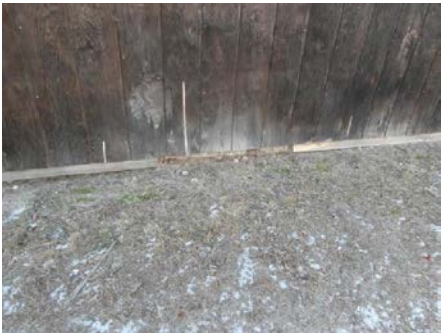
220,Foundation			3		Concrete at top of foundation wall and slab edge is spalled, deteriorating.

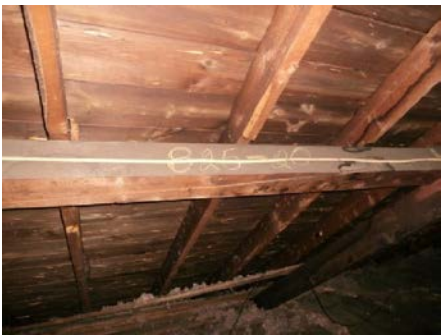
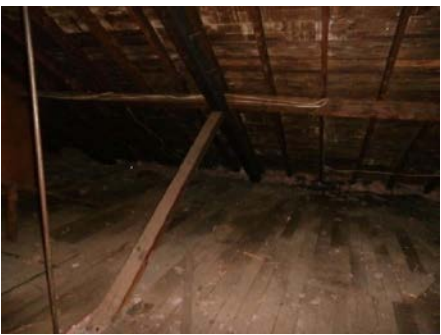
216 Roof Purlins			8	Replace In kind \$5,000	Roof purlins between roof trusses are cracked, split and sagging (undersized).

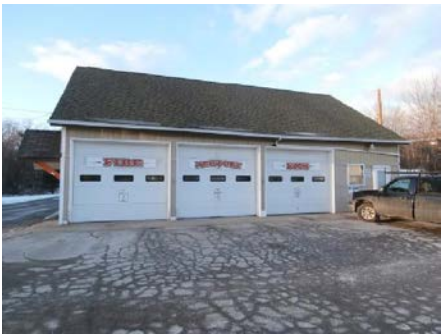
218, Seismic				Will need engineering And \$\$\$\$	Building predates seismic design standards. Apparatus bay doors (3 bays) make the building vulnerable to wind and seismic forces.

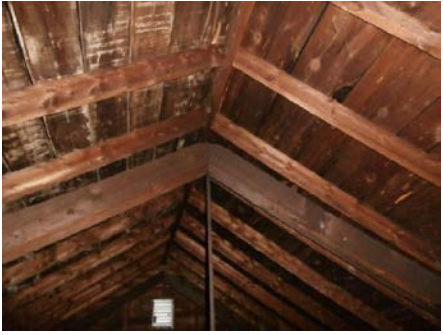
217,Truss			7	Frame into purlins \$400	Three interior roof trusses (between apparatus bays): Top chord of truss is not braced against out-of- plane displacement

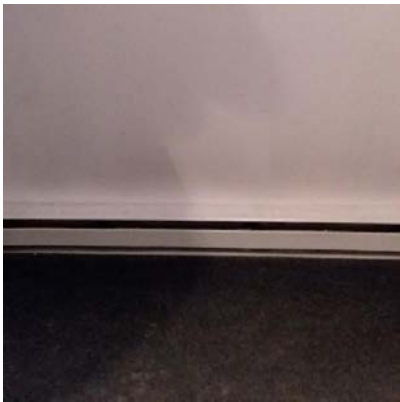
163, Electrical	3 Fully operational, 25-50% life expectancy used, periodic problems	5y	10	\$600 each	Fin tube is supplemental heat for office area.

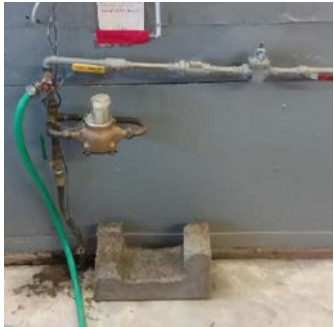
161,Trench drain is piped to town of Newport's storm drain.					Trench drains in each truck bay should tie into Oil separator		
	160,Water Entrance	2 Fully operational, 0-25% of life expectancy used, no issues, no concerns,	15	10	\$500
