Building: Chlorination
Gilman Pond Road
Newport, New Hampshire

Town of Newport, Building Assessment July 31,2017

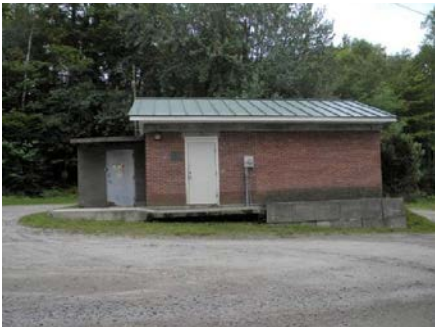
equipment	condition	Est remaining Service life	priority	cost	remarks &recommendations		
	744,Roofing	2	8	10	\$2.50 sq.ft.	A gable roof was over framed on the existing concrete slab and has been covered with a metal roof. Monitor for need to paint

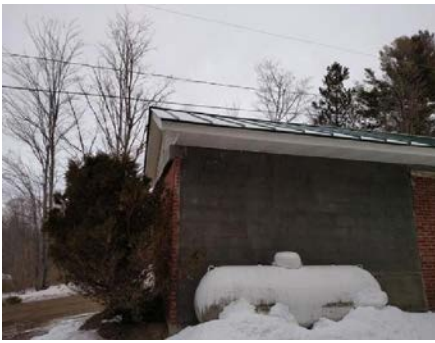
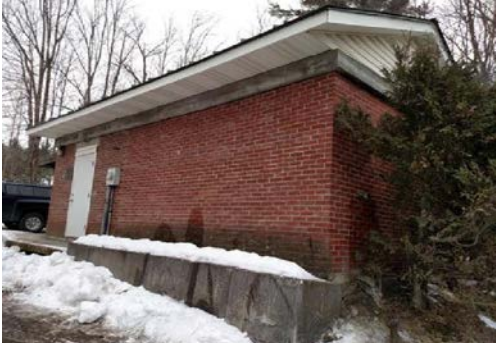
743,Paint Surface	5	5	5	\$2.50 sq.ft.	Paint all surfaces or add vinyl per the rest of the building and paint door.

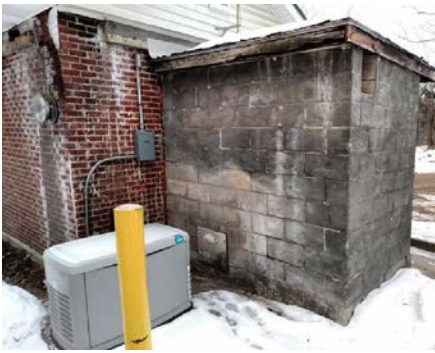
742, Exposed wood	5	3	7	\$1,000	Flash roof to keep water off brick. Finish wood with vinyl soffit and trim adding drip Edge to project water away from siding.

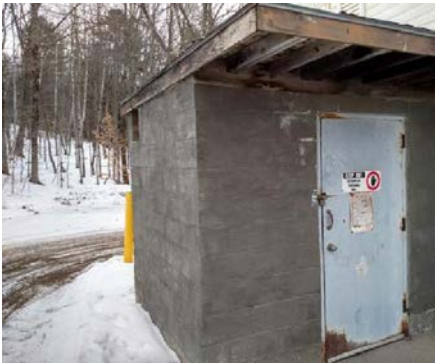
741,Brick					Brick veneer and stucco CMU addition.

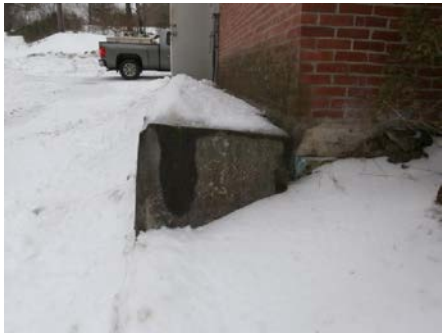
Loading dock: The loading dock has been undermined by water flow along the street side of the building. The dock is constructed in two separate sections, one original to the 1954 building, and the other as a part of the later tank addition. Both sections are seriously undermined and exhibit very significant settlement.

Equipment	Condition	Est. Remaining Service Life	Priority	Cost Estimate		
530,Slab					Precast concrete block slab/loading dock has settled, top surface slopes towards the building.

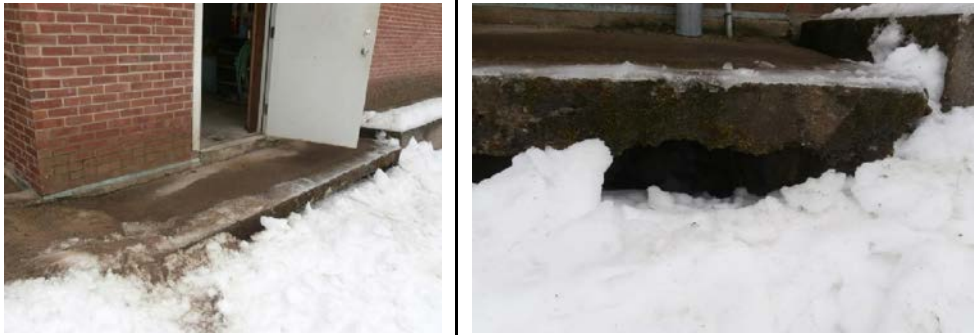
529,Slab					Exterior grade-supported slab/loading dock has been undermined.

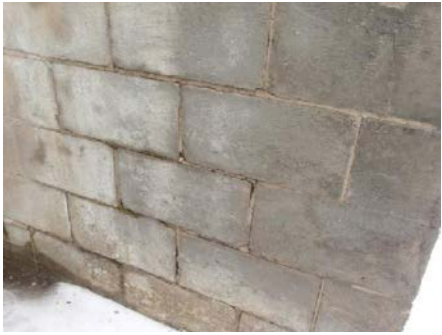
Tool shed: This minor addition, including the perimeter CMU walls and the wood framed flat roof, is poorly constructed and is in poor condition. This shed should be demolished and reconstructed, if it is still needed.

equipment	condition	Est remaining Service life	priority	cost	remarks &recommendations		
	528,Masonry					Masonry Block addition is no longer used and masonry is in poor condition (especially the mortar). Recommend demolition of the addition.

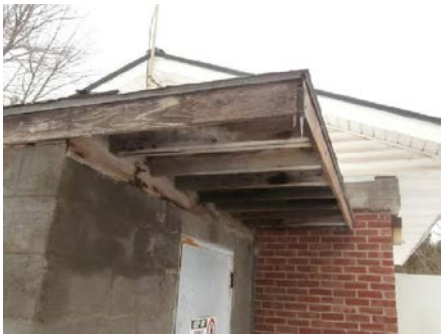
527,Canopy					Canopy overhang inadequately framed and in poor condition.

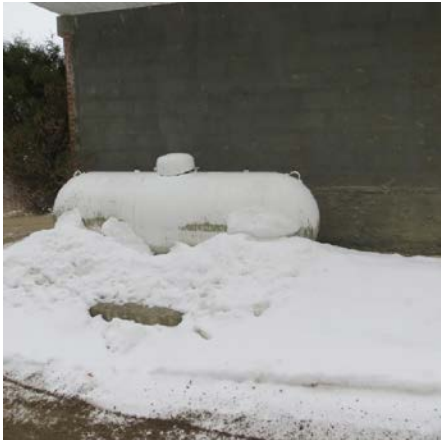
Mechanical								
	Equipment	Condition	Est. Remaining Service Life	Priority	Cost Estimate			
	617,500 Gallon pad mounted LP Gas tank					<p>Serves generator and floor mounted heater on lower level.</p> <p>This is maintained by LP Gas supplier.</p>

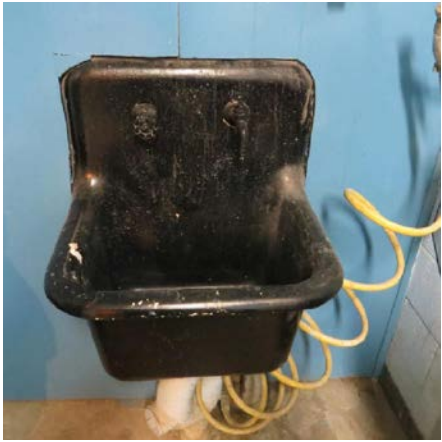
616,Wall-mounted slop sink	3 Fully operational, 25-50% life expectamcy used, periodic problems	5 Years	5	\$1,000 per fixture	<p>Domestic cold water only. Water heater on lower level is no longer in service.</p> <p>Building is not always occupied.</p>

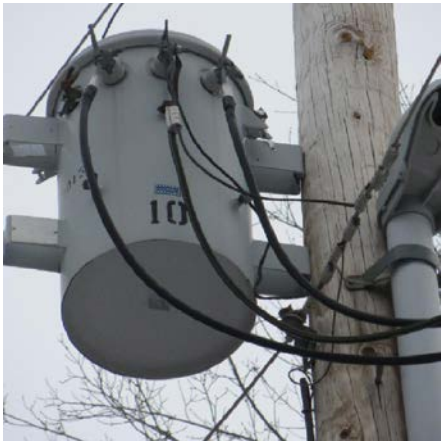
Electrical								
Equipment		Condition	Est. Remaining Service Life	Priority	Cost Estimate	Remarks & Recommendations		
619,10 KVA pole-mounted transformer		2 Fully operational, 0-25% life expectancy used, no issues, no concerns	15 Years	10		Provides power through underground service to the building. Maintained by power supplier.

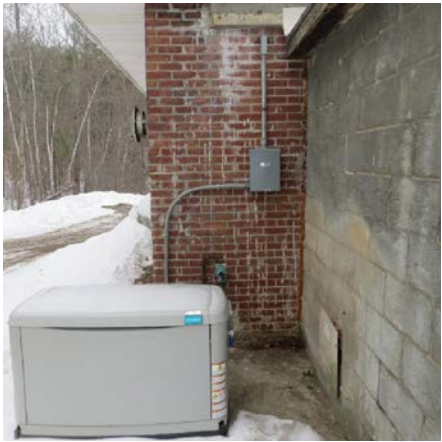
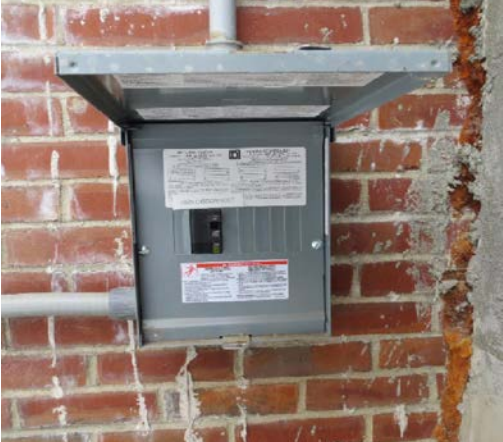
618,14 KV pad mounted LP gas-fired generator w/ 50 – AMP circuit breaker Generator was installed in 2012.		1 Fully operational, new, recently replaced	20 Years	10	\$10,000	Provides emergency power for the complete building.

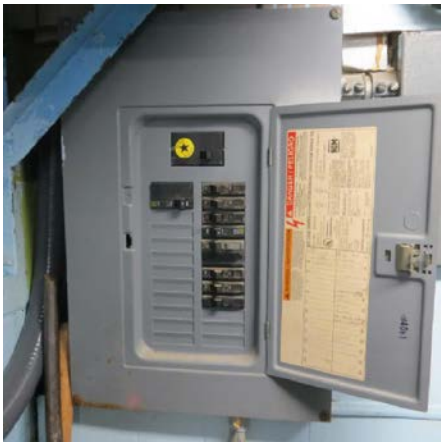
615,Surface mount panel board		4 Operational, 50-75% life expectancy used, occasional problems, frequent repairs needed	5 Years	6	\$600

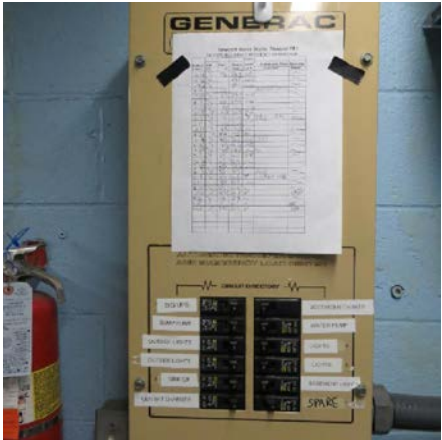
equipment	condition	Est remaining Service life	priority	cost	remarks &recommendations		
	614,Generac generator automatic transfer switch Unknown installation date	3 Fully operational, 25-50% life expectancy used, periodic problems	10 Years	10	\$1,200	Panel appears to be older than generator.

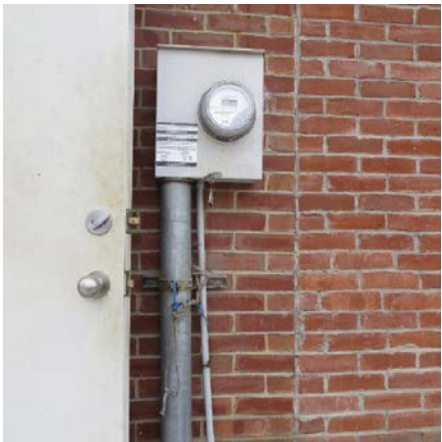
613,Electrical Meter for the building	2 Fully operational, 0-25% life expectancy used, no issues, no concerns	15 Years	10	\$2000	Fed from underground piping. Maintained by power supplier.
