Building: District Court
55 Main Street
Newport, New Hampshire

Town of Newport, Building Assessment July 31,2017

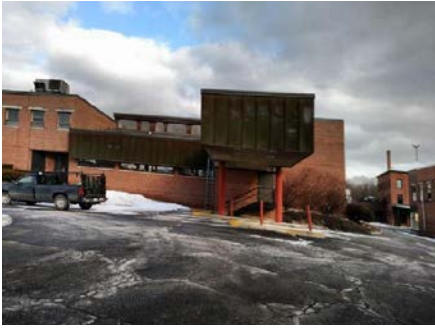
equipment	condition	Est remaining Service life	priority	cost	remarks &recommendations		
	835,Exterior Note:				\$250,000	Drive up teller canopy serves no real purpose and could be removed, enclosing it for a sallyport will be difficult because of grade difference. However This would greatly increase security.

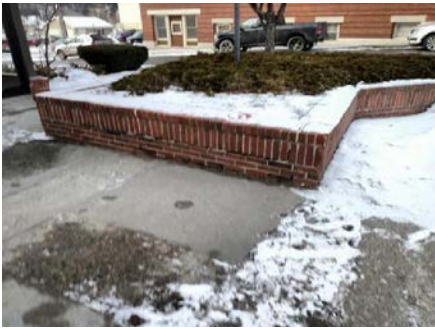
834,Exterior Note:	5	5	5	\$1,500	Exterior planter needs to be repointed.

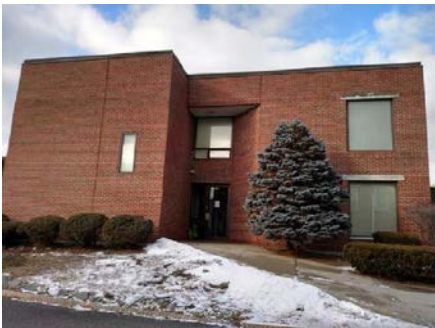
833,Exterior Note:	1	25+	10		Brick and flashing in good condition.

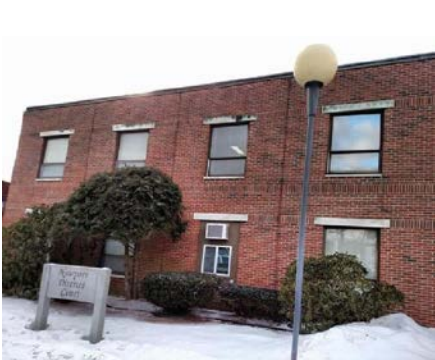
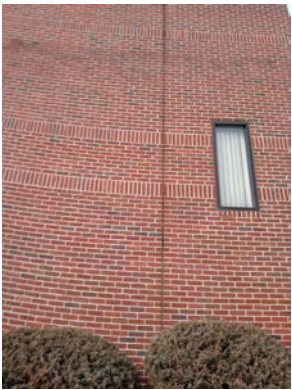
832,Exterior Note:	5	0	4	\$7.00 lineal ft	Re-caulk control joints.

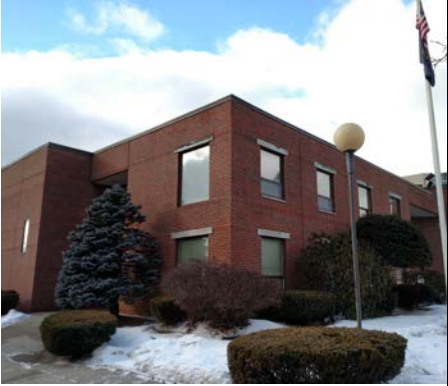
equipment	condition	Est remaining Service life	priority	cost	remarks &recommendations		
	146, Windows	4	5-10y	7	\$50-75 Per square foot	Combination, pella ,alu and other windows all approaching end of life

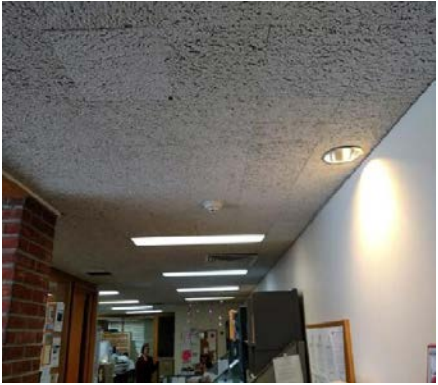
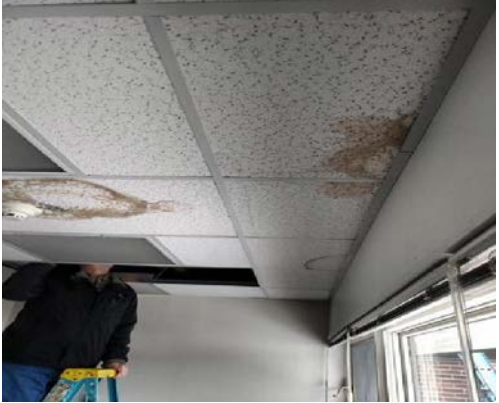
830,Acoustic	4	7	8	\$3.00 sq.ft. Regular 2'x4'	Spline type ceiling is difficult to maintain, suggest replacing when replacing light fixtures.

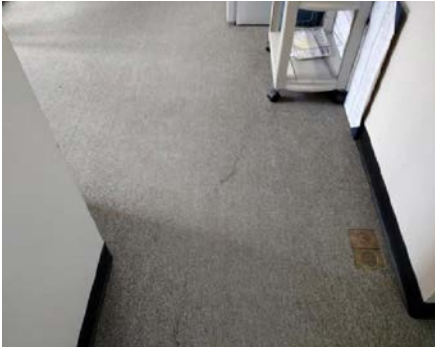
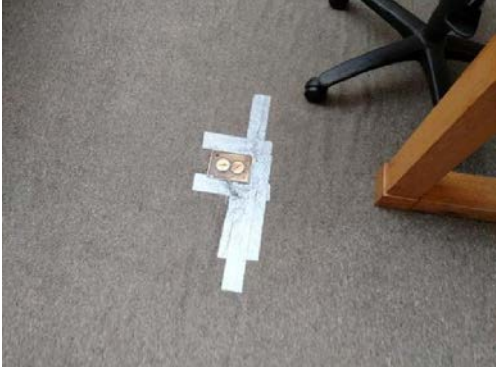
equipment	condition	Est remaining Service life	priority	cost	remarks &recommendations		
	829,Floor Carpet	5	4	5	\$3.00 sq.ft.	Generally replace carpet.

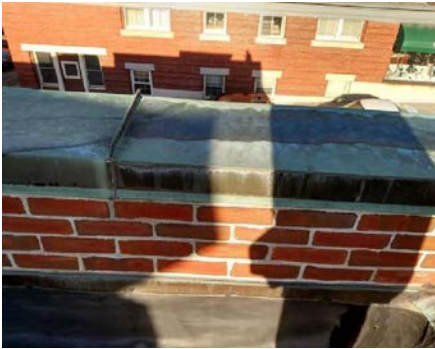
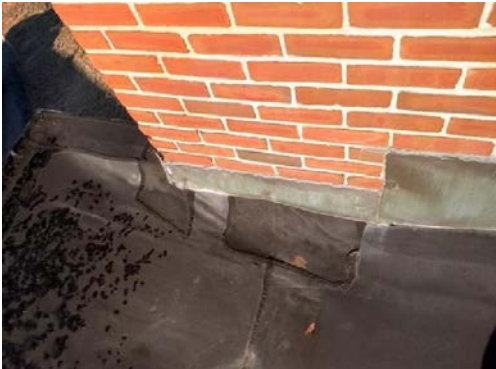
826,Exterior Note:	2	20+	10		Copper flashing appears to be in good condition and should be reused in reroofing.

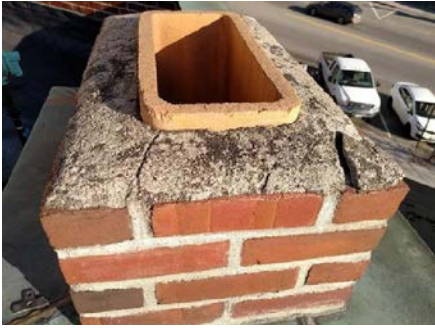
825,Exterior Note:	5	1-2	2	\$500	Repair concrete wash on chimney.

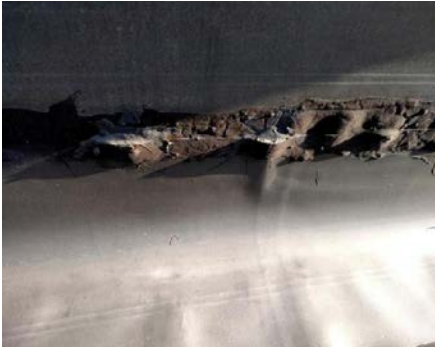
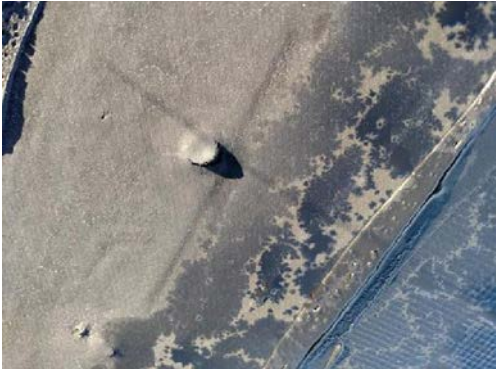
824,Rubber Roof	4	5	4	\$18 sq.ft. 5,105sq.ft. \$91,890	Roof is at end of life and should be replaced.

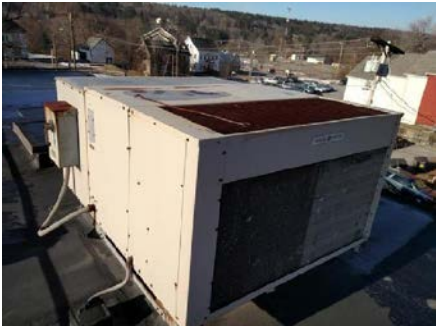
823,Rubber Roof					Remove unused rooftop equipment when replacing roof.

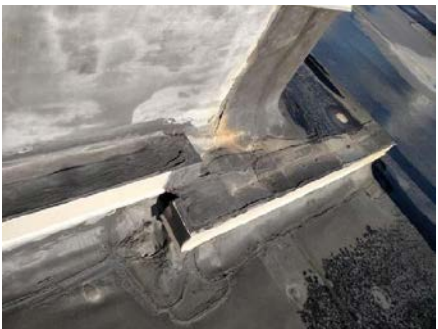
823,Rubber Roof					When roof is replaced, remove non-standard details, follow manufacturer standards at a minimum.

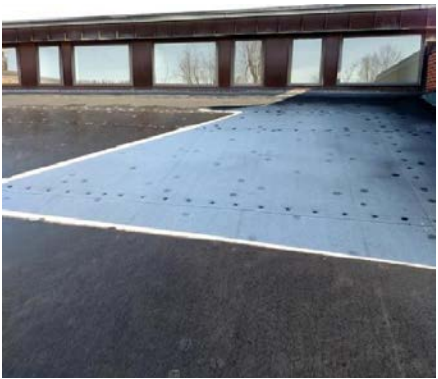
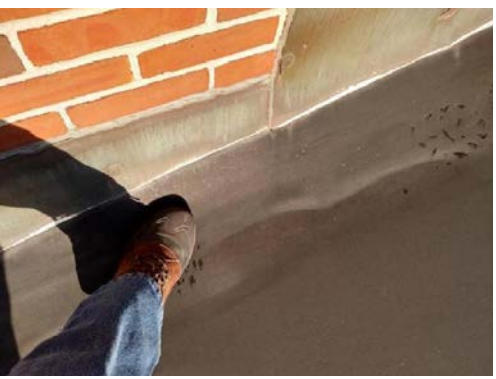
Rubber Roof					Best portion of roof and has been repaired, end of life and should be replaced.

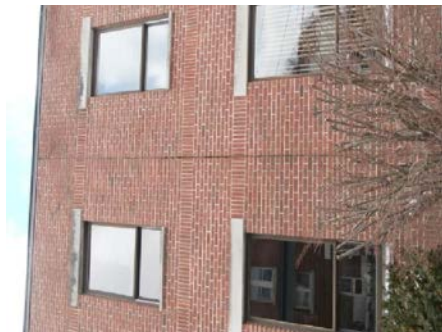
Equipment	Condition	Est. Remaining Service Life	Priority	Cost Estimate			
	215,Caulking					Exterior brick veneer: control joint filler is cracked and needs to be replaced - typical all around building.

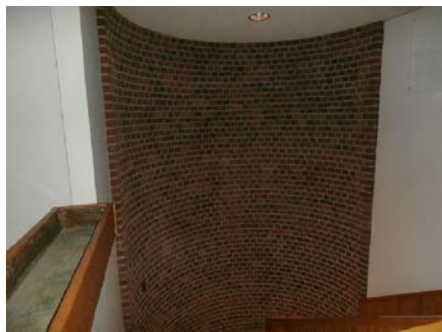
Slab on Grade					First Floor: Slab on Grade (no basement) - For info only.		
	213,Seismic Vulnerability					Decorative brick wall unrestrained at top of wall.

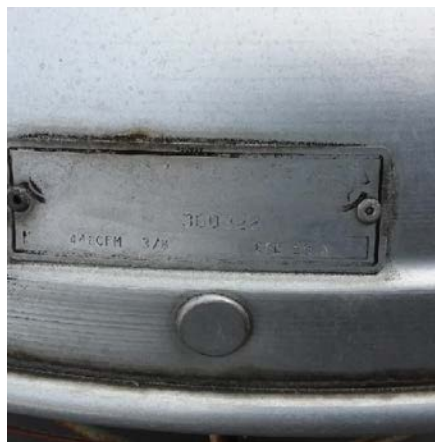
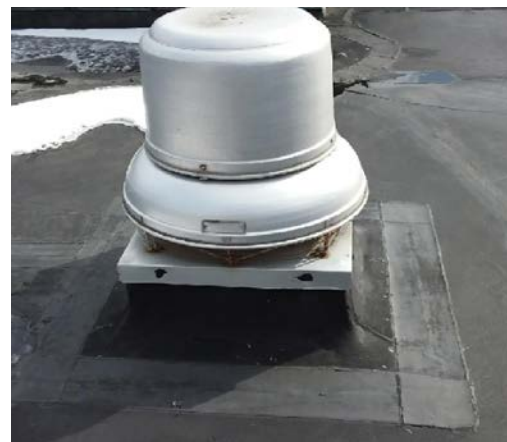
equipment	condition	Est remaining Service life	priority	cost	remarks & recommendations	
Mechanical							
	Equipment	Condition	Est. Remaining Service Life	Priority	Cost Estimate		
	566,Rooftop curb mounted E.F.	3 Fully operational, 25-50% life expectancy used, periodic problems	10 Years	10	\$2,500	Unable to determine what this fan serves and unable to retrieve info on nameplate. Recommend annual inspection.	   
565,Rooftop curb mounted E.F.	3 Fully operational, 25-50% life expectancy used, periodic problems	10 Years	10	\$2,500	Fan exhausts bathrooms. Unable to retrieve information on nameplate. Recommend annual inspection.

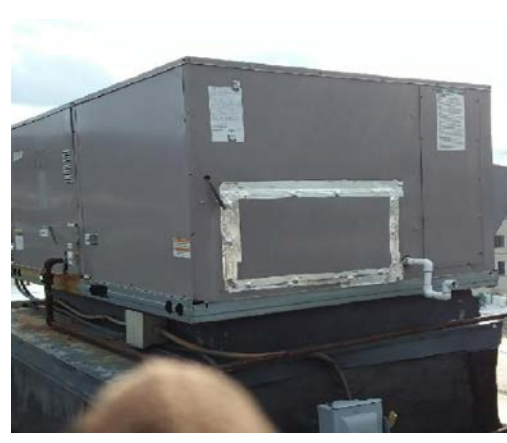
564,180,000 BTU Gas Fire Rooftop Unit w/DX Coil Installed in 2008	4 Operational, 50- 75% life expectancy used, occasional problems, frequent repairs needed	15 Years	10	\$8,500	Unit is installed on a retro fitted curb.

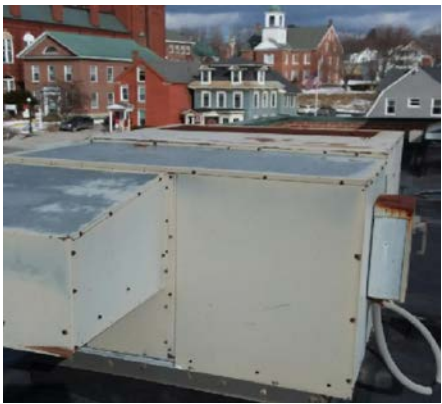
equipment	condition	Est remaining Service life	priority	cost	remarks &recommendations		
	563,Abandoned rooftop unit					Unit is still in place but no longer in service. Should be removed if/when roof is replaced.

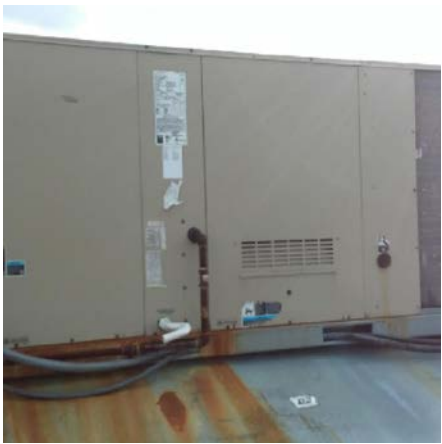
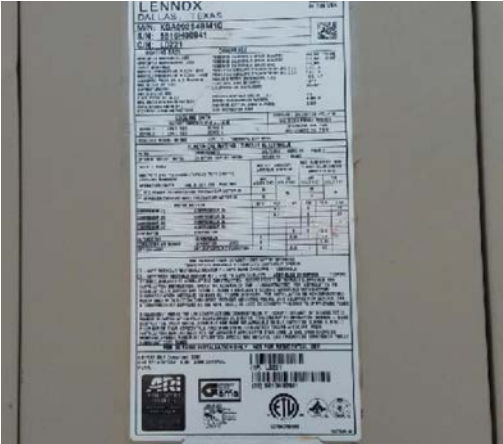
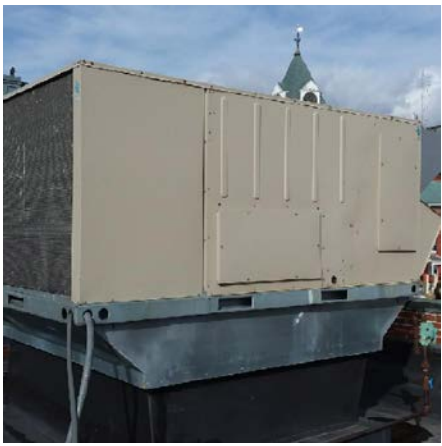
562,180,000 BTU Gas Fired Rooftop Unit w/DX Coil Installed in 2011	2 Fully operational, 0-25% life expectancy used, no issues, no concerns	15 Years	10	\$8,500	Rooftop unit is mounted on existing curb with curb adapter.

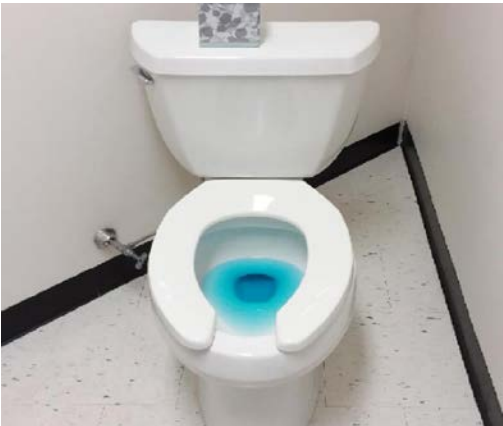
549,Floor mounted tank type toilet Wall mounted lavatory single valve faucet	3 Fully operational, 25-50% life expectancy used, periodic problems	10 Years	10	\$1,000 per fixtures	Fixtures are not the water conserve type.

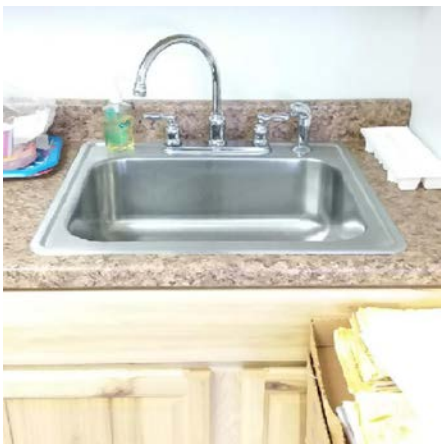
556,Countertop lavatory with dual handle faucet	3 Fully operational, 25-50% life expectancy used, periodic problems	10 Years	10	\$1,000 per fixtures	Fixtures are not the water conserve type.

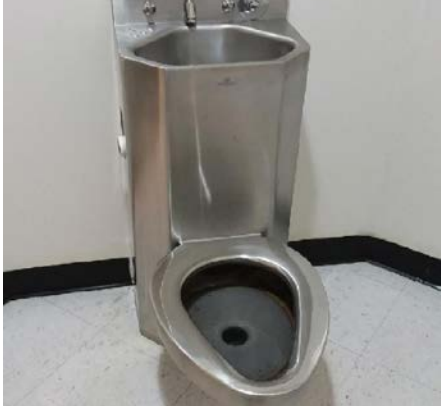
557,Tamper-proof combination toilet and lavatory for one holding cell	2 Fully operational, 0-25% life expectancy used, no issues, no concerns	15 Years	10	\$1,500	Recommend bi-annual inspection for damage.

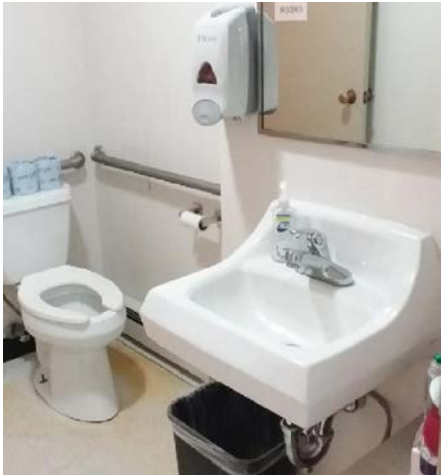
equipment	condition	Est remaining Service life	priority	cost	remarks &recommendations		
	551,Wall mount lavatory single handle faucet Wall mount single handle flush valve urinal Floor Mount tank type toilet fixtures of typical for both men's and women's bathrooms	3 Fully operational, 25-50% life expectancy used, periodic problems	10 Years	10	\$1,000 per fixtures	Fixtures are not the water conserve type.

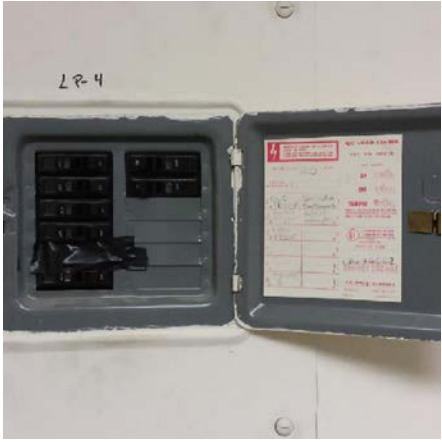
Equipment	Condition	Est. Remaining Service Life	Priority	Cost Estimate	Remarks & Recommendations		
	548,100- AMP Flush Mount Sub Panel Unknown date of install	4 Operational, 25-50% life expectancy used, occasional problems, frequent repairs needed	5 Years	5	\$350	Panelboard requires blank plate over open space.

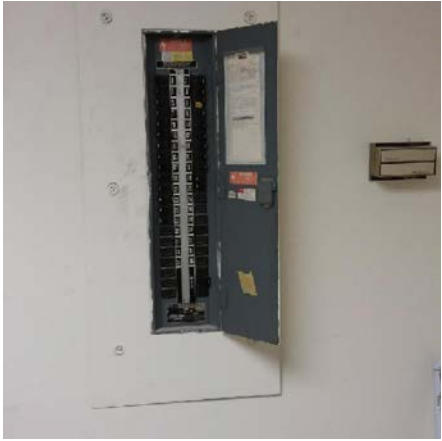
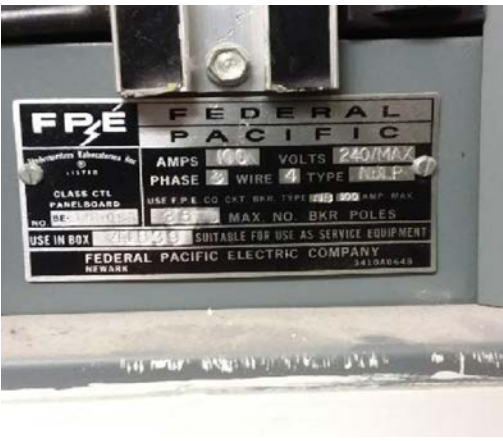
547,100 - AMP 240 Volt 3 Phase Flush Mount Panelboard	4 Operational, 25-50% life expectancy used, occasional problems, frequent repairs needed	5 Years	5	\$1,000

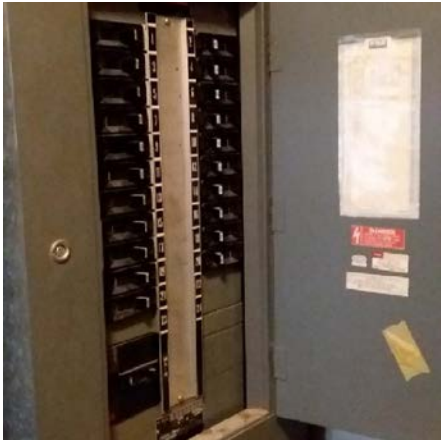
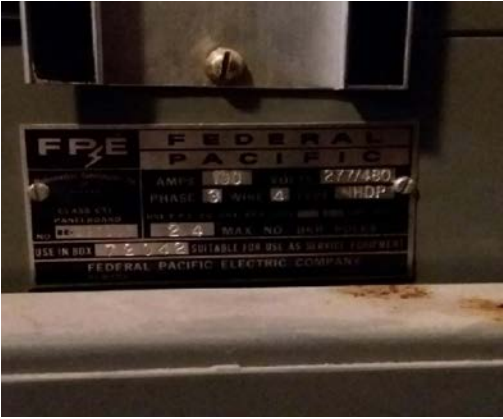
554,100 - AMP 277 / 480 Volt 3-Phase surface mount panel	4 Operational, 25- 50% life expectancy used, occasional problems, frequent repairs needed	5 Years	5	\$1,000

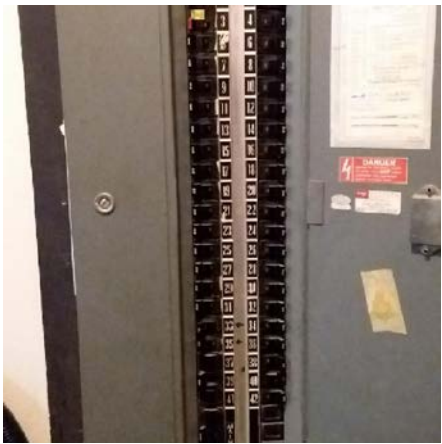
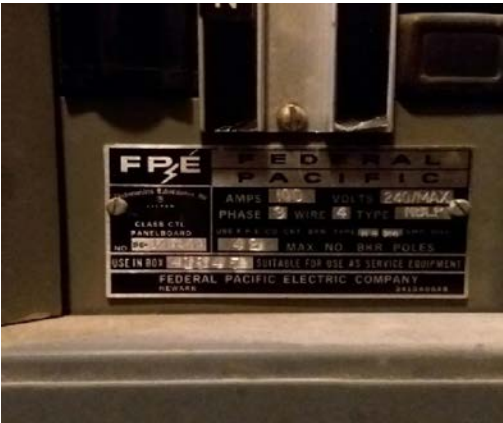
equipment	condition	Est remaining Service life	priority	cost	remarks &recommendations		
	553,100 – AMP 240 volt surface mount panelboard	4 Operational, 25- 50% life expectancy used, occasional problems, frequent repairs needed	5 Years	5	\$1,000

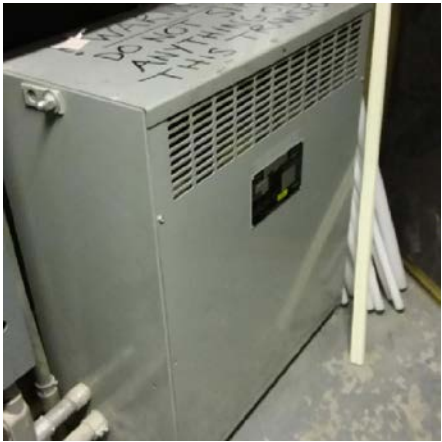
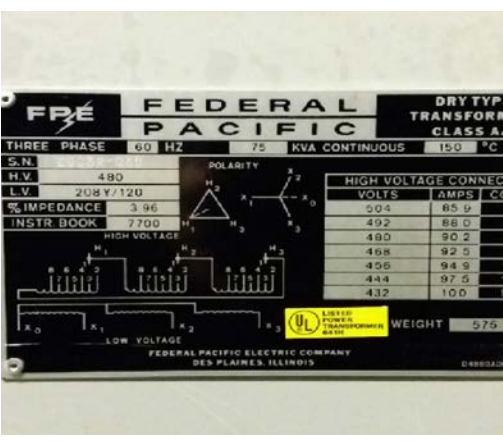
535, Floor mounted 75 KVA transformer	5 Operational only with constant attention, 100% life expectancy used, failure imminent		10		Transformer is no longer in service. Transformer was previously used for the electric heated sidewalks.

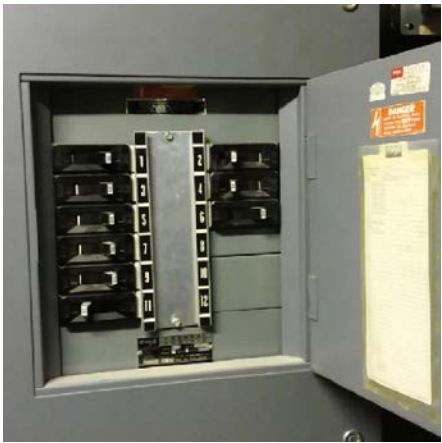
534, 100 – AMP 277 / 480-Volt 3 phase snow-melting	5 Operational only with constant attention, 100% life expectancy used, failure imminent				Panelboard is no longer in service but in place. Existing snow melting no longer in service.

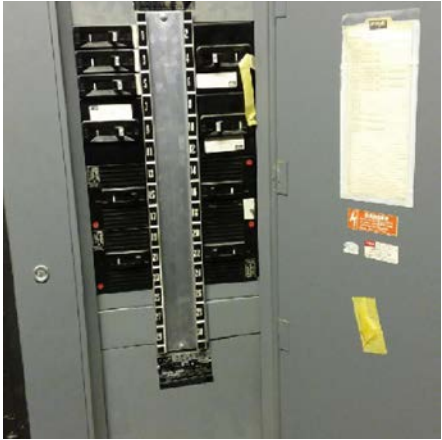
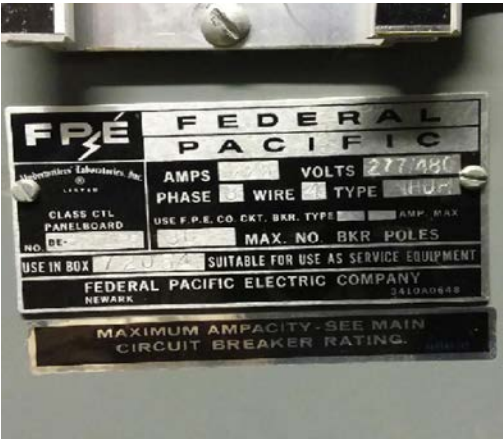
equipment	condition	Est remaining Service life	priority	cost	remarks & recommendations		
	533, 225 – AMP 277 /480 Volt 3-phase Panelboard	4 Operational, 25-50% life expectancy used, occasional problems, frequent repairs needed	5 Years	5	\$4,000

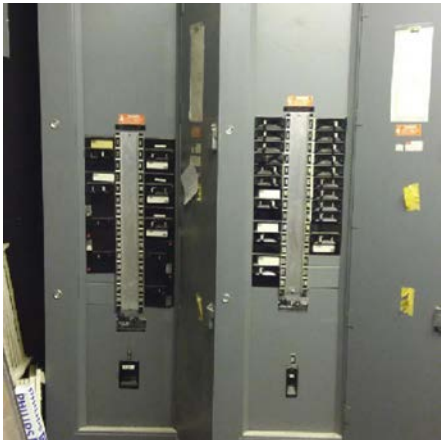
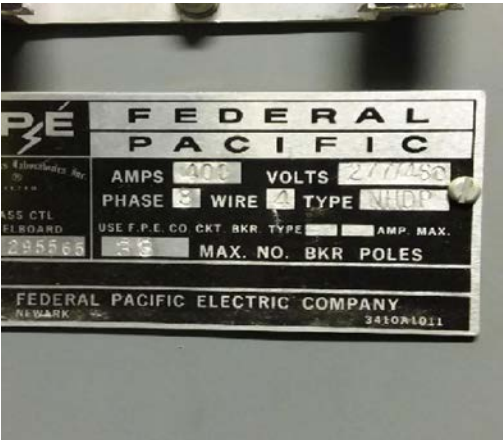
532, Two 400 - AMP 277 / 480 Volt 3 phase Panelboards	4 Operational, 25-50% life expectancy used, occasional problems, frequent repairs needed	5 Years	5	\$8,000

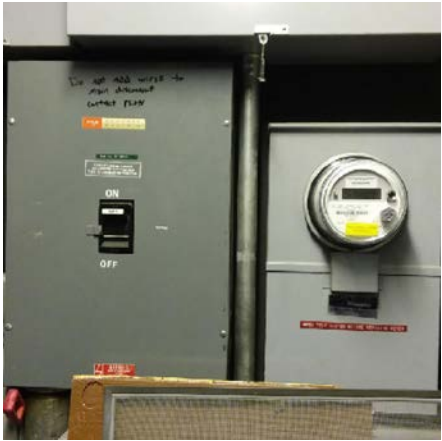
531, 400 – AMP main disconnect with meter fed from pad mounted transformer	4 Operational, 25-50% life expectancy used, occasional problems, frequent repairs needed	5 Years	5	\$1,000

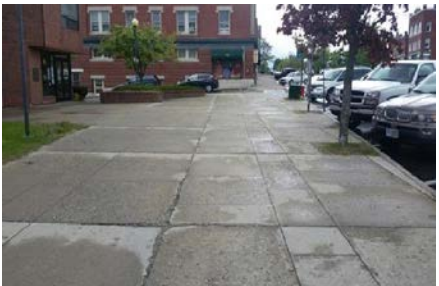
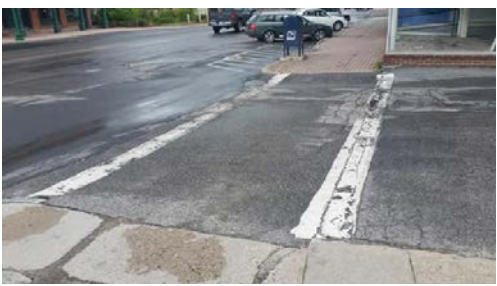
Site								
	Concrete sidewalk at the front side of the building is weathered and worn, especially at the edges of the concrete slabs. Crosswalks show cracking and settlements. The asphalt pavements for the driveway and parking areas to the side and rear of the building show evidence of surface wear (polishing), transverse cracking (along the driveway), transverse and longitudinal cracking, as well as alligator cracking. Potholes, with evidence of sub grade fines pumping were noted at the entrance to the parking lot at West Street.							
	Equipment	Condition	Est. Remaining Service Life	Priority	Cost Estimate	Remarks & Recommendations	Photos	
	Pavement	5	5	3	\$25.00 sq.ft. 5.984 sq.ft	Cracked weathered and eroded concrete sidewalk at front of the courthouse. Suggest pavers to match existing sidewalk standard

Pavement	5	4	5	PT \$2.80 sq.ft. 15,608 sq.ft. PF \$7.17 sq.ft.	Alligator and transverse/ longitudinal cracking at the rear of the courthouse.
