Building: Fire Station  
11 Sunapee Street  
Newport, New Hampshire

Town of Newport, Building Assessment July 31,2017

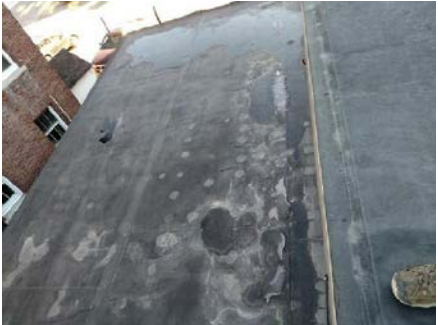
| | equipment | condition | Est remaining<br>Service life | priority | cost | remarks &recommendations | | |
|--|---|---|---|---|---|---|---|---|
| | 739,Rubber Roof | 3 | 5 | 3 | \$18<br>1,200 sq.ft<br>\$21,600 | No apparent issues with<br>this roof but age ,difficulty<br>of access and replacement<br>of upper warrants<br>replacement | | |

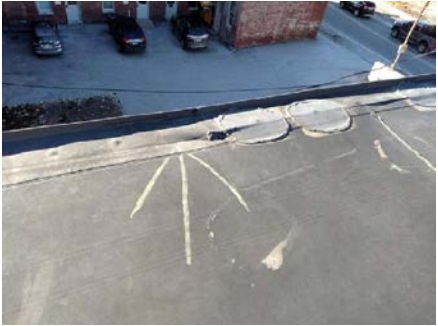
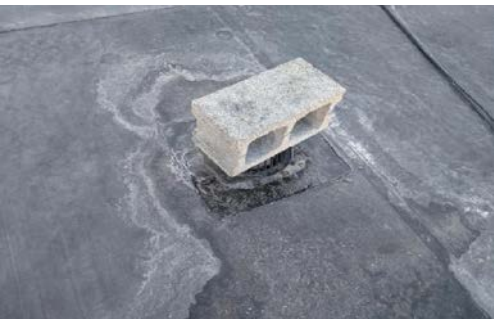
| | equipment | condition | Est remaining<br>Service life | priority | cost | remarks &recommendations | | |
|--|---|---|---|---|---|---|---|---|
| | 738,Rubber Roof | 5 | 1 | 3 | \$18<br>2,400sq.ft<br>\$43,200 | While newer than the<br>lower roof, multiple<br>repairs have been done to<br>this roof. | | |

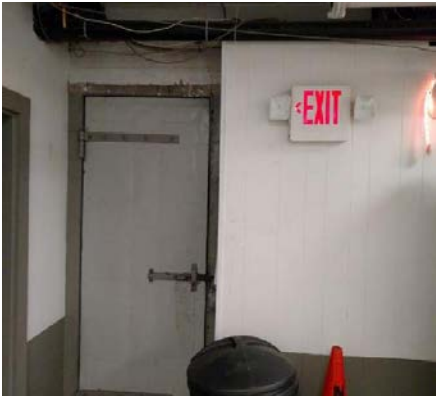
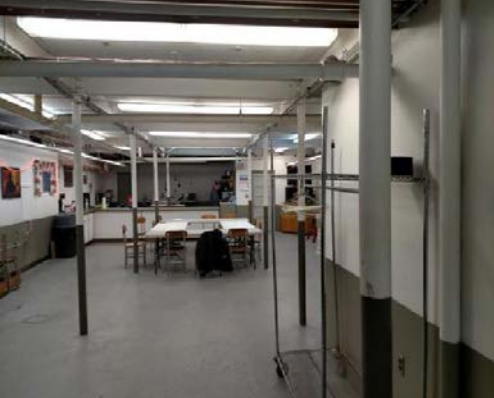
| | equipment | condition | Est remaining<br>Service life | priority | cost | remarks &recommendations | | |
|--|---|---|---|---|---|---|---|---|
| | 737,Code Issue: | 5 | | 1 | \$60,000 | Basement is accessed by<br>non-compliant fire stair<br>which is not rated. It has<br>open doors and exits into<br>the apparatus bay, with a<br>second egress up a few<br>steps and out an alley. All<br>at the same end of the hall.<br>This is not a good<br>situation for the staff and<br>there should be no public<br>meetings in this hall. | | |

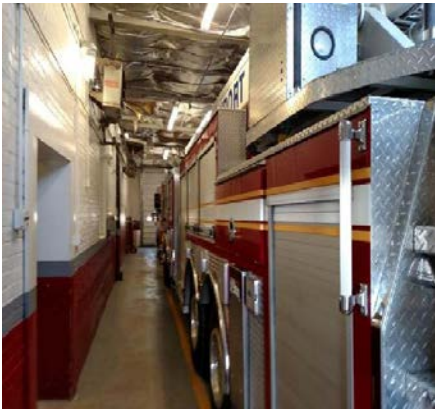
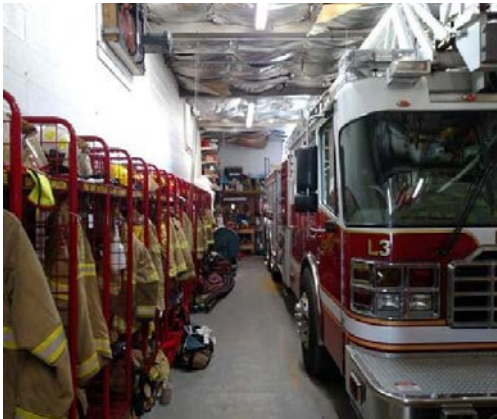
| | equipment | condition | Est remaining<br>Service life | priority | cost | remarks &recommendations | | |
|--|---|---|---|---|---|---|---|---|
| | 735,General Comment: | | | | | EXTREMELY TIGHT clearances everywhere, eventually may not be able to special order apparatus that will fit in ceiling height. Additionally, expensive equipment is in the open with exposure to damage.<br>While they have made the most of limited space, in a fire, the lack of space must hinder response time. | | |

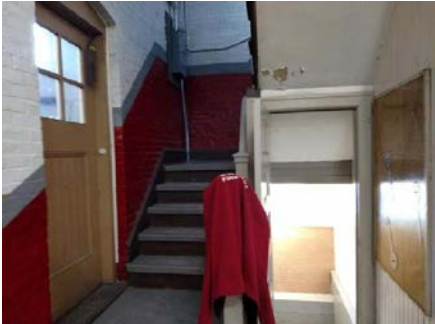
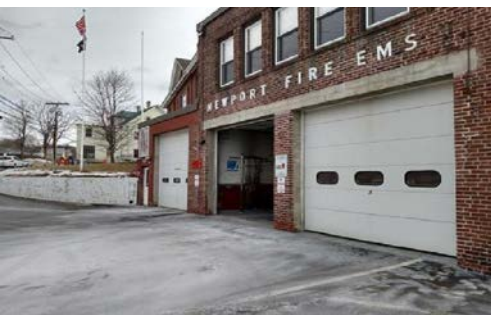
| | equipment | condition | Est remaining<br>Service life | priority | cost | remarks &recommendations | | |
|--|---|---|---|---|---|---|---|---|
| | 732,ADA | | | | | Main entrance and<br>quickest exit from stair<br>does not meet ADA<br>requirements. Only<br>ADA entrance is thru the<br>apparatus apron and then<br>there are no toilets or<br>vertical transport to the<br>second floor. | | |

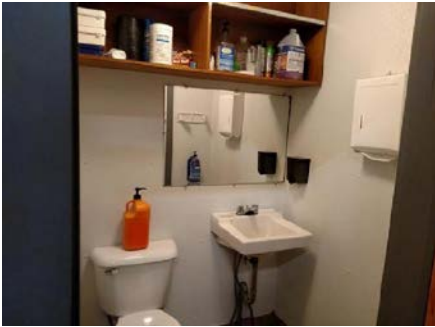
| | equipment | condition | Est remaining<br>Service life | priority | cost | remarks &recommendations | | |
|--|---|---|---|---|---|---|---|---|
| | ADA | | | | \$15,000 | Toilet not ADA. | | |

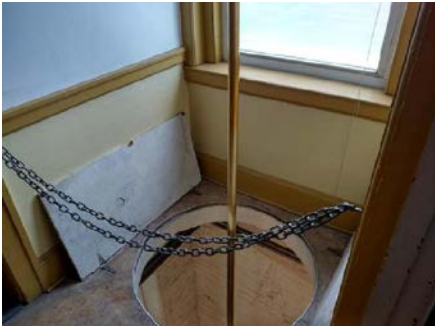
| | equipment | condition | Est remaining<br>Service life | priority | cost | remarks &recommendations | | |
|--|---|---|---|---|---|---|---|---|
| | 872,Code Issue: | | | | | Fire pole should be<br>upgraded with safety<br>features. | | |

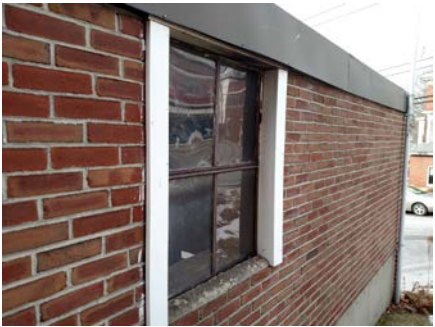
| | equipment | condition | Est remaining<br>Service life | priority | cost | remarks & recommendations | | |
|--|---|---|---|---|---|---|---|--|
| | 736,Window | 4 | 5+ | 8 | \$ 1,000<br>per<br>opening | Second floor has newer<br>vinyl windows.<br>Schedule replacement<br>of main floor windows<br>sills should be corrected<br>at the same time | | |

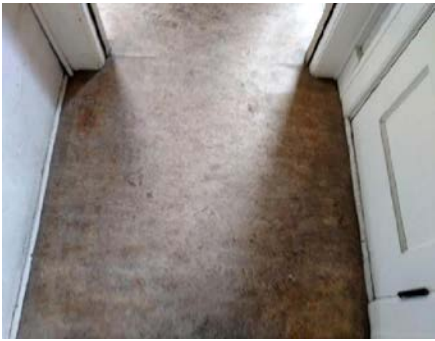
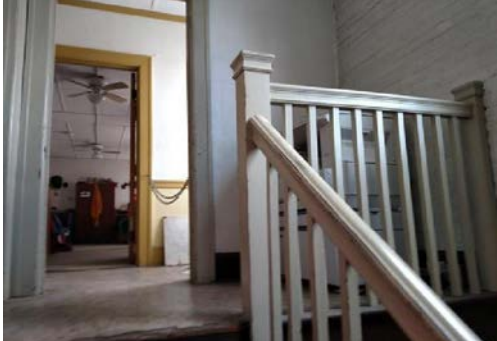
| | equipment | condition | Est remaining<br>Service life | priority | cost | remarks & recommendations | | |
|--|---|---|---|---|---|---|---|--|
| | 729,Flooring | 4 | 1-5 | 6 | \$3-6 sq.ft | Corridor flooring should<br>be replaced, especially at<br>stairs to prevent tripping.<br>And surfaces in general<br>upgraded | | |

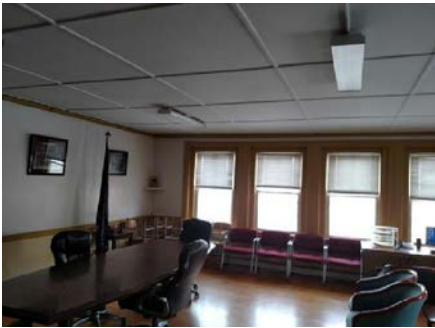
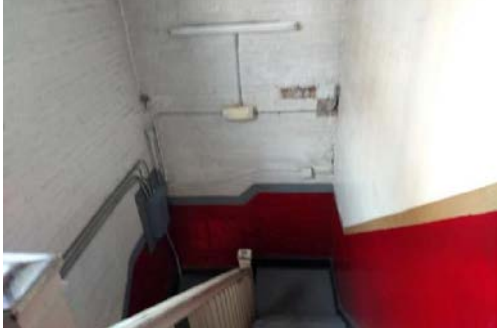
| | equipment | condition | Est remaining<br>Service life | priority | cost | remarks & recommendations | | |
|--|---|---|---|---|---|---|---|--|
| | 728, Code Issue: | | | 1 | \$85,000 | One non-rated, non-<br>enclosed stair from the<br>second floor: offices,<br>dormitory and meeting<br>room. | | |

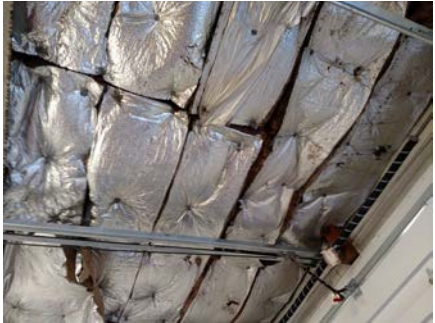
| | equipment | condition | Est remaining<br>Service life | priority | cost | remarks & recommendations | | |
|--|---|---|---|---|---|---|---|--|
| | Loose insulation | 5 | 0 | 8 | | Should close up gaps<br>in insulation; replace with<br>new would be best. | | |

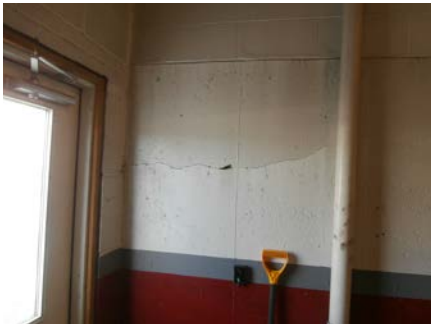
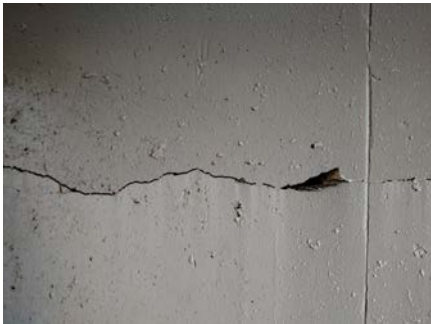
| | equipment | condition | Est remaining<br>Service life | priority | cost | remarks &recommendations | | |
|---|---|---|---|---|---|---|---|---|
| | 596,Foundation | | | | | Horizontal crack in concrete foundation, long side wall, near man door. Foundation not designed to retain earth. CMU above foundation restrained by the building corner, but foundation below has rotated inward to cause the crack. | | |

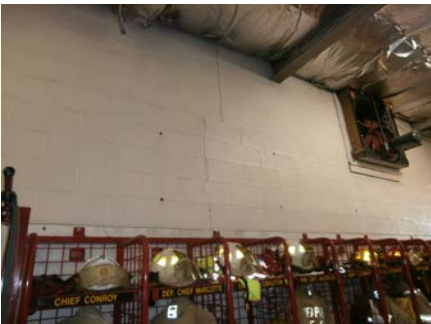
| | equipment | condition | Est remaining<br>Service life | priority | cost | remarks &recommendations | | |
|---|---|---|---|---|---|---|---|---|
| 210,Bearing Wall | | | | | 8” CMU bearing wall - can’t determine if this wall is reinforced. Vertical crack midway down the CMU wall, due to lack of control joints in this long side wall. | | | |

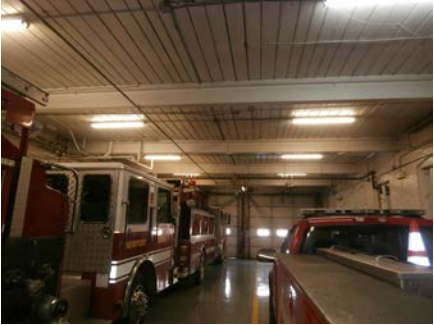
| | equipment | condition | Est remaining<br>Service life | priority | cost | remarks & recommendations | | |
|--|---|---|---|---|---|---|---|---|
| | 208,Seismic<br>Vulnerability | | | | | Unreinforced masonry building predates seismic design standards. Inherent vulnerability due to seismic forces due to apparatus bay doors at one end. | | |

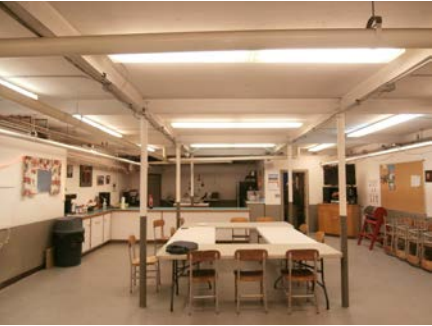
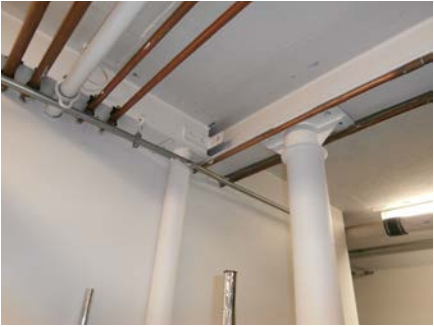
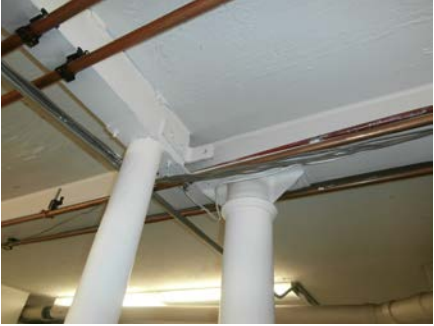
| | equipment | condition | Est remaining<br>Service life | priority | cost | remarks & recommendations | | |
|--|---|---|---|---|---|---|---|---|
| | 206,Load Condition | | | | | Further review of slab and framing is recommended. Framing appears undersized for the vehicular loads of the apparatus bay and the floor was probably designed to support lighter equipment. | | |
| | 205,Floor Framing | | | | | Main Floor (Apparatus Bay), original building: 7" cast in place concrete slab on structural steel framing, supported by steel pipe columns. 3 bays in transverse direction (two interior lines of columns) typical bay is approx. 8'-8" x 10'-4". Steel beams are typically 10" deep in both directions. Numerous misaligned bolt holes in the framing connections (beam-to beam and beam-to-column) – many connections were welded as a result, and in two cases, additional columns were added to compensate for poor connection fit up. | | <br> |

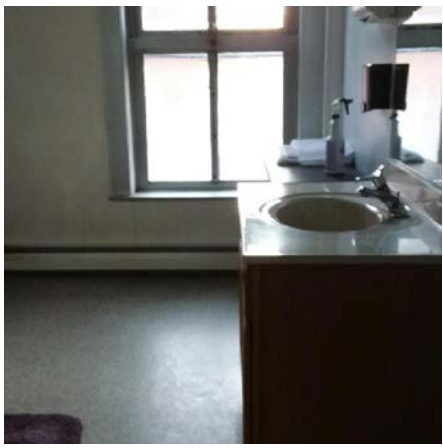
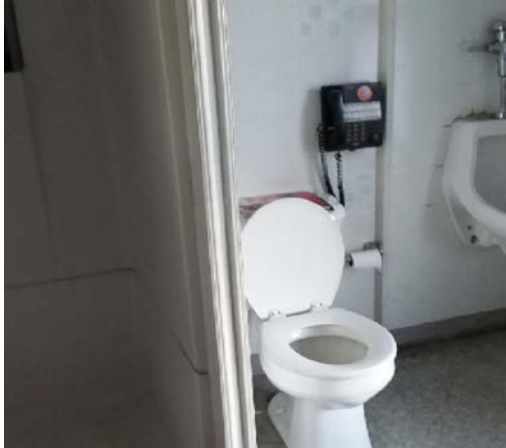
| | Equipment | Condition | Est. Remaining<br>Service Life | Priority | Cost Estimate | | | |
|--|---|---|---|---|---|---|---|---|
| | 53,Bathroom<br>w/shower, urinal, toilet<br>and lavatory | 3<br>Fully operational,<br>25-50% life<br>expectancy used,<br>periodic<br>problems | 10 Years | 10 | \$1,000 per<br>fixture | Fixtures are not water<br>conserving type, | | |

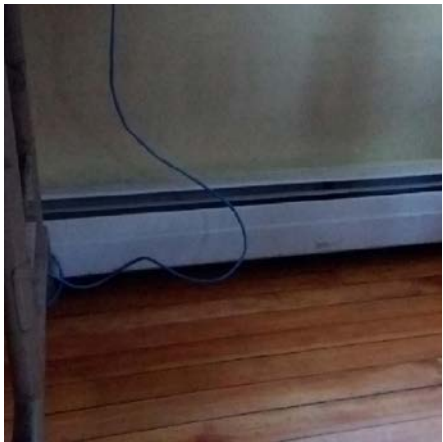
| | Equipment | Condition | Est. Remaining<br>Service Life | Priority | Cost Estimate | | | |
|--|---|---|---|---|---|---|---|---|
| | 48,Hot Water Fin Tube<br>Radiation | 3<br>Fully operational,<br>25-50% life<br>expectancy used,<br>periodic<br>problems | 10 Years | 10 | \$150 per<br>foot | Fintube is controlled by<br>wall-mounted<br>thermostats. Typical<br>throughout second level. | | |

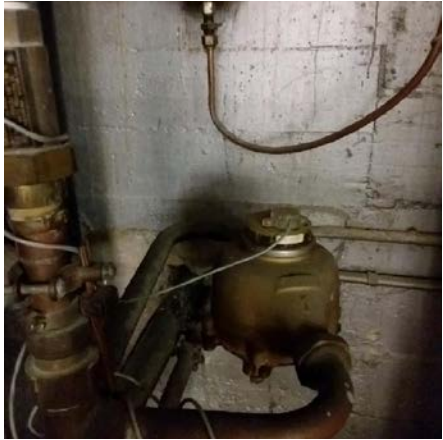
| | equipment | condition | Est remaining<br>Service life | priority | cost | remarks & recommendations | | |
|--|---|---|---|---|---|---|---|--|
| | 40,Water Entrance | 2 | 15 | 1 | \$800 | Three-quarter inch copper water entrance with remote meter read.<br><br>There is also an unmetered two inch water entrance piped to the apparatus bay to fill fire apparatus.<br><br>Maintained by water dept. | | |

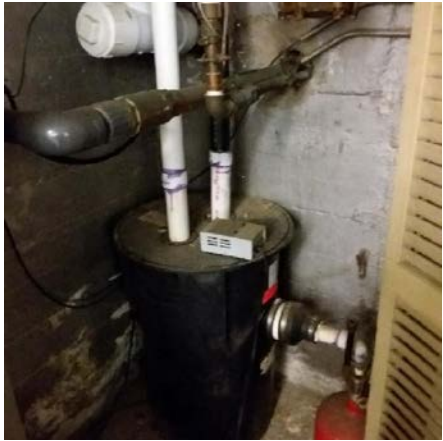
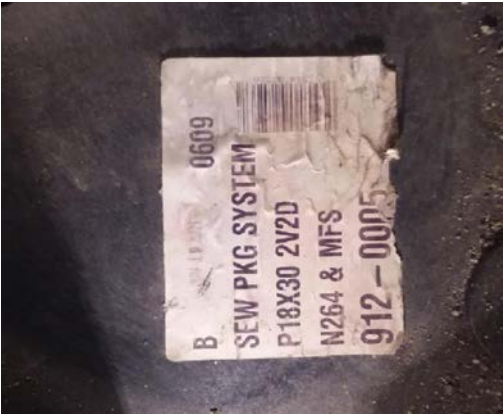
| | equipment | condition | Est remaining<br>Service life | priority | cost | remarks & recommendations | | |
|--|---|---|---|---|---|---|---|--|
| | 38,Sewer Ejector pump | 2<br>Fully operational, 0-25% life expectancy used, no issues, no concerns | 15 Years | 10 | | Floor mounted sewage pump for lower-level kitchen is pumped to town sewer.<br><br>Exposed waste and vent piping in lower level is PVC. | | |

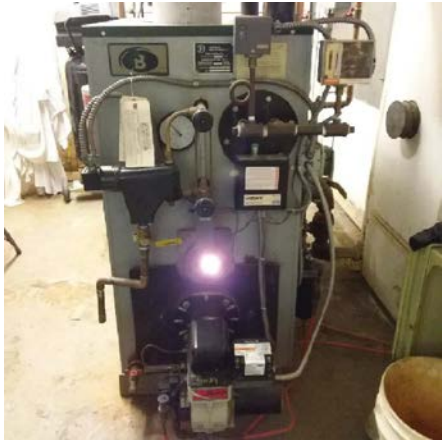
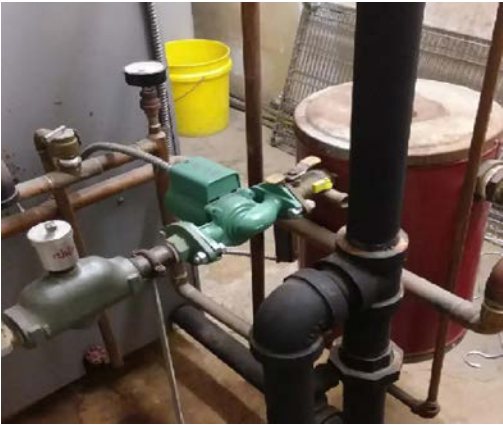
| | equipment | condition | Est remaining<br>Service life | priority | cost | remarks & recommendations | | |
|--|---|---|---|---|---|---|---|--|
| | 36, 389,000 BTU Oil Fired Boiler<br><br>Model: Kingsley SC-08 | 3<br>Fully operational, 25-50% life expectancy used, periodic problems | 10 Years | 10 | \$7,500 | Produces steam to heating terminals and domestic hot water throughout building.<br><br>Domestic hot water is circulated by 2 - TACO circulator pumps.<br><br>Boiler is atmospherically vented two adjacent chimneys.<br><br>Recommend continue annual cleaning. | | |

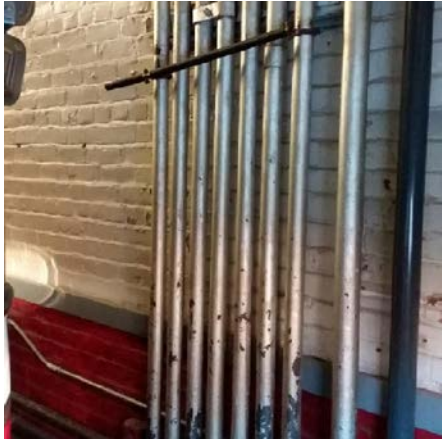
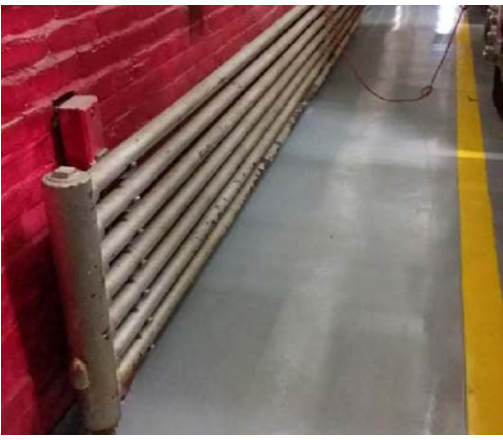
| | equipment | condition | Est remaining<br>Service life | priority | cost | remarks &recommendations | | |
|--|---|---|---|---|---|---|---|---|
| | 44, Exposed Steam Pipe Radiation | | | | | Recommend protection from scalding pipes. | | |

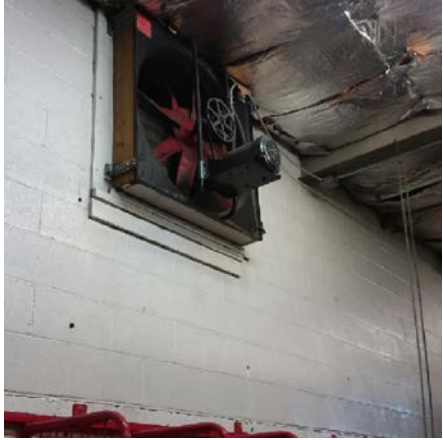
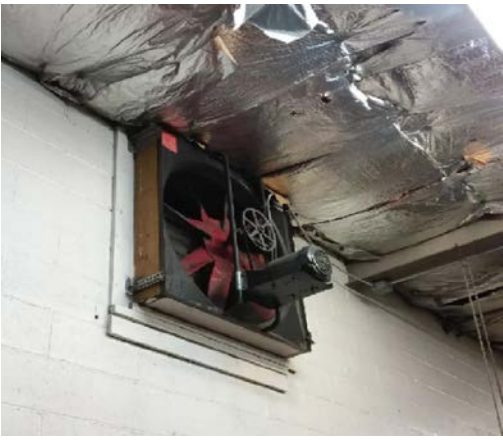
| | equipment | condition | Est remaining<br>Service life | priority | cost | remarks &recommendations | | |
|--|---|---|---|---|---|---|---|---|
| | 43,Sidewall Prop Fan | 3<br>Fully operational,<br>25-50% life<br>expectancy used,<br>periodic<br>problems | 10 Years | 10 | \$3,500 | Exhausts the smaller bay.<br><br>Fan is a source of heat<br>loss during the colder<br>Months. | | |

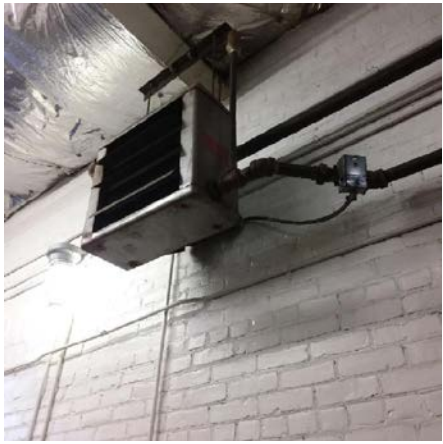
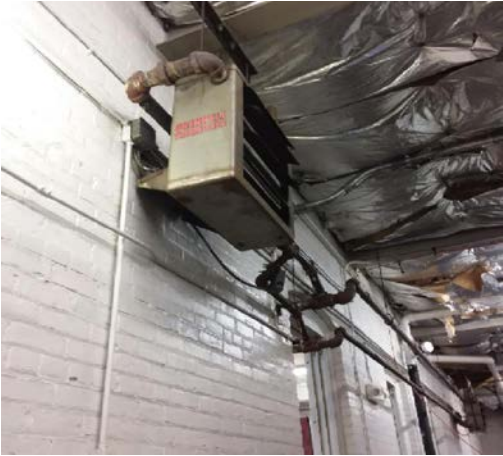
| | equipment | condition | Est remaining<br>Service life | priority | cost | remarks &recommendations | | |
|--|---|---|---|---|---|---|---|---|
| | 41, Steam Unit Heater<br>UH-1 | 3<br>Fully operational,<br>25-50% life<br>expectancy used,<br>periodic<br>problems | 5 to 10<br>Years | 6 | \$5,000 | Ceiling hung fan<br>powered. | | |

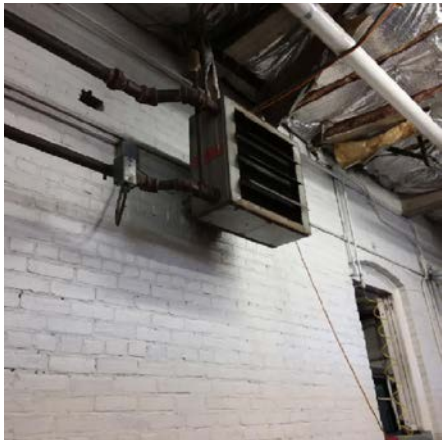
| | equipment | condition | Est remaining<br>Service life | priority | cost | remarks &recommendations | | |
|--|---|---|---|---|---|---|---|---|
| | 42,Steam Unit Heater<br>UH-2 | 3<br>Fully operational,<br>25-50% life<br>expectancy used,<br>periodic<br>problems | 5 to 10<br>Years | 6 | \$5,000 | Ceiling hung fan<br>powered. | | |

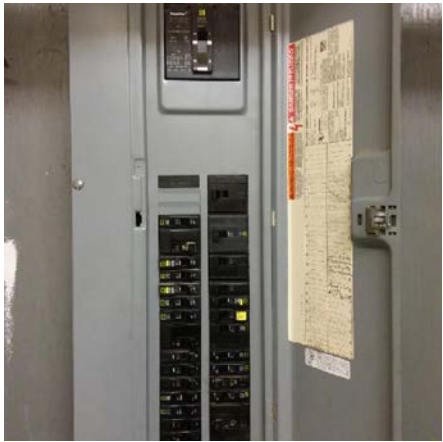
| | Equipment | Condition | Est. Remaining<br>Service Life | Priority | Cost Estimate | Remarks & Recommendations | | |
|--|---|---|---|---|---|---|---|--|
| | 37, 200 – AMP 240 volt surface mount panelboard | 2<br>Fully operational, 0-25% life expectancy used, no issues, no concerns | 15 Years | 10 | \$3000 | This panel is fed from a 200 - AMP breaker from the MDP panel located in town office building. | | |

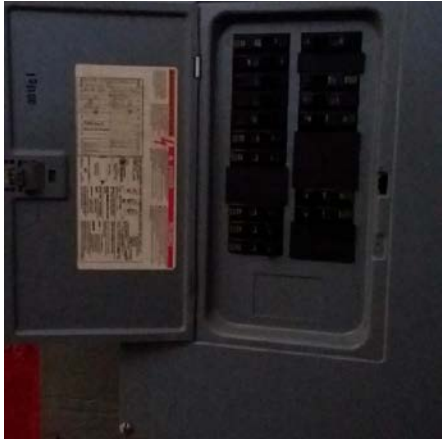
| | equipment | condition | Est remaining<br>Service life | priority | cost | remarks & recommendations | | |
|--|---|---|---|---|---|---|---|--|
| | 47,Electrical<br>Panelboard | 3<br>Fully operational,<br>25-50% life<br>expectancy used,<br>periodic<br>problems | 10 Years | 10 | \$600 | Surface mount<br>panelboard fed from<br>50 - AMP breaker in main<br>panelboard. | | |
