Town of Newport, New Hampshire

Building Assessment | July 31, 2017

Building: Gazebo/Info Booth
1 North Main Street
Newport, New Hampshire

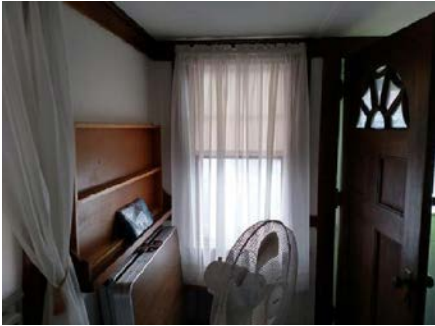
equipment	condition	Est remaining Service life	priority	cost	remarks &recommendations		
	<u>839,Info Booth</u> ADA					Space does not meet ADA requirements.

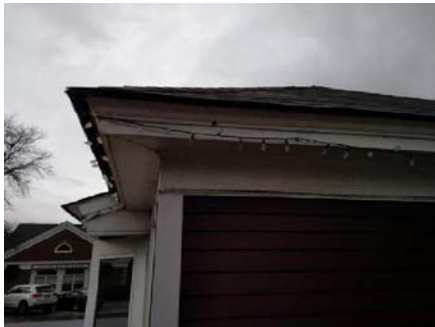
<u>838,Info Booth</u> Paint Surface			7	\$ 2.50 sq.ft	Paint all surfaces.

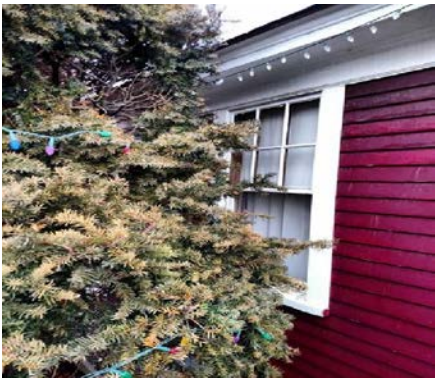
<u>837,Info Booth</u> Exterior Note:	4	4	2	\$100	Cut back shrubs at least 3' from buildings typical.

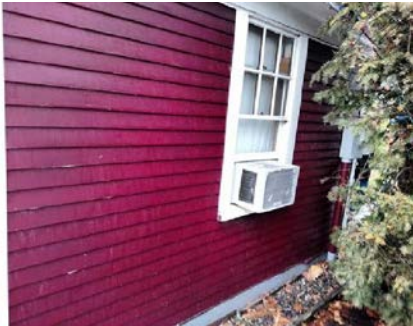
<u>836,Info Booth</u> Exterior wood siding	3	15	10	\$2.50/sq.ft .Paint	Clapboard in good condition.

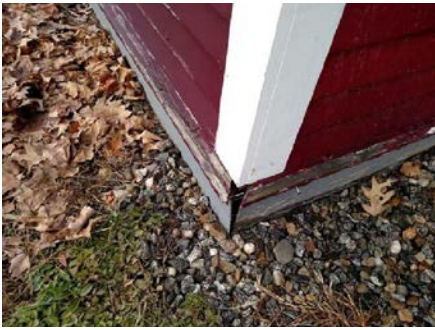
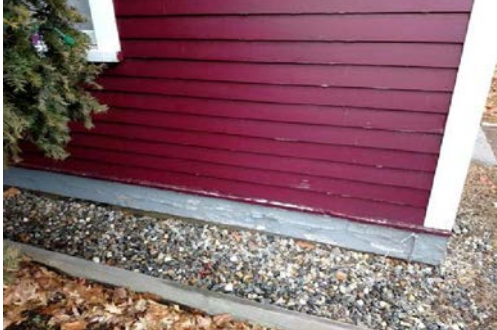
equipment	condition	Est remaining Service life	priority	cost	remarks &recommendations		
	<u>426,Info Booth</u> General Comment:	4	2	2	\$1,000	Building appears to have concrete foundation skirt boards that are in stone, need to lower grade 6".

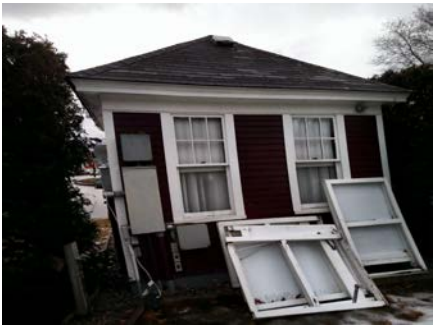
<u>Y840Info Booth</u> Roof	4	5	6	\$ 7.00 sq.ft 200 sq.ft. \$1,400	Roof is beginning to weather replacement should be planned.

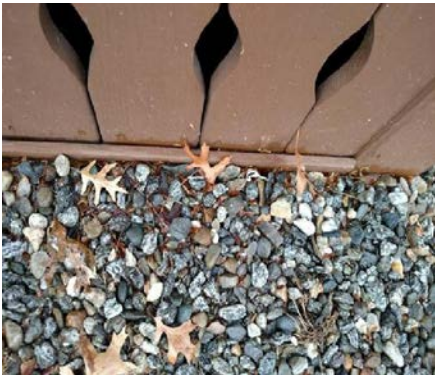
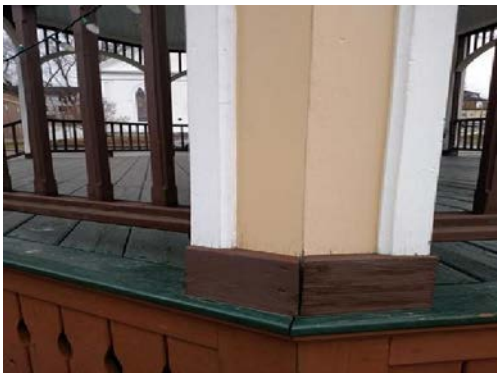
<u>425,Gazebo</u> General Comment:	2	4	6	\$ 2.50 sq.ft	Skirt newer and appear pt, underpinning pt only comment could use paint and lower grade as skirt is in stone.

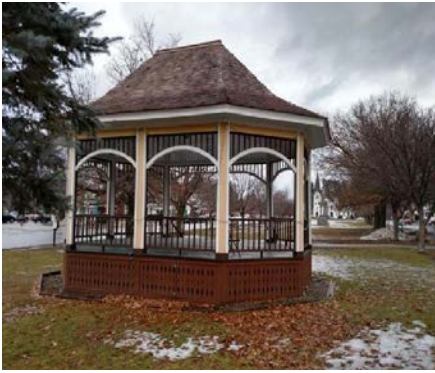
<u>423,Gazebo</u> Roof	1	45	10		New wood roof expected life 50 years.

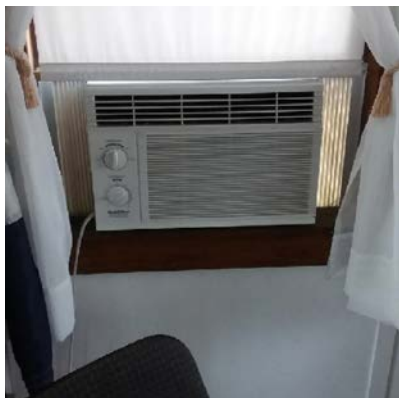
Equipment	Condition	Est. Remaining Service Life	Priority	Cost Estimate		
	<u>313, Info Booth</u>	2 Fully operational, 0-25% life expectancy used, no issues, no concerns	5 to 10 Years	9	\$500	Window A/C installed seasonally.

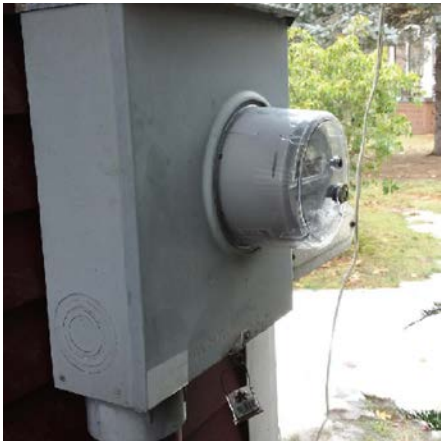
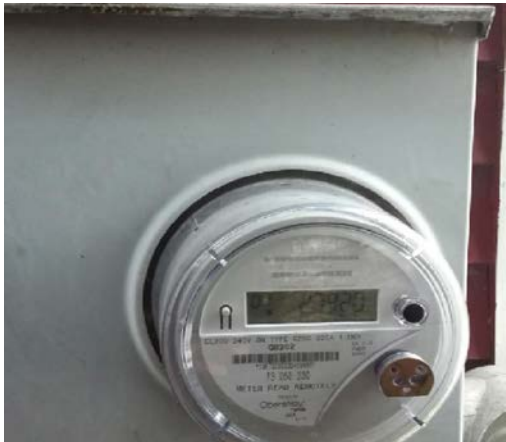
Equipment	Condition	Est. Remaining Service Life	Priority	Cost Estimate	Remarks & Recommendations		
	<u>312,Gazebo & Info Booth</u>	2 Fully operational, 0-25% life expectancy used, no issues, no concerns	20 Years	10	\$2000	Electric Meters for information booth and gazebo. Maintained by the electrical supplier.

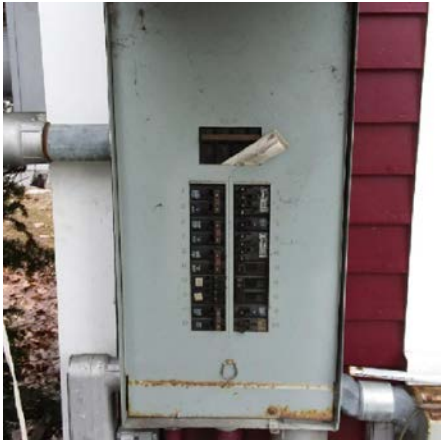
<u>311.Gazebo & Info Booth</u>	3 Fully operational, 25-50% life expectancy used, periodic problems	10 Years	10	\$3000	200 - AMP Panel board supplies power to town common site lighting, info booth and gazebo. Panel is exposed to the elements. Recommend panel cover to be lockable.

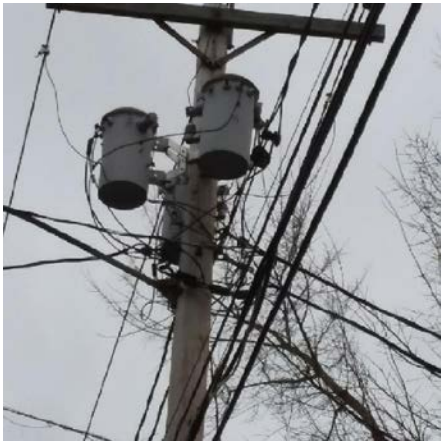
equipment	condition	Est remaining Service life	priority	cost	remarks &recommendations		
	<u>298,Info Booth</u>	2 Fully operational, 0-25% life expectancy used, no issues, no concerns	20 Years	10		Three 10 KVA transformers are located on Cheney Street. Service is overhead from transformers for two poles then underground to info booth. Maintained by electrical supplier.

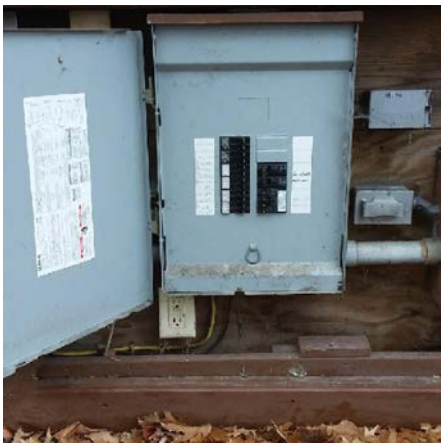
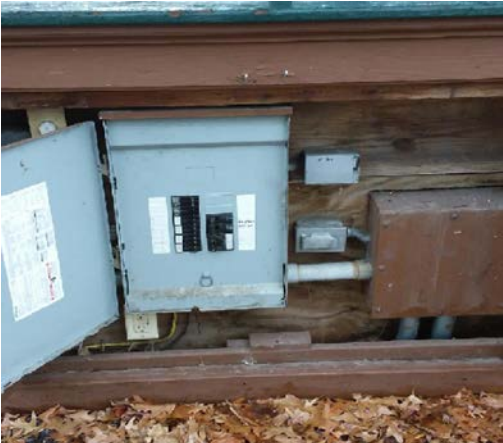
<u>297,Gazebo</u>	3 Fully operational, 25-50% life expectancy used, periodic problems	10 Years	10	\$2000	100 - AMP Sub panel is fed from info booth 200 – AMP panelboard. Panel and receptacle are located just above grade level and are exposed to indirect moisture. Recommend lockable cover.
