Town of Newport, New Hampshire  
Building Assessment | July 31, 2017

Building: Hanger/Office  
8-14 Airport Road  
Newport, New Hampshire

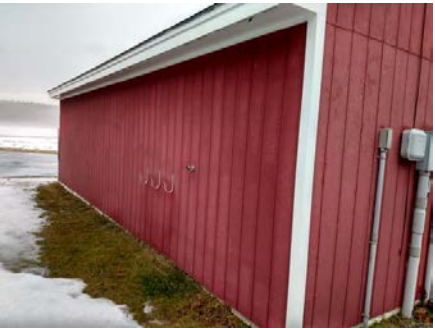
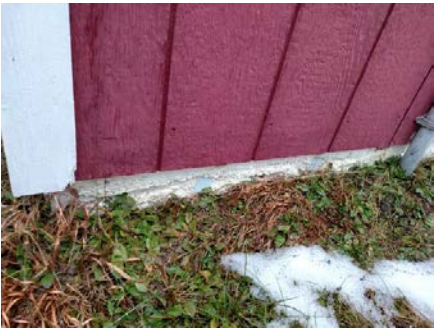
| Architectural | | | | | | | |
|---|---|---|---|---|---|---|---|
| | 790,792,Siding | 3 | 5 | 5 | \$2.50 sq.ft.<br>Painting<br>Cover<br>insulation<br>\$5.00<br>lineal ft. | Siding is in good condition<br>needs paint and cover<br>exposed insulation | |

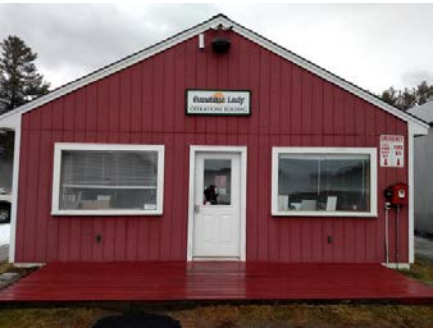
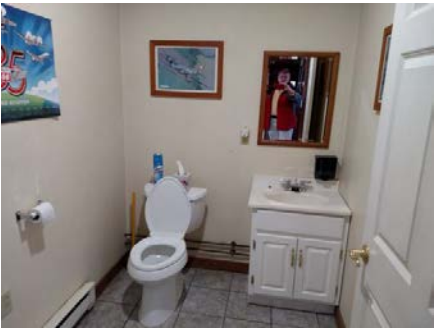
| | equipment | condition | Est remaining<br>Service life | priority | cost | remarks &recommendations | | |
|--|---|---|---|---|---|---|---|---|
| | 794,ADA | | | | ADA ramp | no real ada access and bathroom does not meet ADA | | |

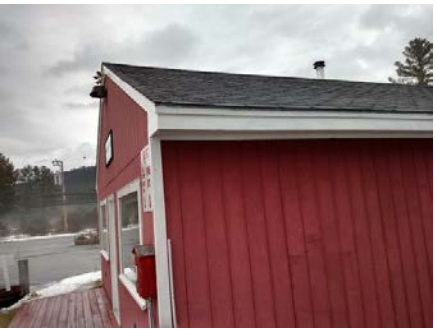
| | equipment | condition | Est remaining<br>Service life | priority | cost | remarks &recommendations | | |
|--|---|---|---|---|---|---|---|---|
| | 791,Roof | 4 | 5 years | 5 | \$7.00 sq.ft.<br>700 sq.ft.<br>\$4,900 | Age of roof 20 years and shingles are starting to curl | | |

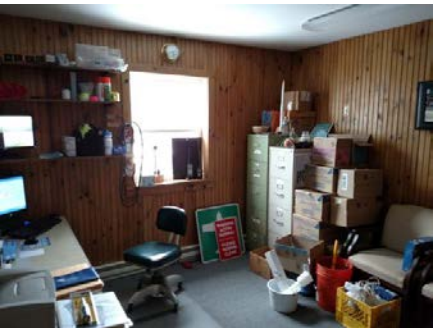
| | equipment | condition | Est remaining<br>Service life | priority | cost | remarks &recommendations | | |
|--|---|---|---|---|---|---|---|---|
| | 793,Flooring | 3 | 10 | 4 | \$.75 sq.ft | Carpet is in good repair but could use cleaning | | |

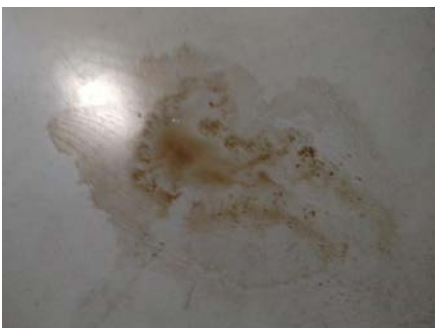
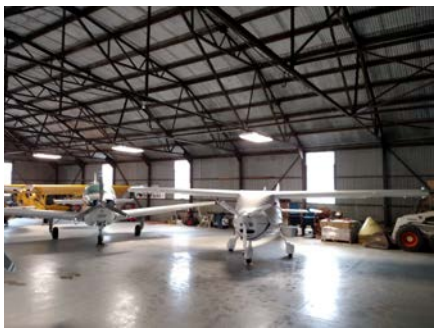
| | equipment | condition | Est remaining<br>Service life | priority | cost | remarks &recommendations | | |
|--|---|---|---|---|---|---|---|---|
| | 338,Flooring | 1 | 10 | 10 | \$3.50 sq.ft | Painted concrete floor in good repair. | | |

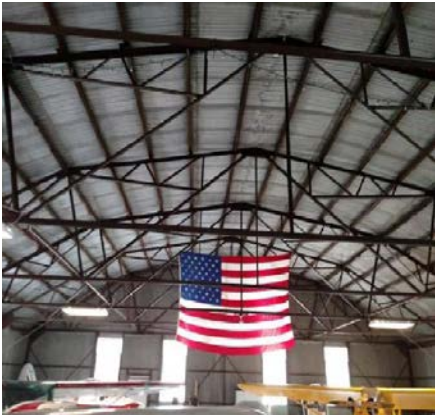
| | equipment | condition | Est remaining<br>Service life | priority | cost | remarks &recommendations | | |
|--|---|---|---|---|---|---|---|---|
| | 341,Roof | 5 | 2-5 | 3 | \$3.50 sq.ft<br>5,000 sq.ft<br>\$52,500 | Roof is same panel as walls and has some holes and is leaking. It appears that the top span may have been bent or is sagging and holding water. Paint this roofing with a substantial product that will protect the roof. They make many with a silver finish, spray on to apply evenly and maintain corrugations in panel. | | |

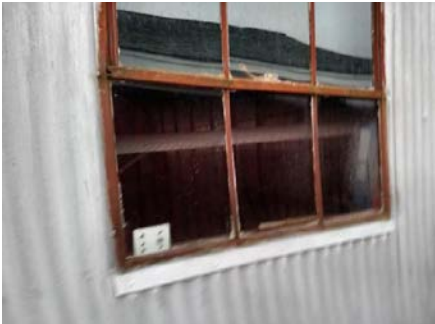
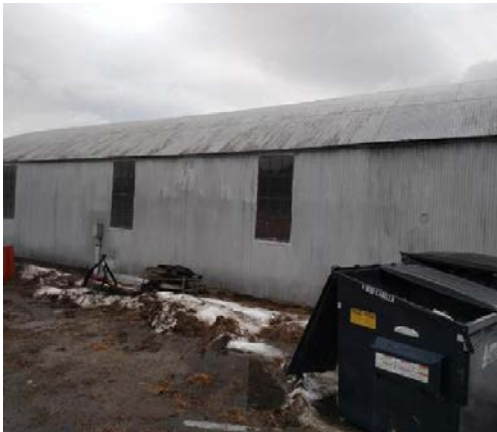
| | equipment | condition | Est remaining<br>Service life | priority | cost | remarks &recommendations | | |
|--|---|---|---|---|---|---|---|---|
| | 787,Paint Surface | 5 | 2-5 | 3 | \$3.50 sq.ft | Paint metal walls and windows. Windows should be repaired. If replaced, the replacement should match existing. | | |

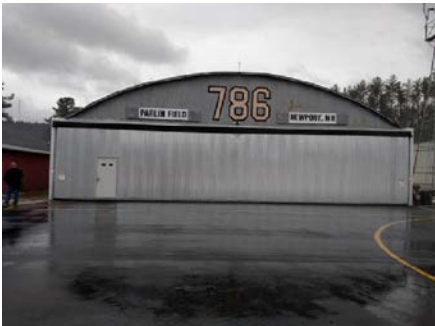
| | equipment | condition | Est remaining<br>Service life | priority | cost | remarks &recommendations | | |
|--|---|---|---|---|---|---|---|---|
| | 786,Paint Surface | 5 | 2-5 | 3 | \$3.50 sq.ft | Re-coat metal surface above door infill. Ultimately restore the Original hangar door which I was told has been saved | | |

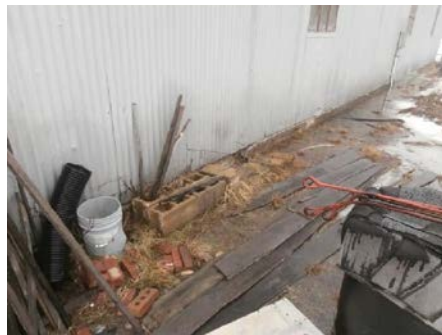
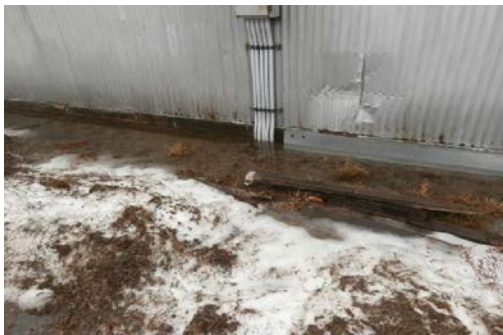
| | equipment | condition | Est remaining<br>Service life | priority | cost | remarks &recommendations | | |
|--|---|---|---|---|---|---|---|---|
| | 446,Foundation | | | | | Poor drainage - standing water against foundation. | | |

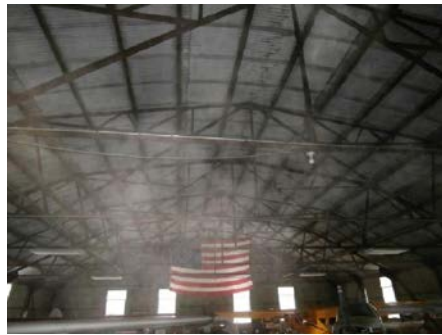
| | equipment | condition | Est remaining<br>Service life | priority | cost | remarks &recommendations | | |
|--|---|---|---|---|---|---|---|---|
| | 341,Roof | | | | | Corrugated metal panel siding and roof panels throughout. | | |

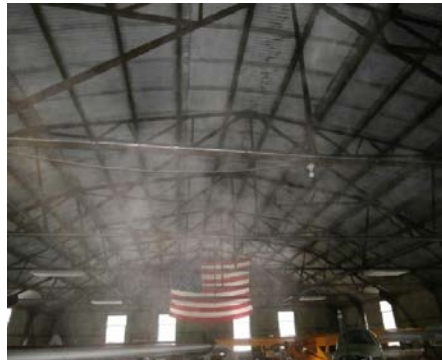
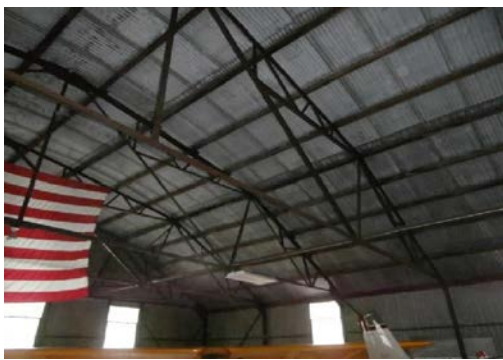
| | equipment | condition | Est remaining<br>Service life | priority | cost | remarks &recommendations | | |
|--|---|---|---|---|---|---|---|---|
| | 340,Truss | | | | | Bowstring steel trusses @ 16’ on center clear span, 80 foot span. | | |
| | | | | | Trusses comprised of WTs and single angles. | | | |
| | | | | | Steel columns (double channels) purlins are steel channels (C8, probably). | | | |

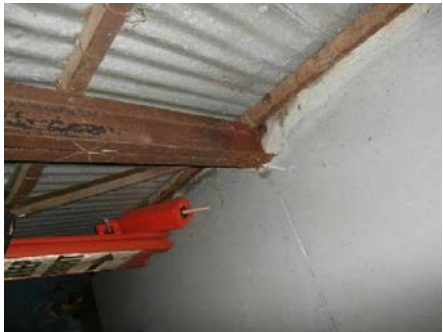
| | equipment | condition | Est remaining<br>Service life | priority | cost | remarks &recommendations | | |
|--|---|---|---|---|---|---|---|--|
| | 339,General Comment: | | | | | No separate rear storage space - entire hanger is one open room – no partitions.<br><br>This tax map implies an interior division of space that does not exist. | | |

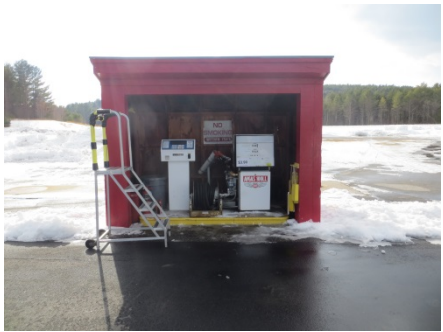
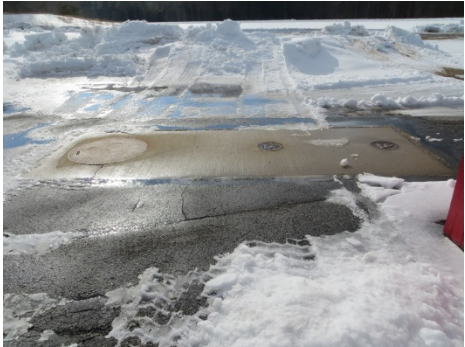
| Mechanical | | | | | | | | |
|---|---|---|---|---|---|---|---|---|
| | 571,General Comment: | Unknown<br>condition | | | | 10,000 - Gallon<br>underground fuel<br>tank and fuel pumps<br>contain jet fuel to supply<br>aviation equipment. | | |

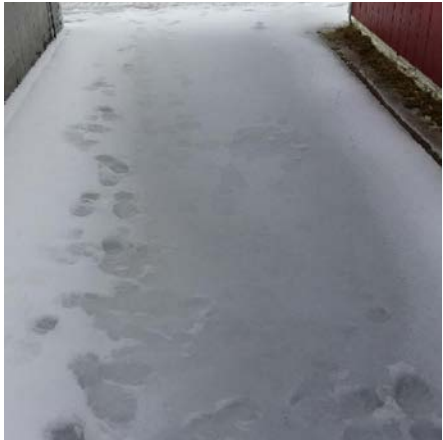
| Mechanical | | | | | | | | |
|---|---|---|---|---|---|---|---|---|
| | 524,Buried Septic Tank<br><br>Unknown capacity<br><br>Installed between 2000<br>and 2003 | 3<br>Fully operational,<br>0-25% life<br>expectancy used,<br>periodic<br>problems | 10 Years | 10 | | Located between the<br>hangar and office<br>building.<br><br>*But should be pumped<br>and inspected. | | |

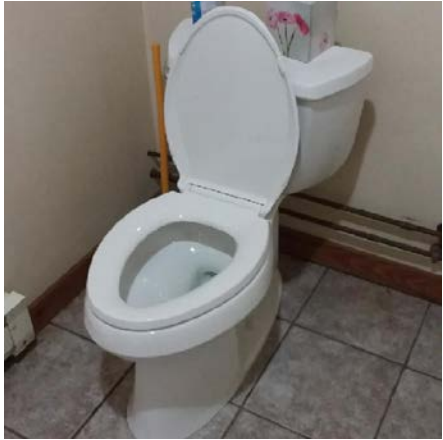
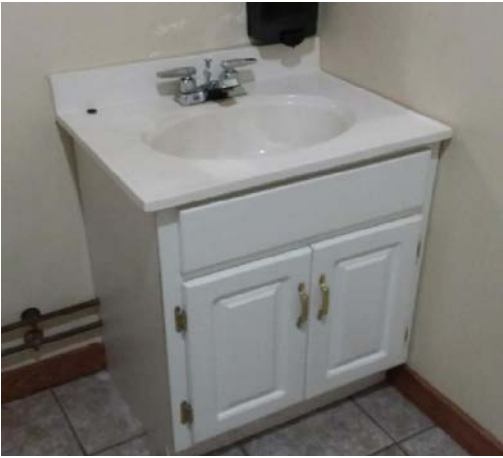
| Mechanical | | | | | | | | |
|---|---|---|---|---|---|---|---|---|
| | 514,Floor mounted<br>tank type toilet,<br>cabinet mounted<br>lavatory with dual<br>handle faucet | 3<br>Fully operational,<br>0-25% life<br>expectancy used,<br>periodic<br>problems | 10 Years | 10 | \$1,000 per<br>fixture | Bathroom in hanger<br>office building. Building is<br>infrequently occupied. | | |

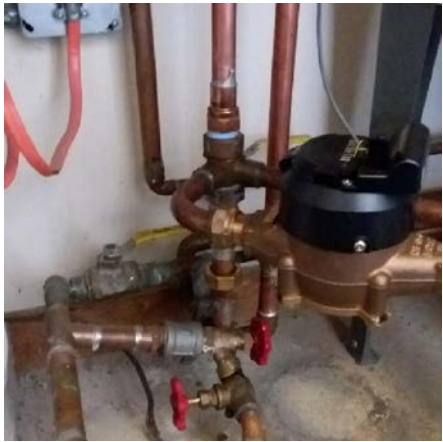
| | equipment | condition | Est remaining<br>Service life | priority | cost | remarks &recommendations | | |
|--|---|---|---|---|---|---|---|--|
| | 512,Three-quarter inch copper water entrance and meter | 2<br>Fully operational, 0-25% life expectancy used, no issues, no concerns | 25 Years | 10 | By water dept. | Meters water for hanger office building. | | |

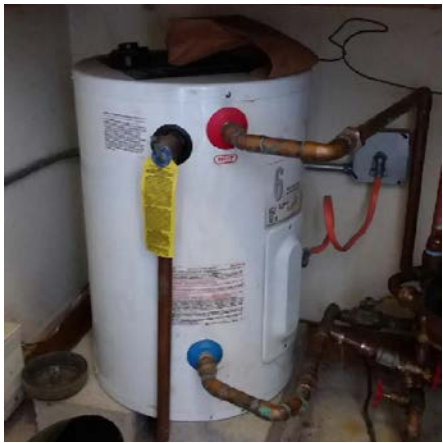
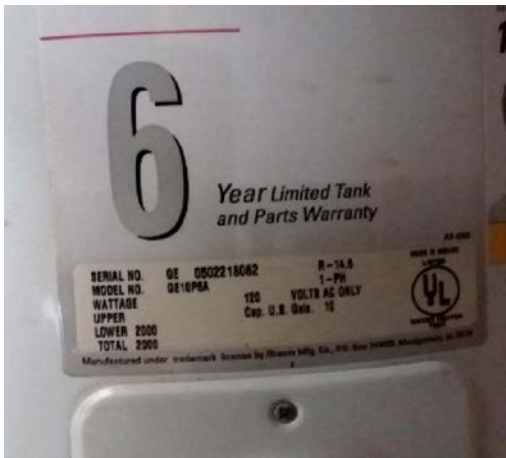
| | equipment | condition | Est remaining<br>Service life | priority | cost | remarks &recommendations | | |
|--|---|---|---|---|---|---|---|--|
| | 511,10 - Gallon Electric water heater<br><br>Make: GE<br><br>Model: GE10PGA | 2<br>Fully operational, 0-25% life expectancy used, no issues, no concerns | 25 Years | 10 | \$300 | Provides hot water for hanger office building. Building is infrequently occupied. | | |

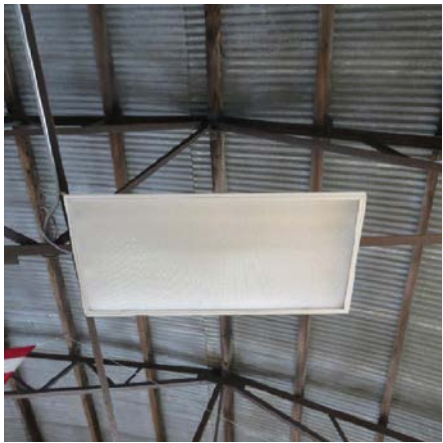
| | Equipment | Condition | Est. Remaining<br>Service Life | Priority | Cost Estimate | Remarks & Recommendations | | |
|--|---|---|---|---|---|---|---|--|
| | 574,2X4 - Foot<br>fluorescent light<br>fixtures<br>typical of 6 | 3<br>Fully operational,<br>25-50% life<br>expectancy used,<br>periodic<br>problems | 5 Years | 5 | \$250 each | Lighting used in the<br>unheated hanger. | | |

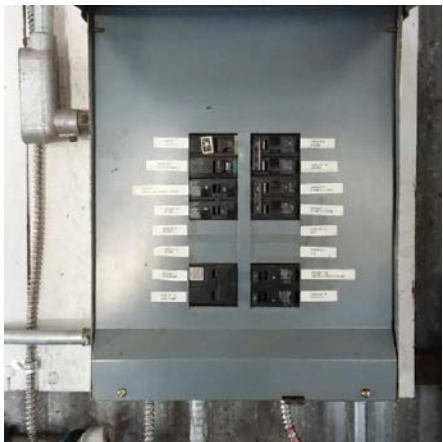
| | Equipment | Condition | Est. Remaining<br>Service Life | Priority | Cost Estimate | Remarks & Recommendations | | |
|--|---|---|---|---|---|---|---|--|
| | 573,Sub panel in<br>hanger | 2<br>Fully operational,<br>0-25% life<br>expectancy used,<br>no issues, no<br>concerns | 10 – 15<br>Years | 10 | \$2,000 | Fed from 100 – AMP<br>2 pole circuit breaker in<br>main panelboard in office<br>building. | | |

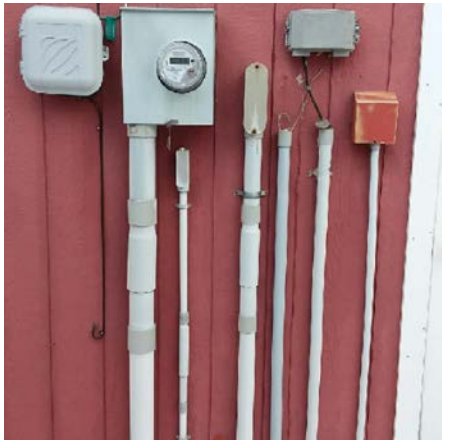
| | equipment | condition | Est remaining<br>Service life | priority | cost | remarks &recommendations | | |
|--|---|---|---|---|---|---|---|--|
| | 525,Electric Meter | 2<br>Fully operational,<br>0-25% life<br>expectancy used,<br>no issues, no<br>concerns | 15 Years | 10 | \$1,000 | Maintained by power<br>supplier. | | |

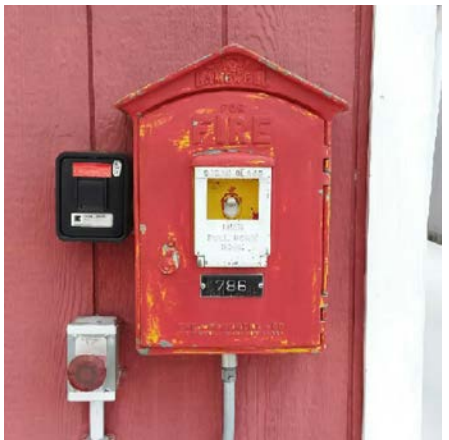
| | equipment | condition | Est remaining<br>Service life | priority | cost | remarks &recommendations | | |
|--|---|---|---|---|---|---|---|--|
| | 521,Fire Alarm:<br>Gamewell box number<br>786 with Knox Box | 2<br>Fully operational,<br>0-25% life<br>expectancy used,<br>no issues, no<br>concerns | 15 Years | 10 | \$10,000 | Maintained by the Fire<br>Dept. | | |

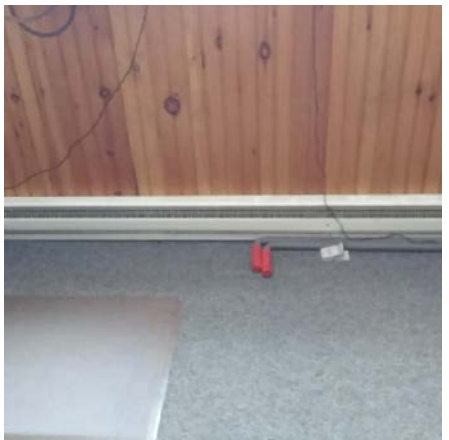
| | equipment | condition | Est remaining<br>Service life | priority | cost | remarks &recommendations | | |
|--|---|---|---|---|---|---|---|--|
| | 513,Electrical radiation | 3<br>Fully operational,<br>25-50% life<br>expectancy used,<br>periodic<br>problems | 10 Years | 10 | \$300 each | Typical throughout<br>building.<br><br>Building is infrequently<br>occupied. | | |

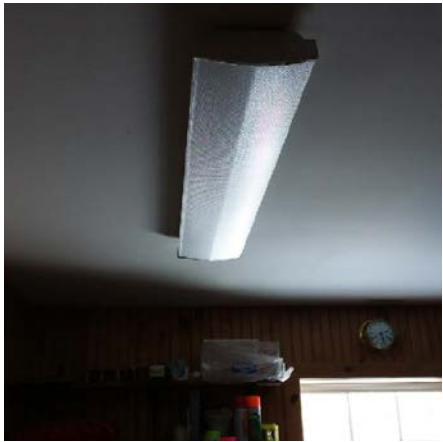
| | equipment | condition | Est remaining<br>Service life | priority | cost | remarks &recommendations | | |
|--|---|---|---|---|---|---|---|--|
| | 516,Surface mount<br>fluorescent (T-8)<br>fixtures | 3<br>Fully operational,<br>25-50% life<br>expectancy used,<br>periodic<br>problems | 10 Years | 8 | \$250 each | Typical throughout<br>building.<br><br>Building is infrequently<br>occupied. | | |

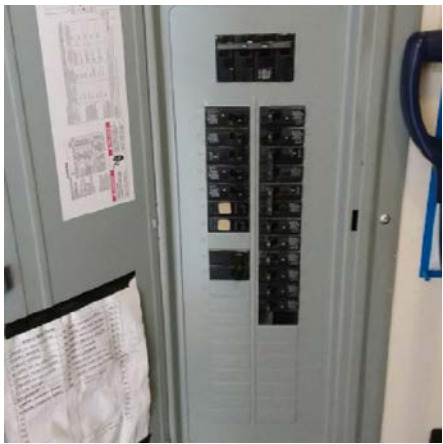
| | equipment | condition | Est remaining<br>Service life | priority | cost | remarks &recommendations | | |
|--|---|---|---|---|---|---|---|--|
| | 510,120 / 208 volt<br>single phase 200 - AMP<br>flush mount<br>panelboard | 2<br>Fully operational,<br>0-25% life<br>expectancy used,<br>no issues, no<br>concerns | 20 Years | 10 | \$3,000 | Provides power for office<br>and hanger panelboard,<br>has room to expand. | | |

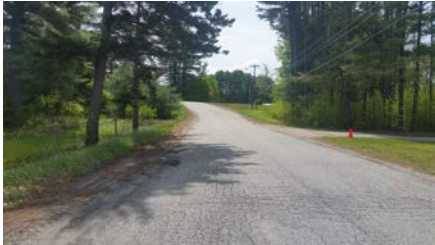
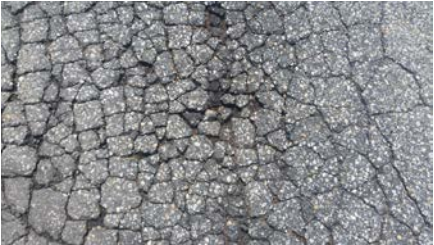
| Site | | | | | | | | |
|---|---|---|---|---|---|---|---|---|
| | Airport Road is significantly worn and has extensive alligator cracking which may be the result of a failed or inadequate base course. The pavement itself is weathered, and exhibits a brittle texture associated with age and oxidation. The parking area in front of the Airport office and hanger buildings appears newer than that associated with the roadway. These pavements show some longitudinal/transverse cracking centered at the flagpole monument. There is an obvious crack between the older pavement associated with Airport Road and that of the parking area. | | | | | | | |
| | 864,pavement | 5 | 6-7 y | 4 | \$2.80 sq.ft.<br>top<br>\$7.17 sq.ft.<br>Full box | Will not last<br><br>14,707 full box | | |

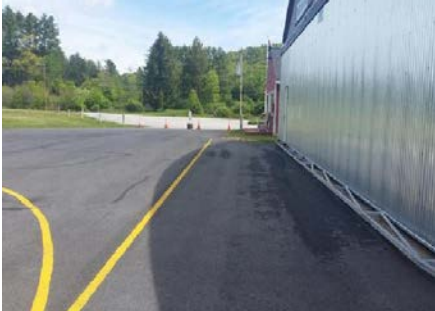
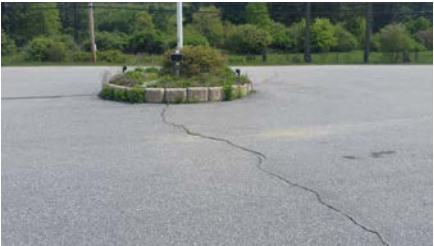
| Site | | | | | | | | |
|---|---|---|---|---|---|---|---|---|
| | 866,pavement | 2 | 10 | 10 | \$3.50 sq.ft.<br>Pavement<br>37,000<br>sq.ft<br>\$129,500 | The parking area in front of the Airport office and hanger buildings, appears newer than that associated with the roadway. Grind off the existing wearing surface (approx. ¾-inches) and using smaller walk behind unit grind out the longitudinal cracks to a width of 6-8 inches wide, replace with new binder and apply thin lift of new wearing surface over the entire area. | | |
