Building: Maintenance Shed

Newport, New Hampshire

Town of Newport, Building Assessment July 31,2017

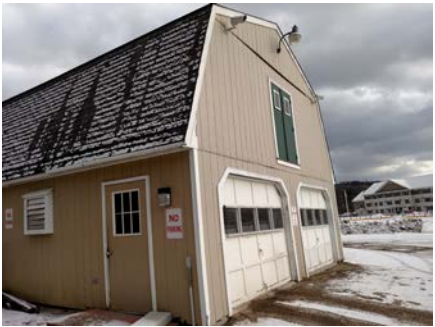
equipment	condition	Est remaining Service life	priority	cost	remarks &recommendations		
	700,Asphalt Shingle	4	5	7	\$7.00 sq.ft  800 sq.ft  \$5,600	Roof is nearing end of life and should be scheduled for replacement

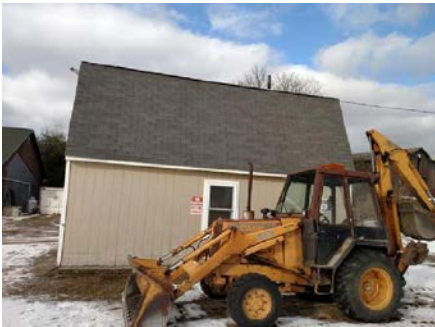
699,Exterior Note:					Could add roof over backhoe by extending top roof pitch supported on columns.

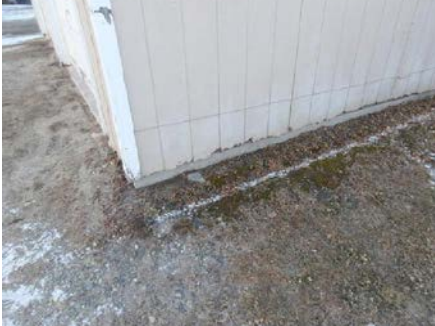
899,Exterior Wood Siding	3	5	6	\$15.00 lineal ft. For PVC skirt board	T-111 too close to grade,cut back bottom, flash and install synthetic base material.

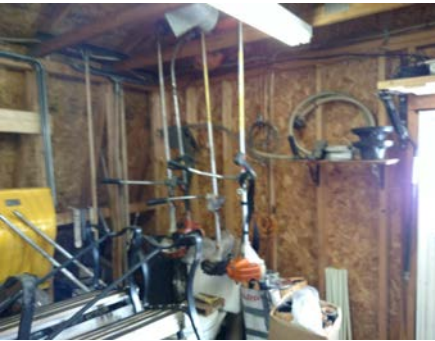
697, Finish					Interior is very organized with no finish

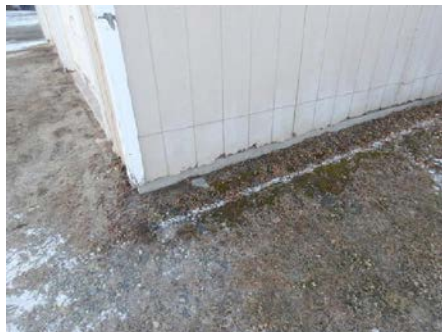
Equipment	Condition	Est. Remaining Service Life	Priority	Cost Estimate		
	899,Exterior wood siding					Rot/deterioration of T1-11 siding due to proximity to surrounding grade.

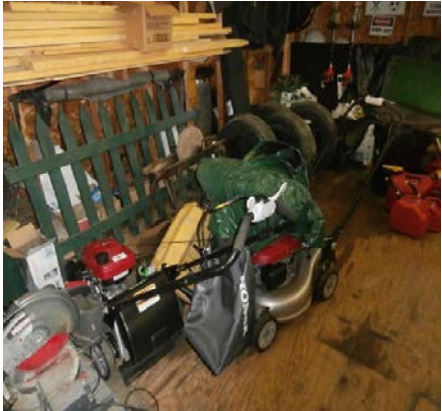
equipment	condition	Est remaining Service life	priority	cost	remarks &recommendations		
	898,Floor framing					Second floor is used for storage - floor is lightly framed and the floor partially supports the gambrel roof. Floor was heavily loaded with stored equipment and materials at the time of this visit. Recommend removal of stored materials and equipment from this floor.

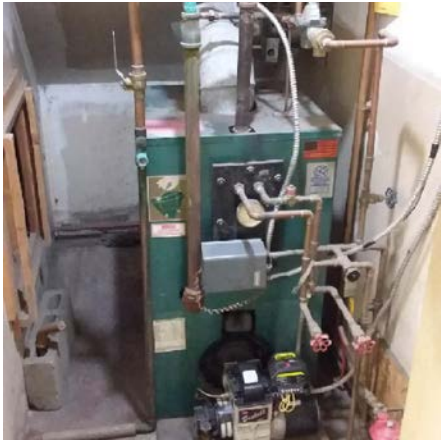
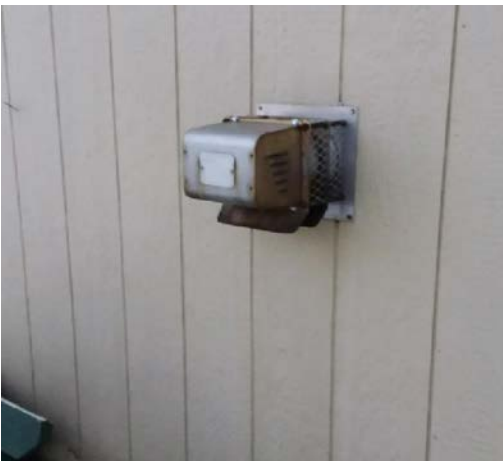
Equipment	Condition	Est. Remaining Service Life	Priority	Cost Estimate			
	640, 119,000 BTU oil fired boiler  Make: Columbia Emerald series  Model: EM-85	3 Fully operational, 25-50% life expectancy used, periodic problems	10 Years	10	\$8,500	Produces heating water to fin tube radiation and provides domestic hot water throughout the building.  Boiler is vented through a sidewall vent kit.

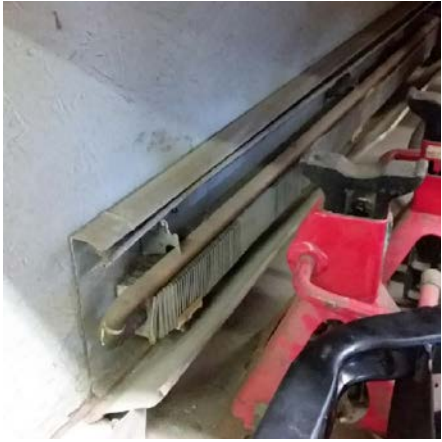
equipment	condition	Est remaining Service life	priority	cost	remarks &recommendations		
	639,Fin tube enclosure has been compromised	4 Operational, 50- 75% life expectancy used, occasional problems, frequent repairs needed	5 Years	5	\$150 lin ft.	Aluminum fins have been damaged and the enclosures have been removed.  Recommend to comb fins and install enclosures to allow the transfer of cold air over the heating element.

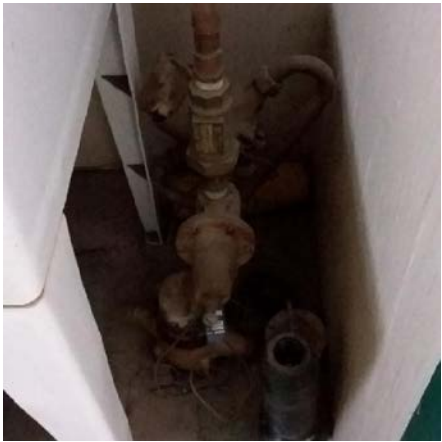
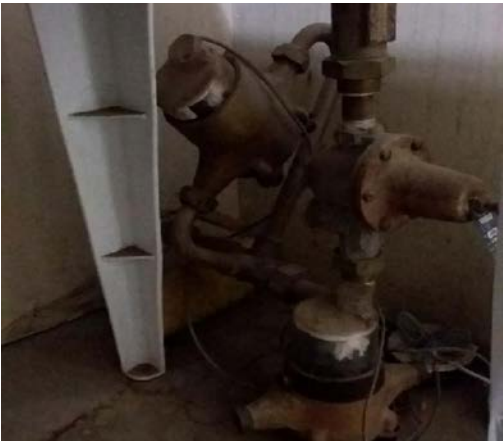
638,Water Entrance					Maintained by water dept.

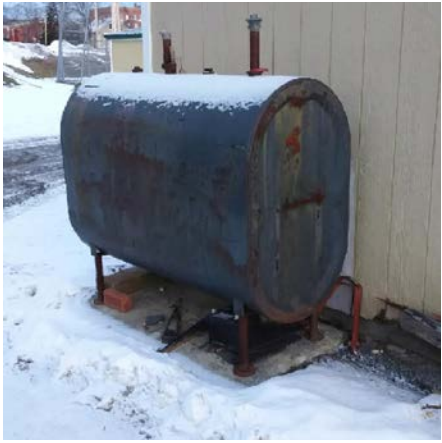
631,275 Gallon fuel tank	4 Operational, 50- 75% life expectancy used, occasional problems, frequent repairs needed	5 Years	5	\$1,500	Tank is located outdoors.  Recommend inspection of surface rust on bottoms seams of tank.

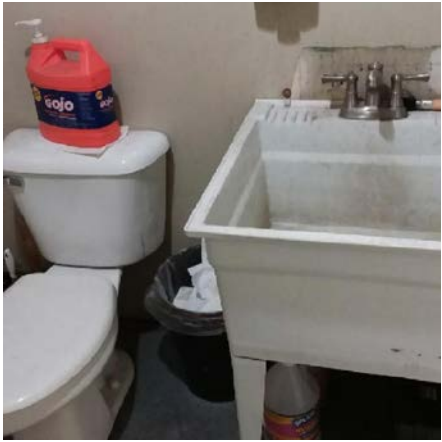
equipment	condition	Est remaining Service life	priority	cost	remarks &recommendations		
	635,Floor mount tank type toilet, floor mount lavatory/slop sink	3 Fully operational, 25-50% life expectancy used, periodic problems	10 Years	10	\$1,000 per fixture	Fixtures are not used by many people.

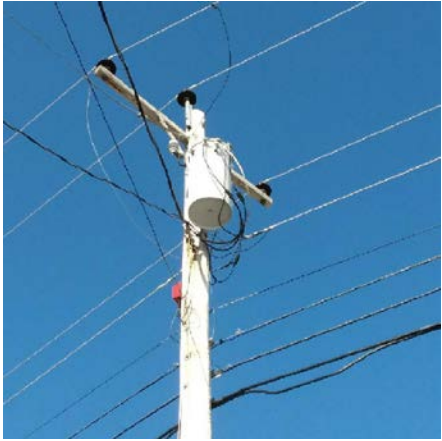
Equipment	Condition	Est. Remaining Service Life	Priority	Cost Estimate	Remarks & Recommendations		
	637,25 KVA pole- mounted transformer	2 Fully operational, 0-25% life expectancy used, no issues, no concerns	15 Years	10		Provides power through overhead service.  Transformer is located on pole adjacent to number 40 Pearl St.  Maintained by power supplier.

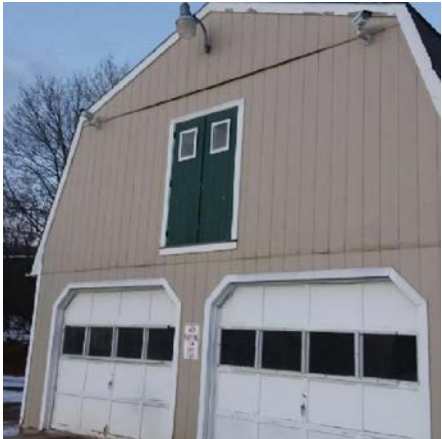
633,Security Camera					Unknown if this camera reports to anyone or anything.

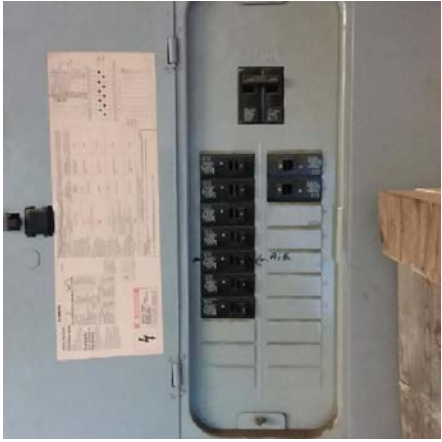
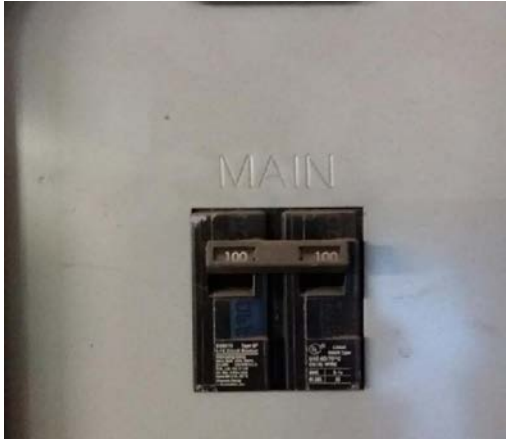
equipment	condition	Est remaining Service life	priority	cost	remarks & recommendations		
	634,100 AMP service surface mount Panel	3 Fully operational, 25-50% life expectancy used, periodic problems	10 Years	10	\$1000

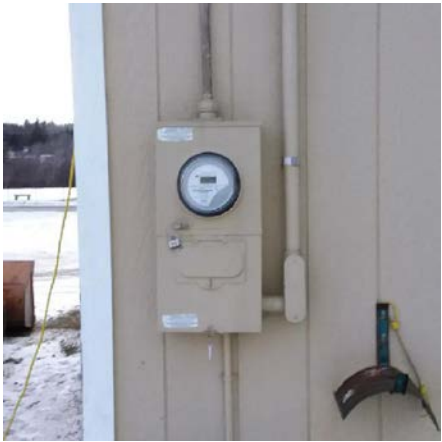
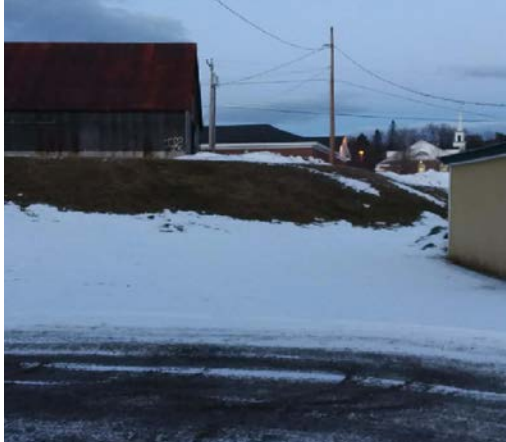
632,Electrical Meter	2 Fully operational, 0-25% life expectancy used, no issues, no concerns	15 Years	10		Maintained by power supplier.

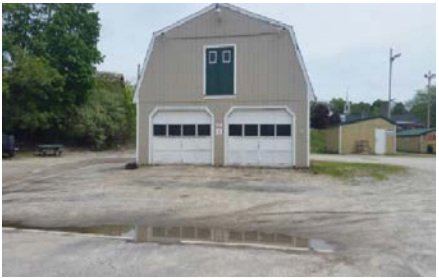
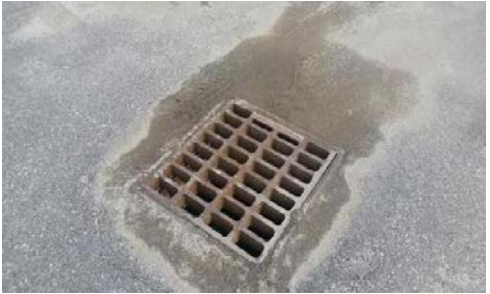
equipment	condition	Est remaining Service life	priority	cost	remarks &recommendations		
	Pavement					The 2-car garage associated with the Ambulance Building, appeared to have pavement just at the front garage doors, but was unpaved on the other sides.

Gravel/Pavement	4		5	PF \$7.17 sq.ft.  250sq.ft  \$1,792	Maintain gravel surface  At minimum , add apron and walk to door.
