Building: Horsey Bath House  
Meadow Street  
Newport, New Hampshire

Town of Newport, Building Assessment July 31,2017

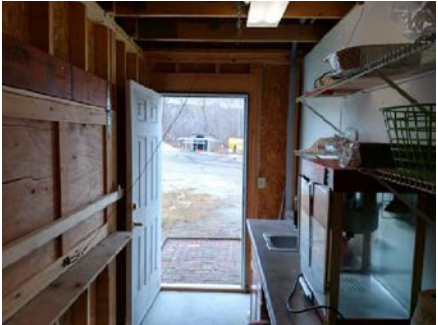
| | equipment | condition | Est remaining<br>Service life | priority | cost | remarks &recommendations | | |
|--|---|---|---|---|---|---|---|--|
| | 681,Flooring | 1 | 40 | 10 | | Bare concrete, stud wall,<br>concession stand. | | |

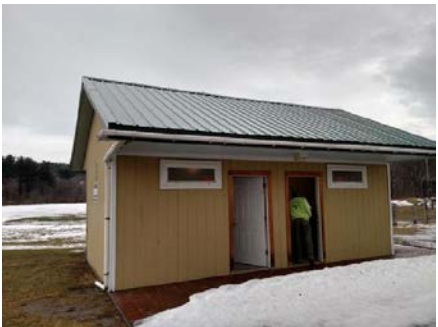
| | equipment | condition | Est remaining<br>Service life | priority | cost | remarks &recommendations | | |
|--|---|---|---|---|---|---|---|--|
| | 680,Exterior Note: | 1 | 15 | 10 | \$2.50<br>sq.ft.<br><br>300sq.ft.<br><br>\$750 | Metal roofing.<br>Probably only paint vs full<br>replacement | | |

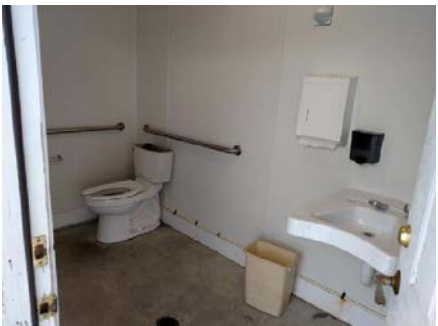
| | equipment | condition | Est remaining<br>Service life | priority | cost | remarks &recommendations | | |
|--|---|---|---|---|---|---|---|--|
| | 679,Flooring | 1 | 30 | 10 | | Bare concrete with FRP<br>covered walls.<br>Other than cleaning there<br>should not be ongoing<br>wall/floor repair | | |

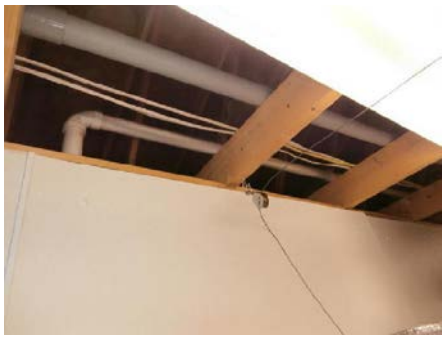
| | 897, Truss | | | | | Roof trusses are bearing on the center demising wall - this wall should not be load-bearing. | | |

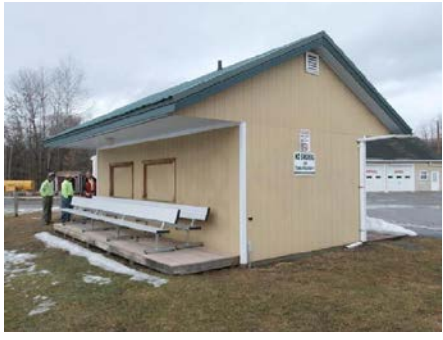
| | 896, Floor Framing | | | | | Exterior deck facing baseball field: deck framing and posts are too close to grade and will be subject to premature rot as a result. | | |

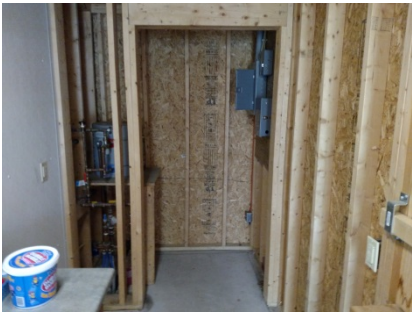
| | Equipment | Condition | Est. Remaining<br>Service Life | Priority | Cost Estimate | | | |
|--|---|---|---|---|---|---|---|---|
| | Y98,Electric water heater | 2<br>Fully operational,<br>0-25% life expectancy used,<br>no issues, no concerns | 15 Years | 10 | \$1,000 | Provides hot water to one lavatory. | | |

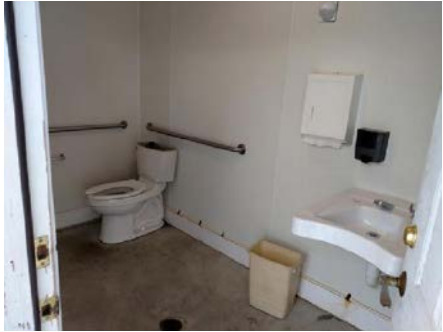
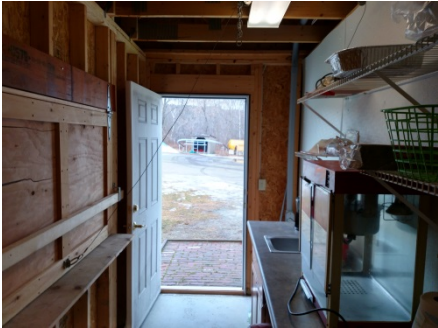
| | Equipment | Condition | Est. Remaining<br>Service Life | Priority | Cost Estimate | | | |
|--|---|---|---|---|---|---|---|---|
| | Y99,Floor mounted tank type toilet, wall mount lavatory with single handle cold water faucet | 2<br>Fully operational,<br>0-25% life expectancy used,<br>no issues, no concerns | 15 Years | 10 | \$1,000<br>Per fixture | Bathrooms are only fed with cold water.<br><br>Building is not used in winter months. | | |

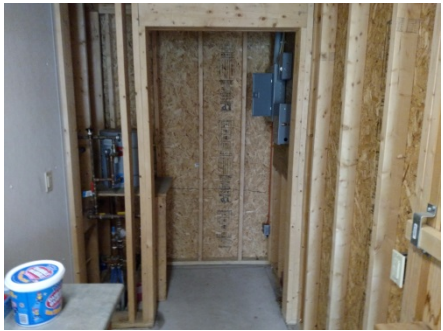
| | Equipment | Condition | Est. Remaining<br>Service Life | Priority | Cost Estimate | Remarks & Recommendations | | |
|--|---|---|---|---|---|---|---|--|
| | Y100,One surface mount panelboard | 3<br>Fully operational,<br>25-50% life expectancy used,<br>periodic problems | 10 Years | 10 | \$500 | Provides power to lighting, receptacles and water heater. Building is closed for winter months. | | |

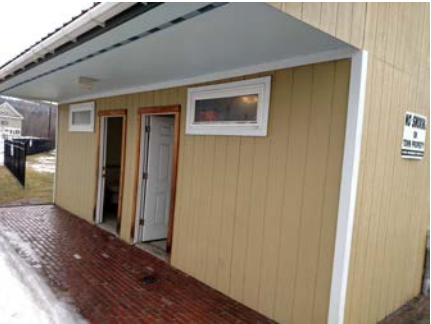
| Equipment | Condition | Est. Remaining<br>Service Life | Priority | Cost Estimate | Remarks & Recommendations | Photos | |
|---|---|---|---|---|---|---|---|
| Y101,Small strip of<br>pavers | 1 | 30 | 10 | | No work scheduled other<br>than maintenance for 30<br>years | | |
