Town of Newport, New Hampshire  
Building Assessment | July 31, 2017

Building: Museum  
30 Main Street  
Newport, New Hampshire

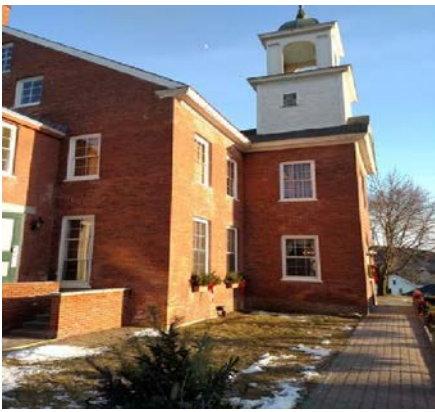
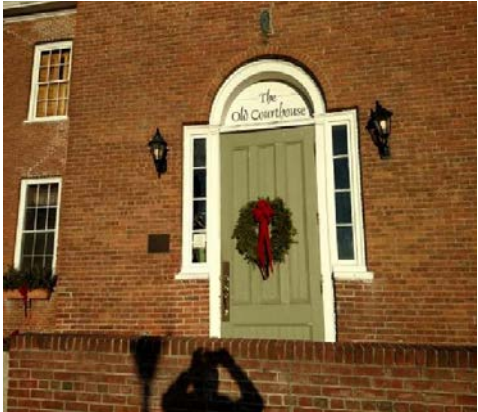
| | equipment | condition | Est remaining<br>Service life | priority | cost | remarks & recommendations | | |
|--|---|---|---|---|---|---|---|---|
| | 820,Exterior Brick | 2 | 15-50y | 10 | \$5.00 sq.ft. | Potential re-pointing cost | | |

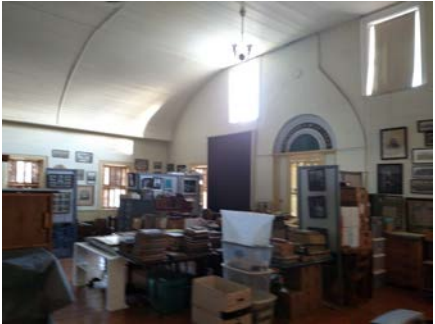
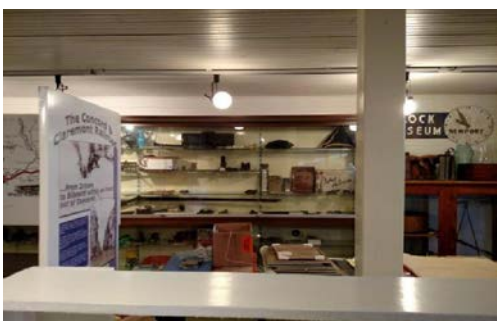
| | equipment | condition | Est remaining<br>Service life | priority | cost | remarks & recommendations | | |
|--|---|---|---|---|---|---|---|---|
| | 819, General Comment: | 4 | 10+ | 10 | | Museum finishes date some time back but in keeping with the historical nature of the space should be maintained not replaced. | | |

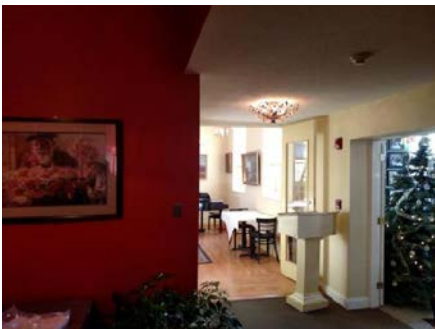
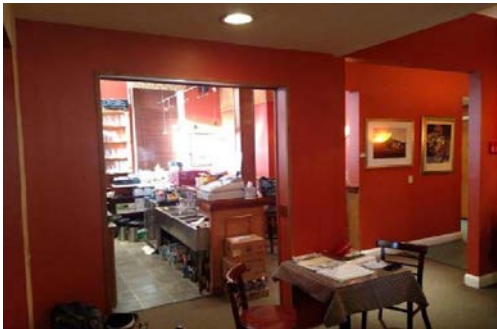
| | equipment | condition | Est remaining<br>Service life | priority | cost | remarks & recommendations | | |
|--|---|---|---|---|---|---|---|---|
| | 818General Comment: | | | 10 | | First floor finishes are in overall good condition and the responsibility of the tenant. | | |

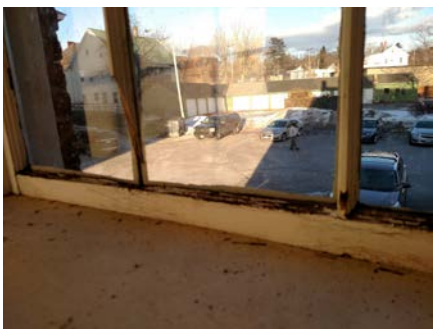
| | equipment | condition | Est remaining<br>Service life | priority | cost | remarks & recommendations | | |
|--|---|---|---|---|---|---|---|---|
| | 137,Window Single | 4 | 5 | 6 | \$1200 per window | Single pane windows painted 5 years ago, painted shut, no storms. | | |

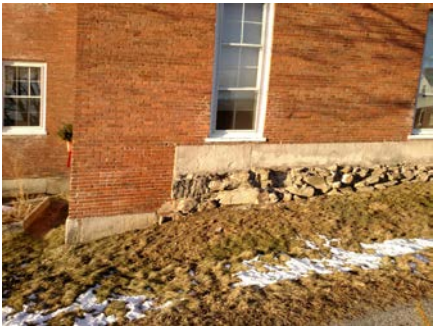
| | equipment | condition | Est remaining<br>Service life | priority | cost | remarks &recommendations | | |
|--|---|---|---|---|---|---|---|--|
| | 136,General Comment: | 1 | 20+ | 10 | | Re-pointed last year, on historic register, no basement, but foundation work also done, first floor extensively renovated, second floor original bead board, unheated. | | |

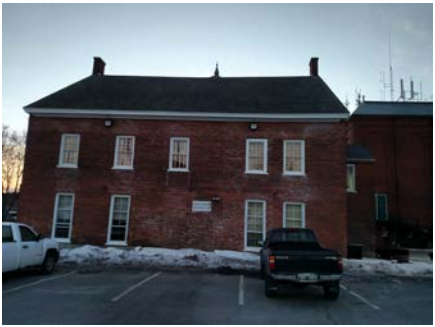
| | equipment | condition | Est remaining<br>Service life | priority | cost | remarks &recommendations | | |
|--|---|---|---|---|---|---|---|--|
| | 134,Asphalt Shingle | 3 | 7 | 7 | \$7.00<br>sq./ft.<br><br>3,500 sq.ft.<br><br>\$24,500 | | | |

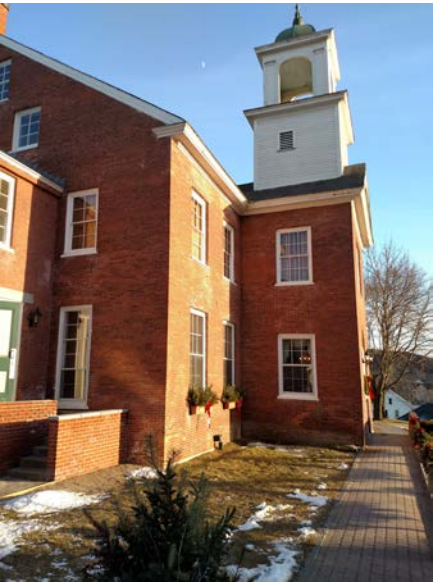
| | equipment | condition | Est remaining<br>Service life | priority | cost | remarks &recommendations | | |
|--|---|---|---|---|---|---|---|--|
| | 821-CH Wood trim & tower | 2 | 8 | 8 | | Ongoing maintenance of painted wood surfaces | | |

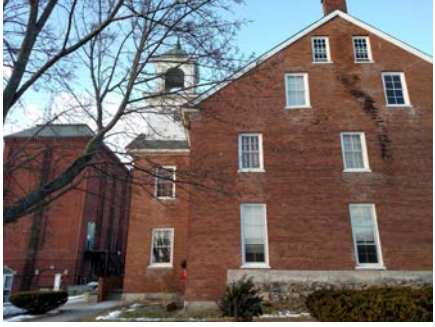
| | equipment | condition | Est remaining<br>Service life | priority | cost | remarks &recommendations | | |
|--|---|---|---|---|---|---|---|--|
| | See outline of flue either attracting dirt or carbon migration | | | | | | | |

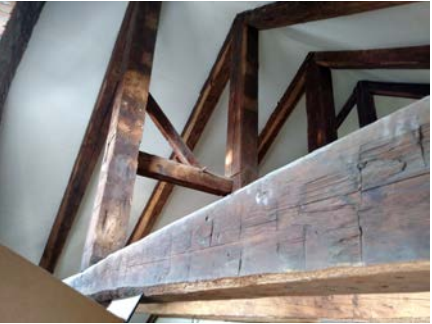
Roof trusses: Mortise and tennon roof truss connections – particularly the truss bottom chords – are secured with oak pegs. The pegs are frequently located too close to the member edges to be effective as tension connections (i.e., no wood cover over oak pegs). Some of these connections have been previously reinforced by the addition of iron bar side rods. Further review and analysis of the roof truss connections is warranted. Additional augmentation of these connections is recommended.

| | equipment | condition | Est remaining<br>Service life | priority | cost | remarks &recommendations | | |
|--|---|---|---|---|---|---|---|--|
| | 201, Roof | | | | | <p>Roof Framing: Kingpost roof trusses@ 3’ on center: Truss connections are oak pegs, pegs are too close to surface of connected members and accordingly connections have little or no tensile capacity.</p> <p>Some iron ties have been added where horizontal bottom chord meets top chord/rafter.</p> <p>Typical throughout entire roof.</p> | | |

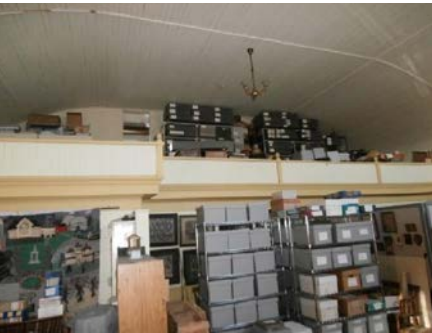
Second floor and loft floor loads: Racked and boxed file storage of museum records and documents are imposing heavy concentrated loads that likely exceed the ratable capacity of the floor framing. This condition should be further reviewed. Removal of ceiling finishes will be required to determine floor joist sizes and spacings in order to further analyze this condition. Consideration should be given to moving heavier loads to a more suitable storage location (i.e., off this floor).

| | equipment | condition | Est remaining<br>Service life | priority | cost | remarks &recommendations | | |
|--|---|---|---|---|---|---|---|--|
| | 200,Floor Framing | | | | | <p>Second and third floor framing is overloaded by file storage.</p> | | |

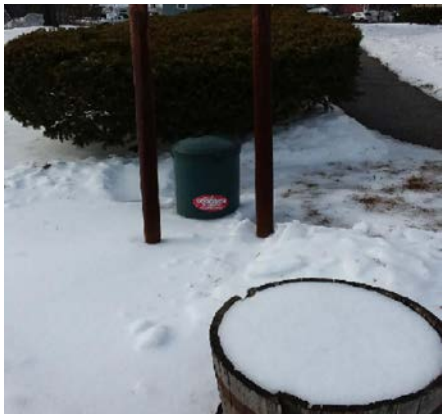
| | 482,500 Gallon<br>underground LP tank | Unknown date of<br>installation | | | | Serves the kitchen<br>equipment. | | |

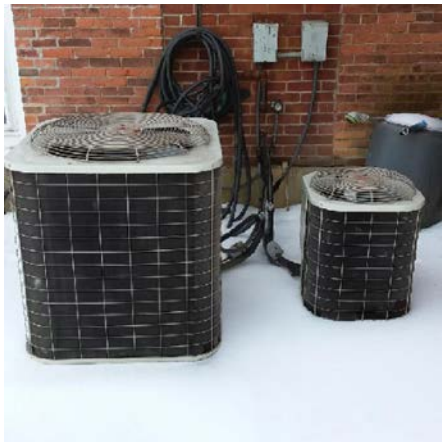
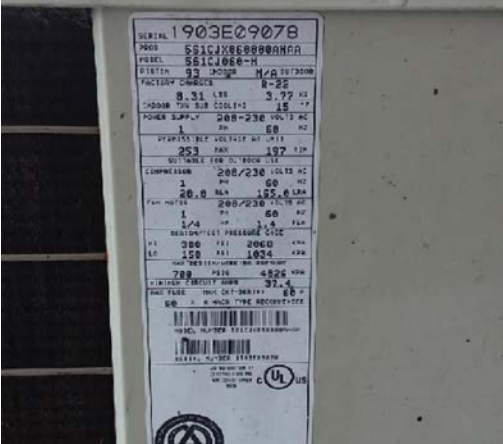
| | 479,One 5 - ton and one<br>2 - ton Bryant<br>condensers for duct<br>mounted DX<br>coils | 3<br>Fully operational,<br>25-50% life<br>expectancy used,<br>periodic<br>problems | 10 Years | 10 | 5 – Ton<br>\$3,500<br><br>2 – Ton<br>\$2,500 | Condensers provide air<br>conditioning to the<br>restaurant portion of the<br>building.<br><br>Recommend annual<br>service. | | |

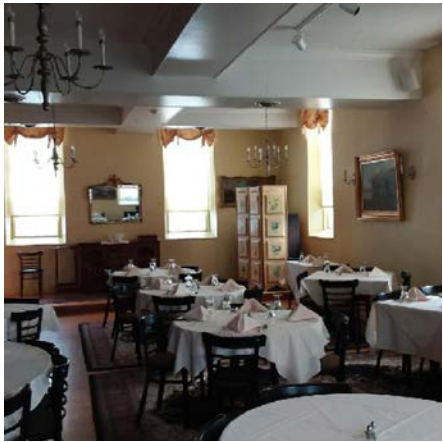
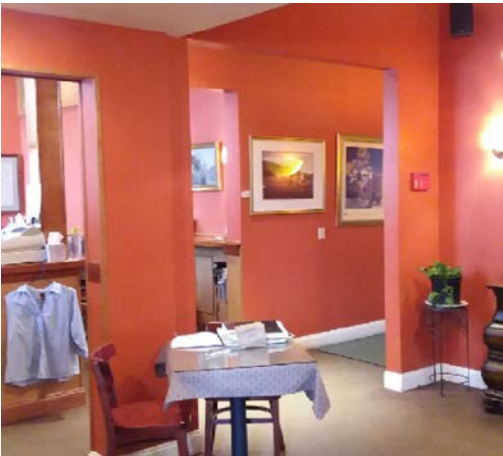
| | equipment | condition | Est remaining<br>Service life | priority | cost | remarks &recommendations | | |
|--|---|---|---|---|---|---|---|---|
| | 478,General Comment: | | | | | Building is currently used as a restaurant bar with an open concept. This section of the building was renovated in 2004. | | |

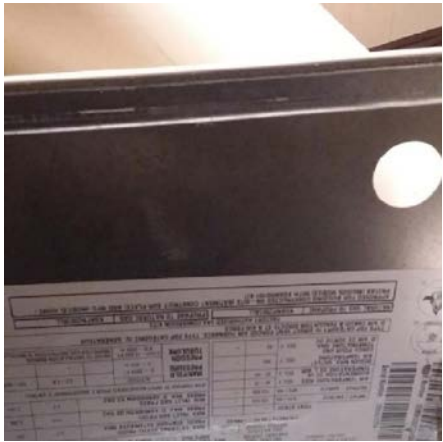
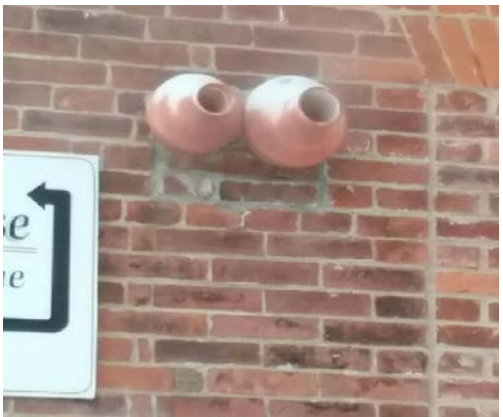
| | equipment | condition | Est remaining<br>Service life | priority | cost | remarks &recommendations | | |
|--|---|---|---|---|---|---|---|---|
| | 476,Bryant 120,000 BTU high efficiency L.P gas-fired furnace with a DX coil<br><br>Installed in 2004 | 3<br>Fully operational, 25-50% life expectancy used, periodic problems | 10 Years | 10 | \$2,500 | Vented through side wall. | | |

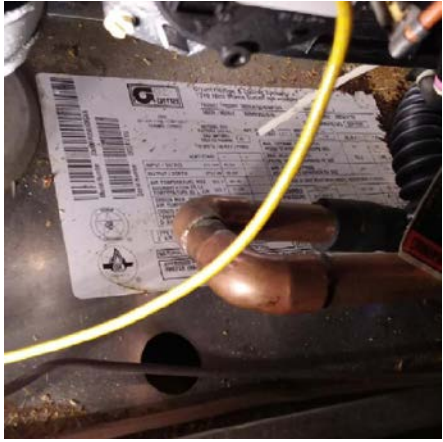
| | equipment | condition | Est remaining<br>Service life | priority | cost | remarks &recommendations | | |
|--|---|---|---|---|---|---|---|---|
| | 475,Bryant 40,000 BTU high efficiency L.P. gas-fired furnace with a DX coil<br><br>Installed in 2004 | 3<br>Fully operational, 25-50% life expectancy used, periodic problems | 10 Years | 10 | \$2,000 | Vented through side wall. | | |

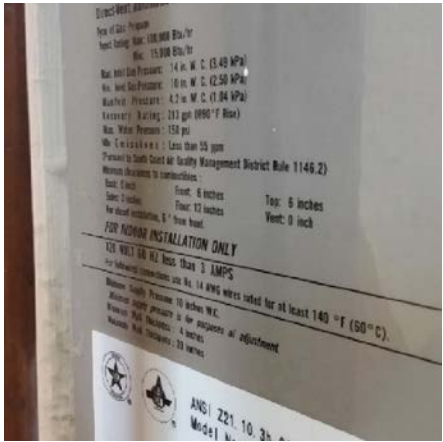
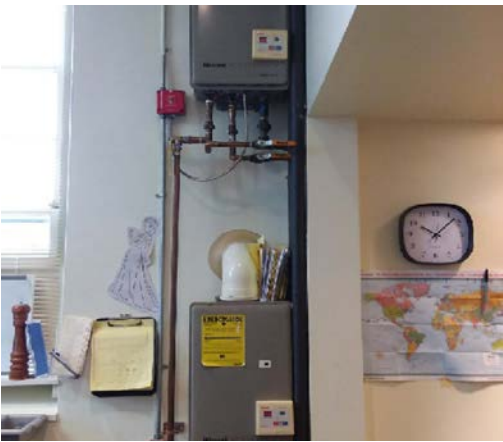
| | equipment | condition | Est remaining<br>Service life | priority | cost | remarks &recommendations | | |
|--|---|---|---|---|---|---|---|---|
| | 474,Two Rinnai wall mounted on demand direct vent L.P. gas fired water heaters | 2<br>Fully operational, 0-25% life expectancy used, no issues, no concerns | 15 Years | 10 | \$3,500 each | Provide domestic hot water to a storage tank for kitchen needs.<br><br>Each on-demand water heater is rated for 180,000 BTUs. | | |

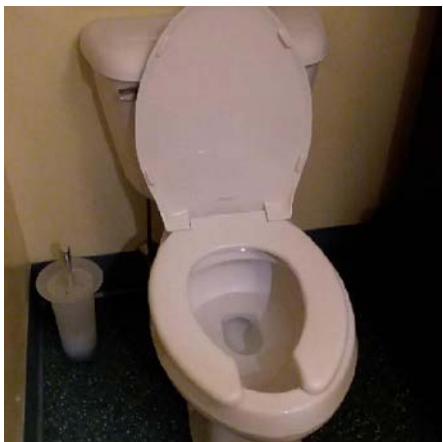
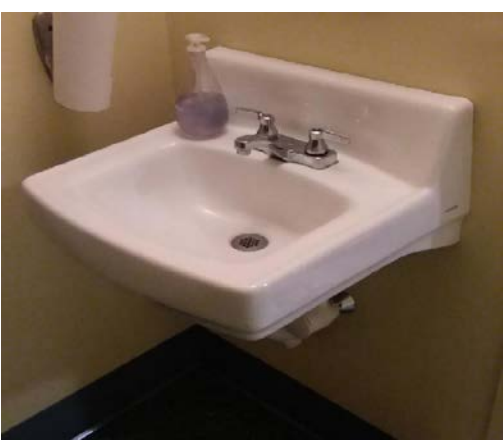
| | equipment | condition | Est remaining<br>Service life | priority | cost | remarks &recommendations | | |
|--|---|---|---|---|---|---|---|---|
| | 473,Floor mounted tank type toilets, wall mounted lavatories dual handle faucets typical for bathroom | 3<br>Fully operational, 25-50% life expectancy used, periodic problems | 10 Years | 10 | \$1,000 per fixture | | | |

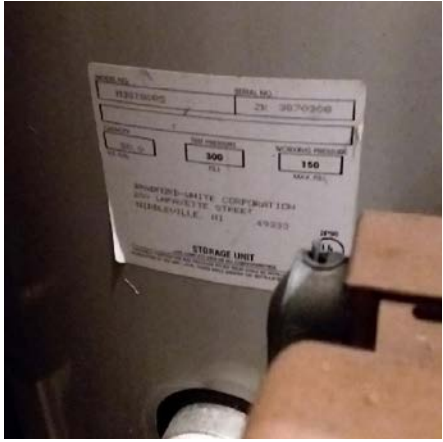
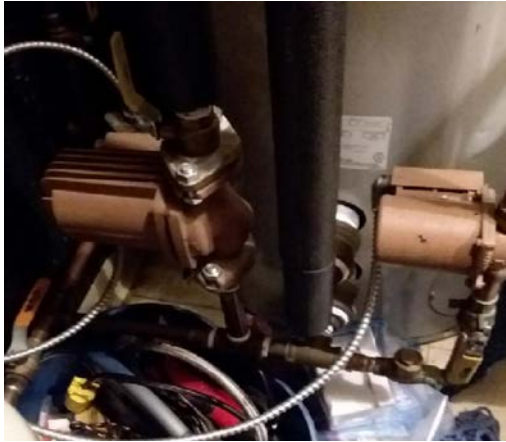
| | equipment | condition | Est remaining<br>Service life | priority | cost | remarks &recommendations | | |
|--|---|---|---|---|---|---|---|---|
| | 470,80 Gallon capacity<br>Bradford White<br>electric water heater | 3<br>Fully functional,<br>25-50% life<br>expectancy used,<br>periodic<br>problems | 10 Years | 10 | \$2,000 | Receives heated water<br>from on-demand water<br>heaters. Water heater<br>acts as a storage tank for<br>kitchen demand.<br><br>Domestic hot water is<br>circulated through two<br>inline recirculating<br>pumps. | | |

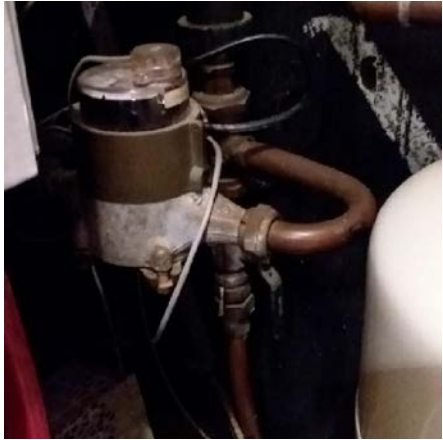
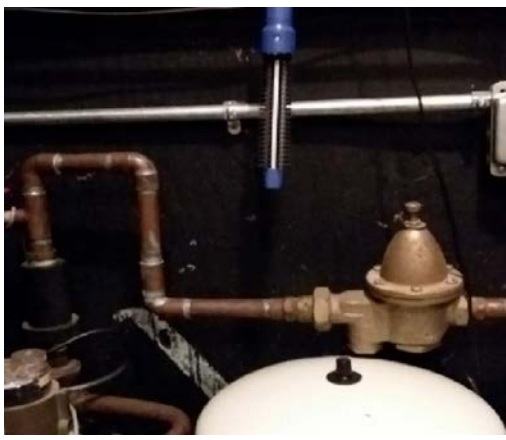
| | equipment | condition | Est remaining<br>Service life | priority | cost | remarks &recommendations | | |
|--|---|---|---|---|---|---|---|---|
| | 469,1 inch copper<br>water entrance<br>w/Meter | | | | | Meter is maintained by<br>Water Dept. | | |

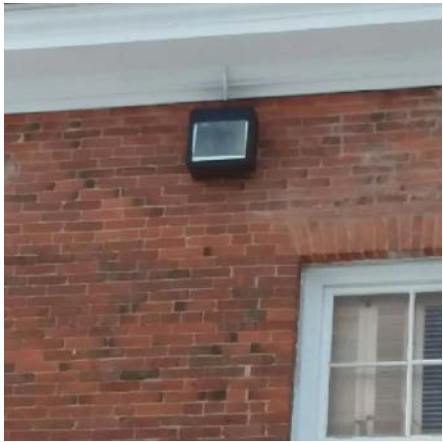
| | Equipment | Condition | Est. Remaining<br>Service Life | Priority | Cost Estimate | Remarks & Recommendations | | |
|--|---|---|---|---|---|---|---|--|
| | 483,150 Watt sodium exterior lighting typical | 4<br>Fully operational, 50-75% life expectancy used, occasional problems, frequent repairs needed | 5 Years | 5 | \$1,000 per fixture | Some lighting is not operation. | | |

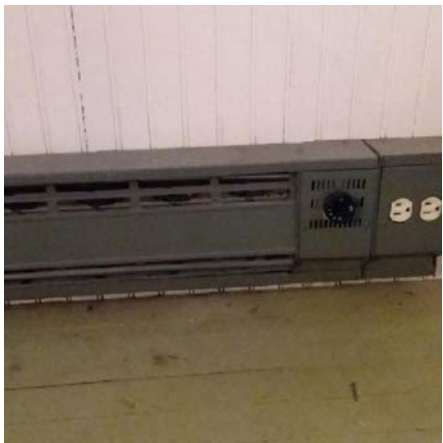
| | Equipment | Condition | Est. Remaining<br>Service Life | Priority | Cost Estimate | Remarks & Recommendations | | |
|--|---|---|---|---|---|---|---|--|
| | 231,Electrical Fintube Radiation | 3<br>Fully operational, 25-50% life expectancy used, periodic problems | 10 Years | 10 | \$600 per strip | Fintube is thermostatically controlled individually.<br><br>This is in the upper level, which is used as storage museum. | | |

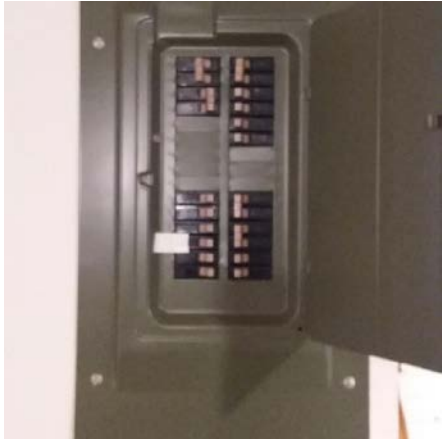
| | equipment | condition | Est remaining<br>Service life | priority | cost | remarks &recommendations | | |
|--|---|---|---|---|---|---|---|---|
| | 226,220 Volt sub-panel | 3<br>Fully operational,<br>25-50% life<br>expectancy used,<br>periodic<br>problems | 10 Years | 10 | \$1,000 | Panel board is not labeled<br>with a nameplate for<br>identification.<br><br>This panel serves the<br>upper level. | | |

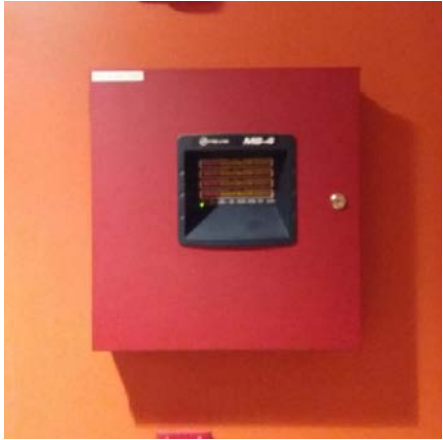
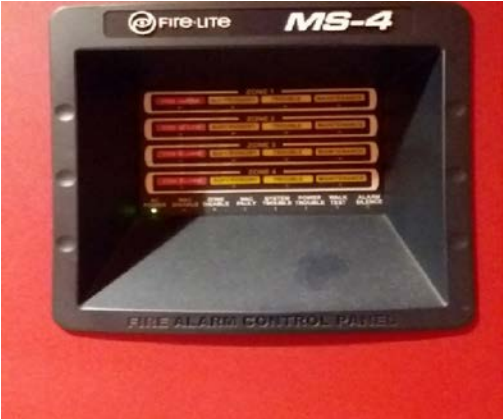
| | equipment | condition | Est remaining<br>Service life | priority | cost | remarks &recommendations | | |
|--|---|---|---|---|---|---|---|---|
| | 472,Fire Alarm<br>Annuciator Panel<br><br>Installed 2013 | 1<br>Fully operational,<br>new, recently<br>replaced | 25 Years | 10 | \$1,000 | | | |

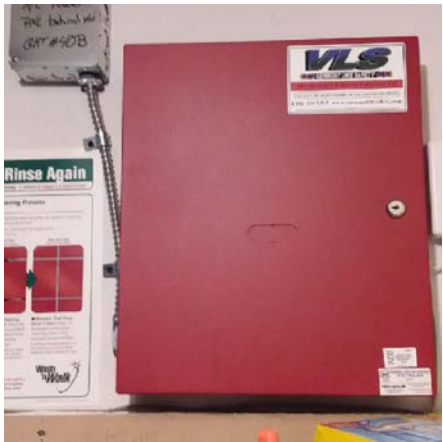
| | equipment | condition | Est remaining<br>Service life | priority | cost | remarks &recommendations | | |
|--|---|---|---|---|---|---|---|---|
| | 471,FACP<br><br>Installed in 2013 | 1<br>Fully operational,<br>new, recently<br>replaced | 25 Years | 10 | \$3,000 | Control panel is<br>dispatched to the police<br>station which is the<br>Central Dispatch. | | |

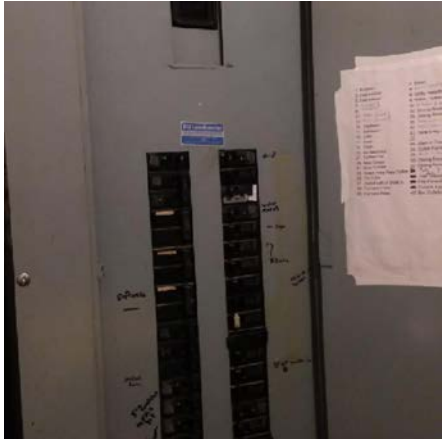
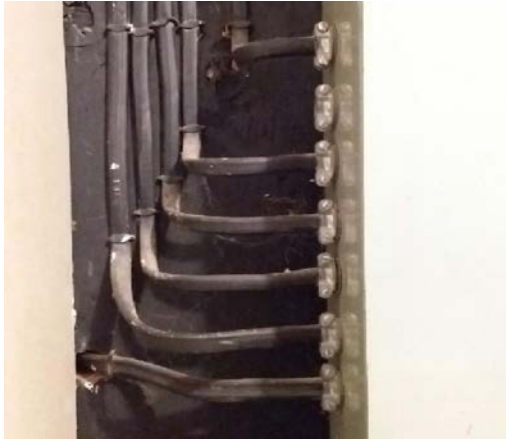
| | equipment | condition | Est remaining<br>Service life | priority | cost | remarks & recommendations | | |
|--|---|---|---|---|---|---|---|---|
| | 468,Electrical<br>Panelboard | 2<br>Fully operational,<br>0-25% life<br>expectancy used,<br>no issues, no<br>conerns | 15 Years | 10 | \$5,000 | Electrical service<br>underground from town<br>offices. Meter is in town<br>office building. | | |
