Town of Newport, New Hampshire
Building Assessment | July 31, 2017

Building: Opera House
 20 Main Street
 Newport, New Hampshire

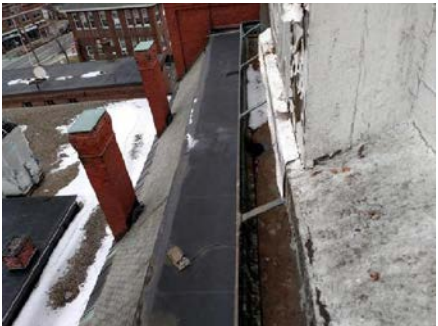
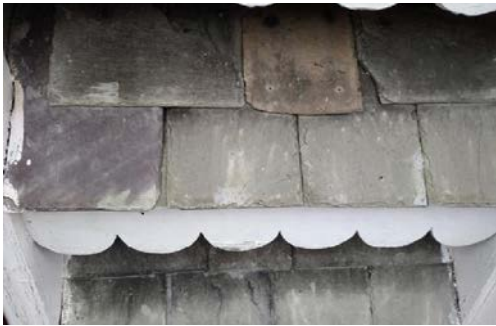
Equipment	Condition	Est. Remaining Service Life	Priority	Cost Estimate	Remarks & Recommendations	Photos	
906,Exterior Note:	4	3	3	\$5,000	Portions of clock tower need to be painted, check flashing and/or install new flashing to minimize maintenance, appears slate in vents needs to be worked on.

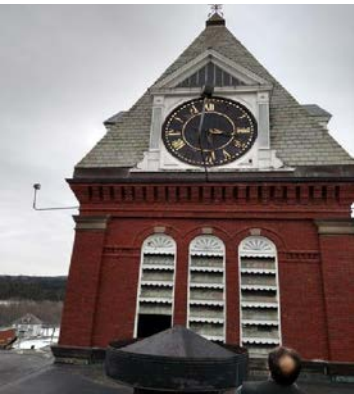
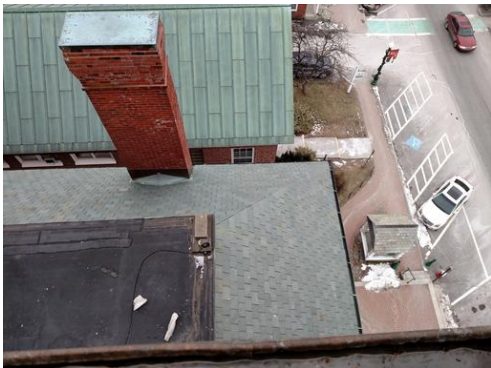
equipment	condition	Est remaining Service life	priority	cost	remarks & recommendations		
	841,Slate	1	75	10	\$18.00 sq.ft	Roof slate was replaced in 1995 and should last from 50-100 years depending on the slate quarry

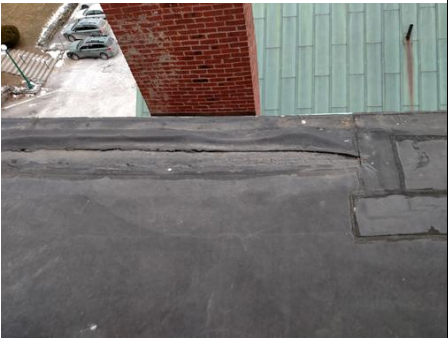
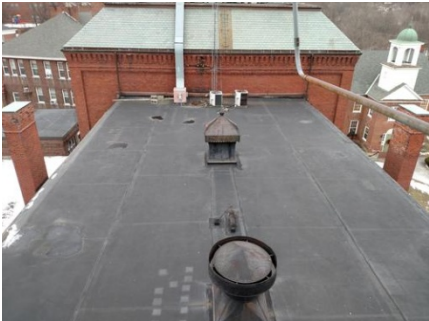
840,Rubber roof	5	0	1	\$ 18/sq.ft. 5,000sq.ft. \$90,000	Rubber roof dates to 1989 making it 27 years old; this roof should be scheduled for replacement as it is at end of life. The challenge will be replacing the rubber under the antennae array; hopefully the lease agreement has some language in favor of the town.

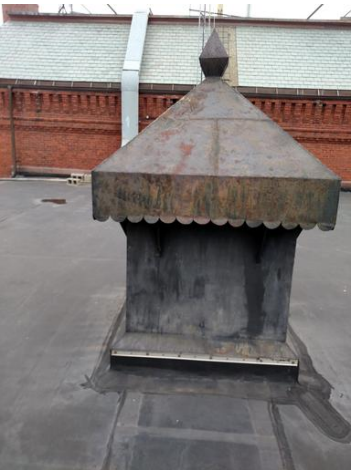
842,General Note					maintain distinctive ventilators, either re purposed or as dummies, should be painted

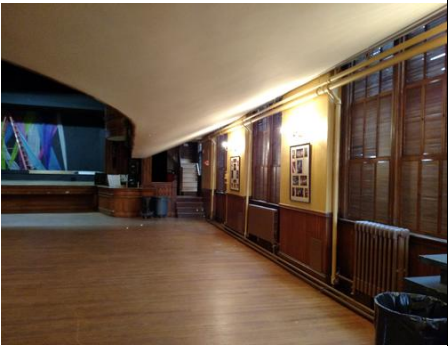
equipment	condition	Est remaining Service life	priority	cost	remarks &recommendations		
	909,General Note					continue excellent work preserving these original wooden shutters

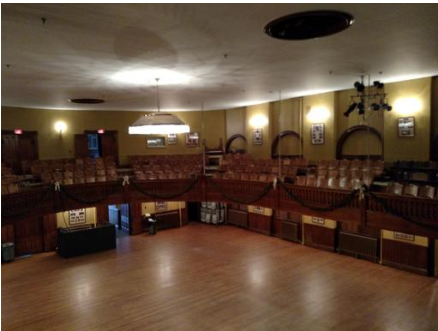
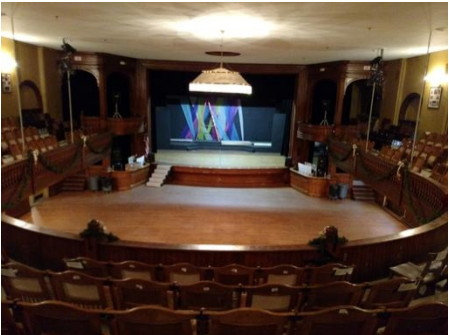
843,General Note					incredible hall in very good condition, work periodically performed, stained glass windows being restored, plaster ceiling under mezzanine replaced great job

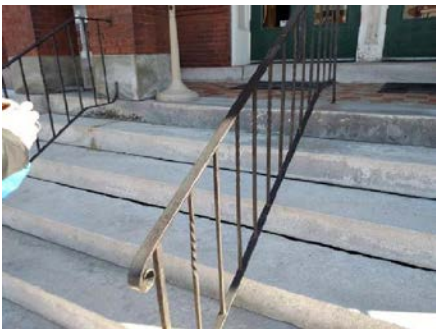
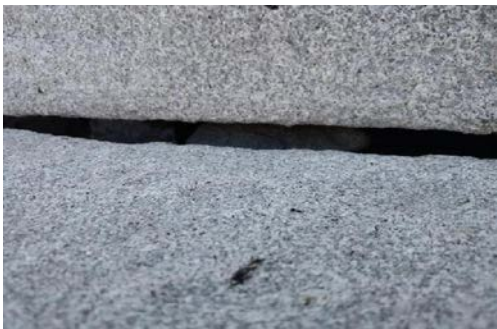
903,Exterior Note:	5	50	1	\$15,000	Granite stairs should be rebuilt to close gaps and water entry.

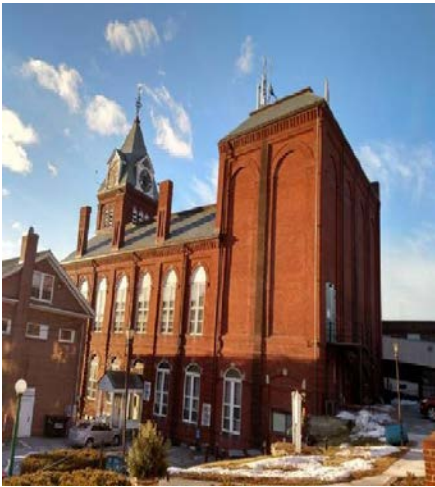
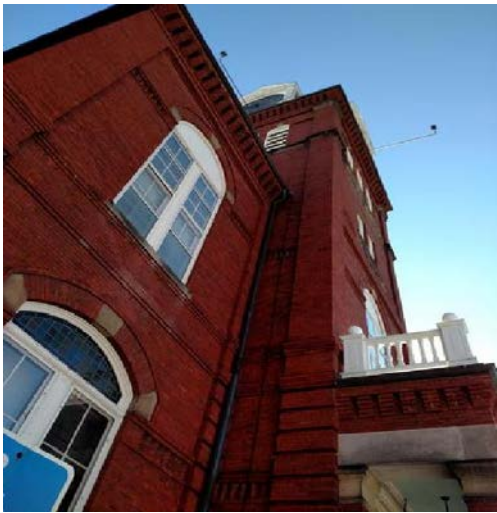
equipment	condition	Est remaining Service life	priority	cost	remarks & recommendations		
	847,Brick	2	50+	6	\$5-10 sq.ft.	Brick is in good condition, mortar should be checked for potential re-pointing, make sure pointing cement matches strength of existing (no stronger) and no colored mortar.

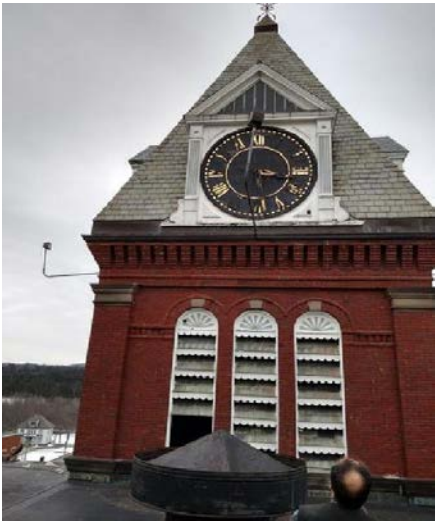
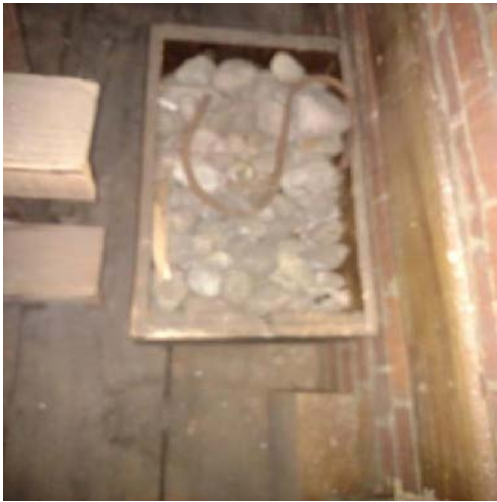
equipment	condition	Est remaining Service life	priority	cost	remarks &recommendations		
	846,Exterior Note:					Clocks work and there is a system to replace lights, should install LED bulbs at least in existing to minimize replacement intervals, old weighted clock system has been electrified, used to run off wood baskets in corner of tower filled with rocks, akin to weight on grandfather clocks

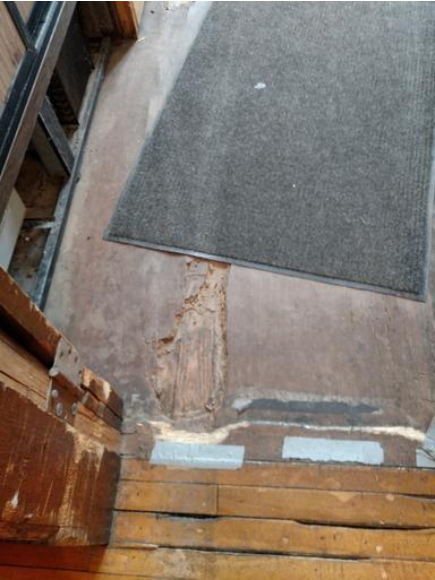
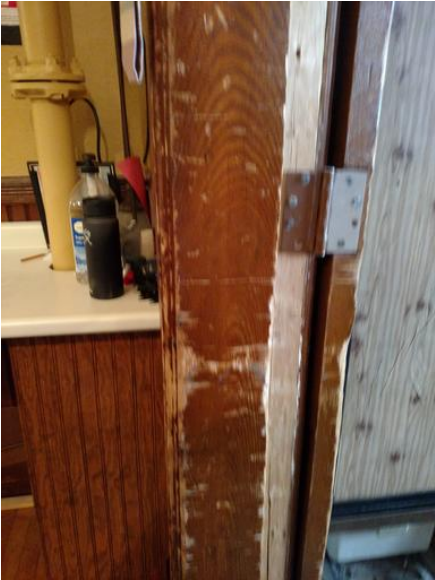
equipment	condition	Est remaining Service life	priority	cost	remarks & recommendations		
	852,Interior note	4	3	4	\$1,000	repair flooring and possibly add protective covers for jambs, moving chairs and tables is not going to stop . Floor makes it more difficult and potentially banging into trim

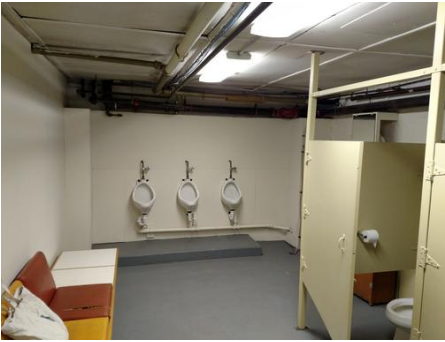
845, Law & ADA					bathrooms in basement (only other beside two on hall floor) are not vertically accessible nor are they accessible if you could get to that floor, there are people that need ADA features who are not in wheelchairs

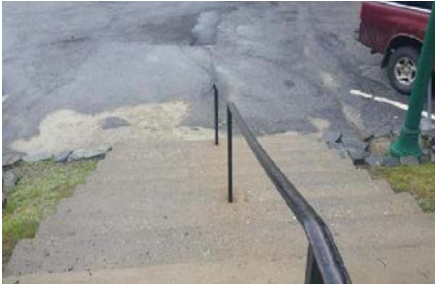
913,Stairs	4	4	1		Stairs from shared parking lot need paint and repair of treads and also grading to steps.

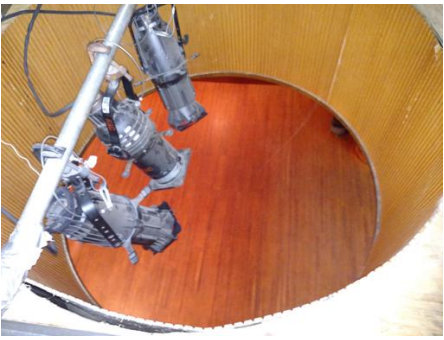
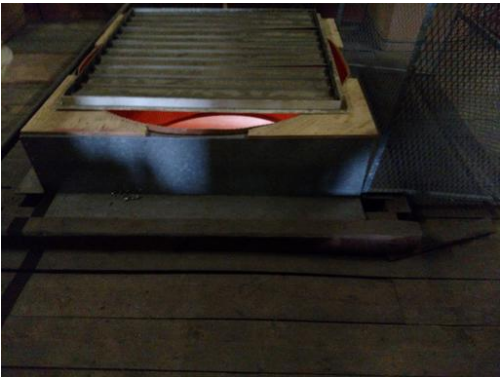
equipment	condition	Est remaining Service life	priority	cost	remarks & recommendations		
	851, Energy	1		4		accommodations should be made to close these openings in during heating season, they presently are open to the attic and heat pours thru them , take care to accommodate the heat of the lights.

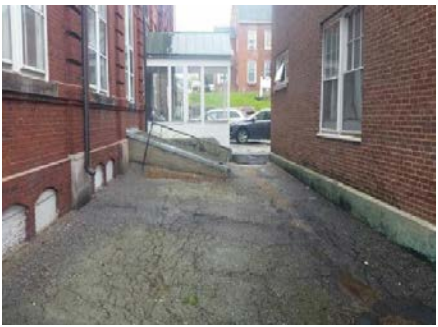
915, Exterior note	4	5	5		Pavement keeps water from basement, could be replaced with rubber membrane and stone.

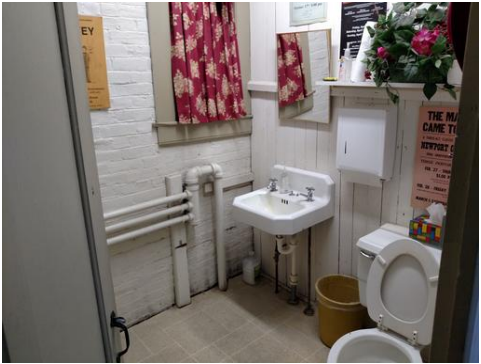
850, Law					dressing rooms do not meet ADA and potentially have longer than allowed dead end corridors, keep all emergency lighting, detectors and pull stations up to date, area overheats and suggest steam pipes that travel thru rooms be insulated for energy savings and safety

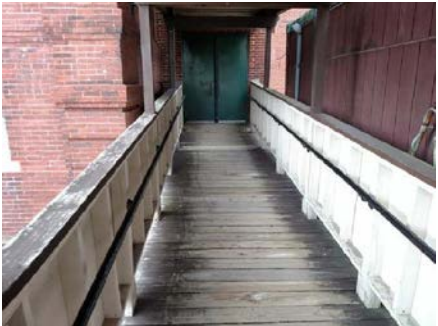
911, Exterior Note:	4	3	4	\$3.50 sq.ft	Suggest wood planks be painted with 'Rescue It' by Olympic and general painting of handrail and walls.

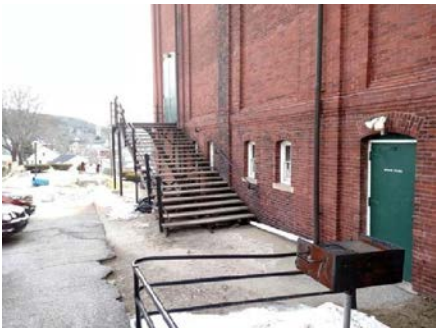
equipment	condition	Est remaining Service life	priority	cost	remarks &recommendations		
	910, Exterior Note:	4	3	4	\$3.50 sq.ft	Paint metal and suggest renewal type paint for the wood like Olympic 'Rescue It'.

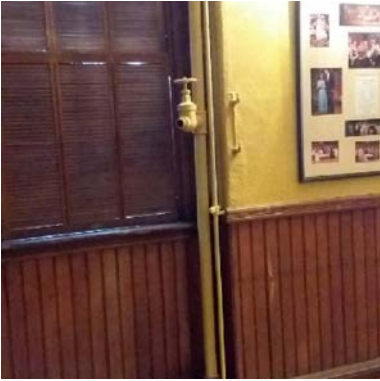
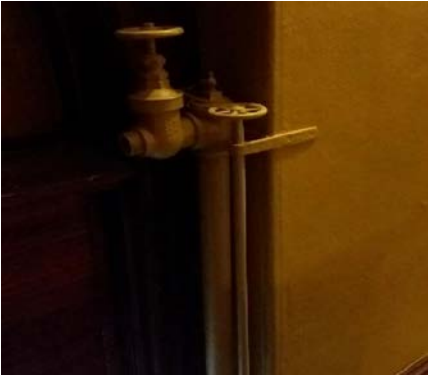
586,Sprinkler standpipe					Sprinkler piping is exposed in many areas.

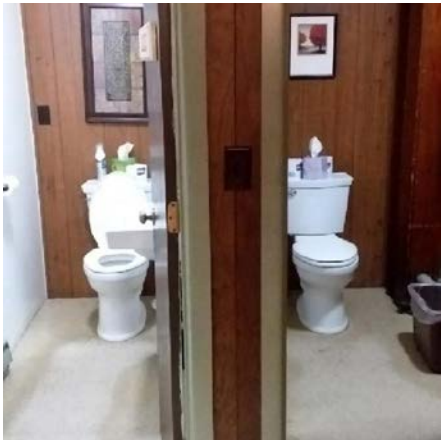
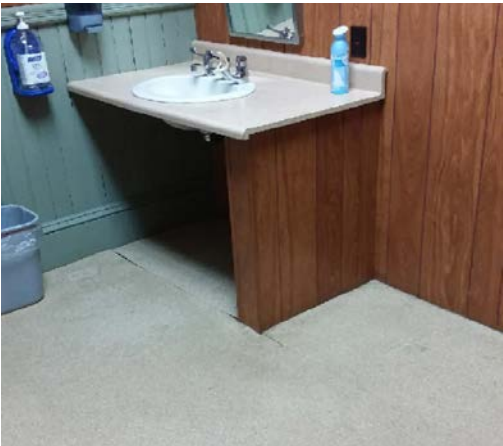
289,Bathroom	3 Fully operational, 25-50% life expectancy used, periodic problems	10 Years	8	\$1,000 per fixture	*for ADA Compliance Floor mount tank type toilets, counter mount single handle faucet w/drinking water fountain attachment. These bathrooms serve as public bathrooms for the multipurpose hall. They do not appear to be ADA Compliant.

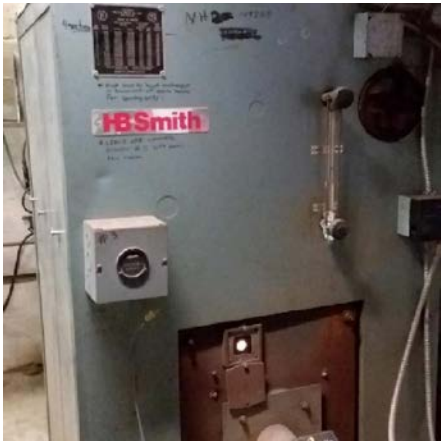
equipment	condition	Est remaining Service life	priority	cost	remarks & recommendations		
	290,598,600 BTU oil fired steam boiler	5 Operational only with constant attention, 100% life expectancy used, failure imminent	1 to 2 Years	1		Boiler to be replaced soon.

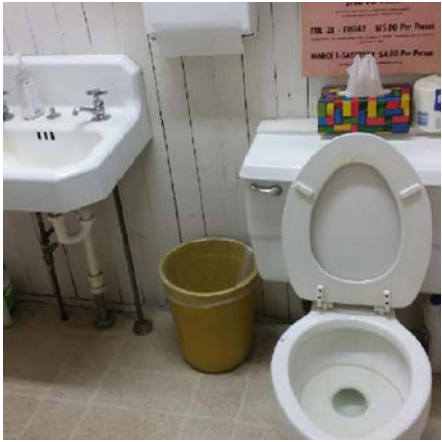
583,Wall-mounted lavatory with dual handle faucets, floor mounted tank type toilet	4 Fully operational, 50-75% life expectancy used, occasional problems, frequent repairs needed	3 to 5 Years	3	\$1,000 per fixtures	This bathroom serves the backstage dressing room area and is used regularly.

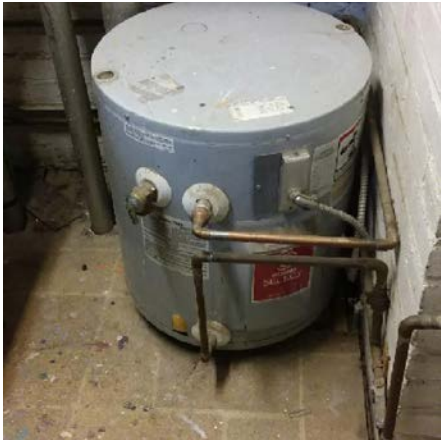
288,Electric water heater Make: STATE	3 Fully operational, 25-50% life expectancy used, periodic problems	5 to 10 Years	7	\$1,000	Provides domestic hot water to backstage dressing room area. Unable to visualize nameplate. Recommend installing a water tight drain pan a under water heater to prevent a safety hazard if water heater was to fail. Also, pipe pressure relief away from people using the bathroom.

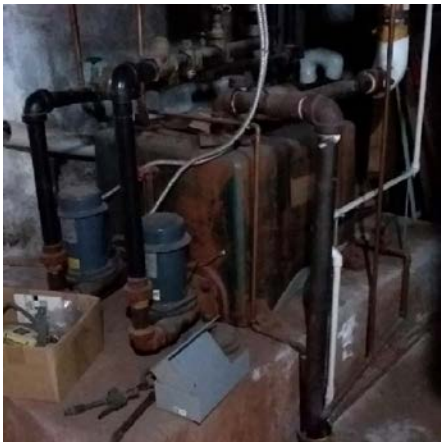
equipment	condition	Est remaining Service life	priority	cost	remarks & recommendations		
	284, Steam condensate metering					Pumps are no longer in service. Steam services should be removed completely if not longer used.

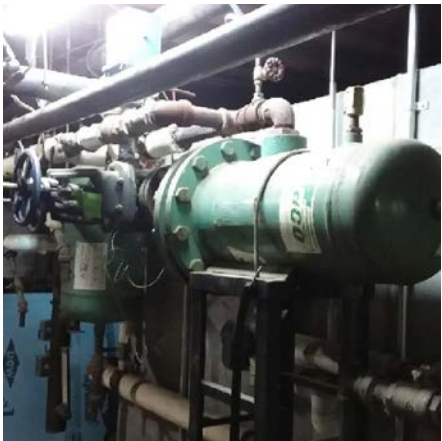
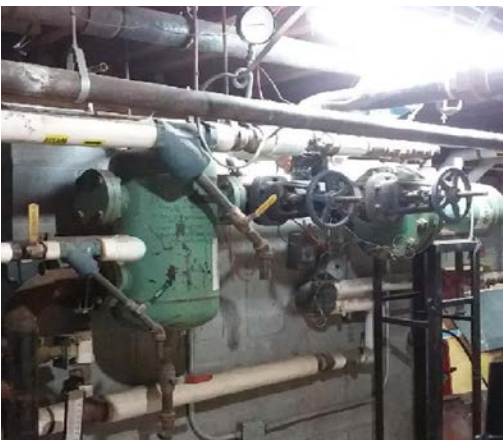
283, Abandoned in place steam piping and valves					Steam services should be removed completely if not longer used.

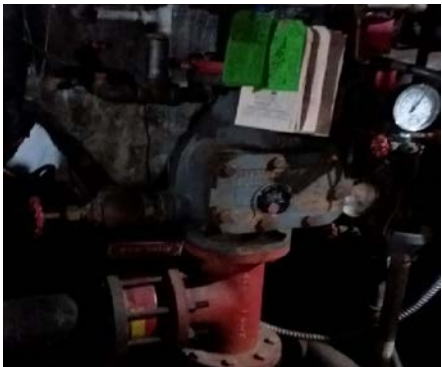
282, Sprinkler system	4 Fully operational, 50-75% life expectancy used, occasional problems, frequent repairs needed	1 to 5 Years	1	\$4.00 sq.ft.	Consists of one wet zone in occupied areas and one dry zone in the attic area. Sprinkler is mostly run exposed to view. System appears to have been installed 35 plus years ago. During our visit, a leak developed.

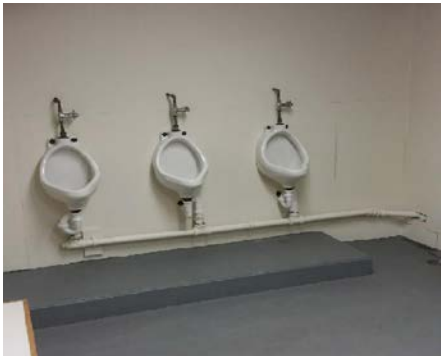
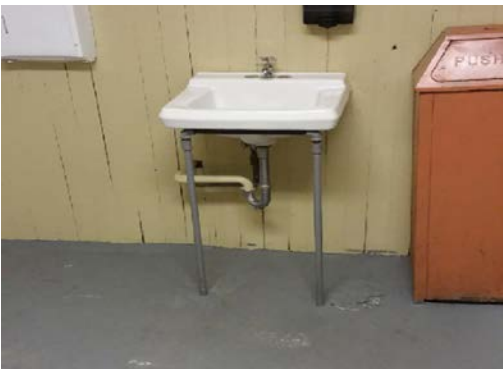
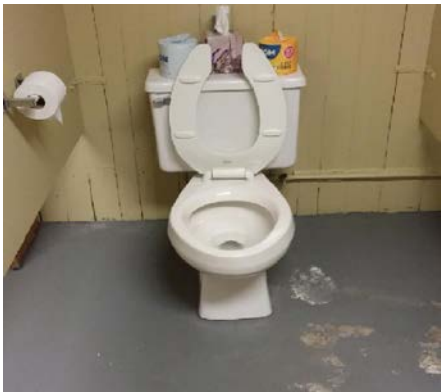
equipment	condition	Est remaining Service life	priority	cost	remarks &recommendations		
	279,Floor mounted tank type toilets, wall mounted lavatories with single handle faucets, wall mounted urinals with single handle flush valves and exposed waste piping	3 Fully operational, 25-50% life expectancy used, periodic problems	5 Years	6	\$1,000 per fixture	Typical for bathrooms in lower level below multipurpose hall. Fixtures are not water conservation type.
