Building: Opera House
 20 Main Street
 Newport, New Hampshire

Town of Newport, Building Assessment July 31,2017

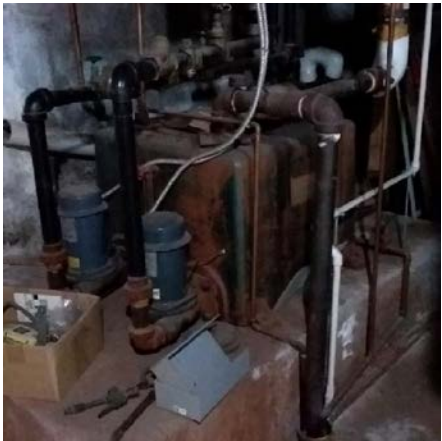
equipment	condition	Est remaining Service life	priority	cost	remarks & recommendations		
	283,Abandoned in place steam piping and valves					Steam services should be removed completely if not longer used.

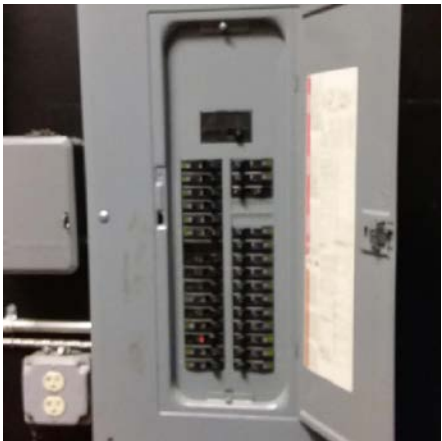
equipment	condition	Est remaining Service life	priority	cost	remarks & recommendations		
	267,Pull stations horn strobe at all exits	2 Fully operational, 0-25% life expectancy used, no issues, no concerns	20 Years	10	\$250 each		 	
	581,Surface mount fluorescent lighting fixture	4 Operational, 50- 75% life expectancy used, occasional problems, frequent repairs needed	1 to 5 Years	3	\$300 each	Research with power supplier for lighting rebate options. Light lenses have discolored and require ballast replacements occasionally.	 	
	582,100 AMP flush mount panel No name plate for identification	3 Fully operational, 25-50% life expectancy used, periodic problems	10 Years	10	\$1,000	Serves courtroom in office area lighting and power. Panel is labeled but recommend confirming labeling is correct.

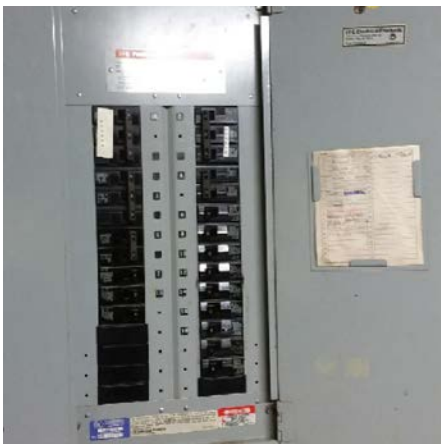
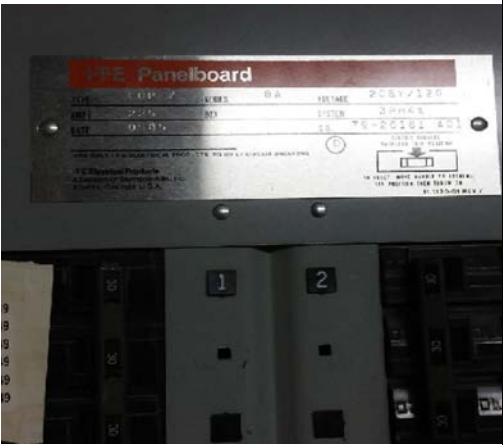
281,120 / 208 volt 225 AMP 3-phase surface mount panelboard	2 Fully operational, 0-25% life expectancy used, no issues, no concerns	20 Years	10	\$4,000	No panelboard name plate for identification.

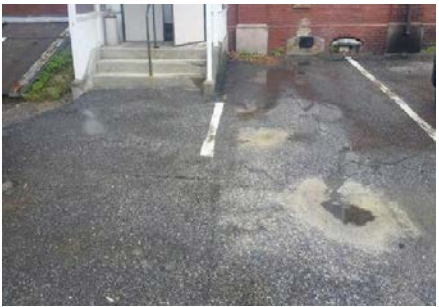
Parking area is shared by current Town Hall, Opera House and Museum/Restaurant. Pavers out front on Main Street should be repaired as they have settled. Asphalt pavements show typical alligator cracking, settlement and potholing in several areas. It appears that some areas may have had two or more lifts of asphalt applied to correct settlement/drainage issues as well as cracking/wear in the interior parking area behind the Town Hall							
	914,Pavement	4	3	2	PF \$7.17 sq.ft.	Potholes in lower parking area.
