# Town of Newport, New Hampshire

## Building Assessment | July 31, 2017

Building: Pine Grove Cemetery  
6 Sunapee Street  
Newport, New Hampshire

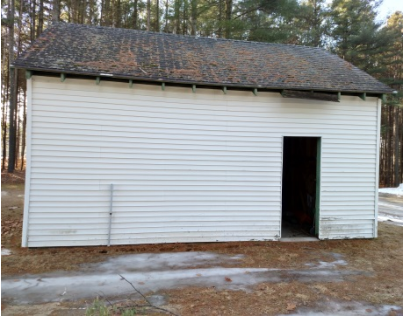
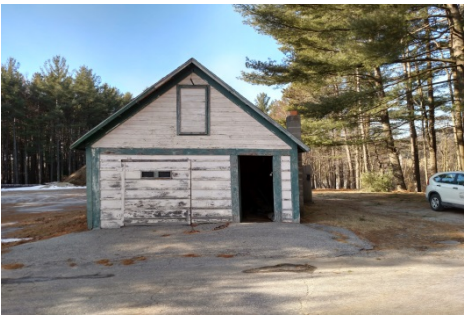
| | equipment | condition | Est remaining<br>Service life | priority | cost | remarks & recommendations | | |
|--|---|---|---|---|---|---|---|---|
| | | | | | | Building One right<br><br>Building Two far right | | |

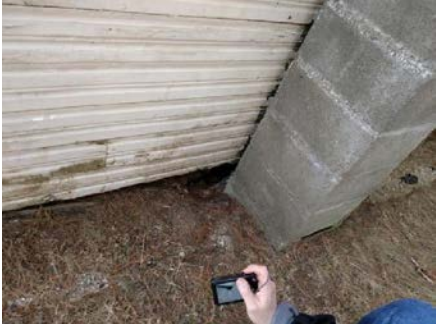
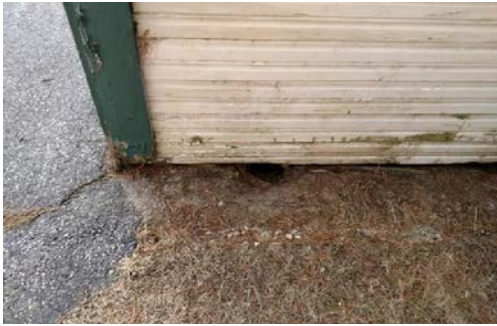
| | equipment | condition | Est remaining<br>Service life | priority | cost | remarks & recommendations | | |
|--|---|---|---|---|---|---|---|---|
| | 817,Exterior Note: | 5 | | | | Various locations of<br>animal living under floor. | | |

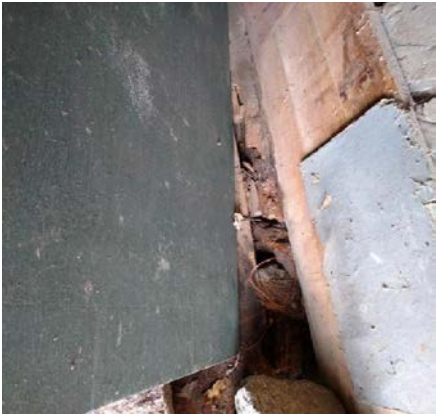
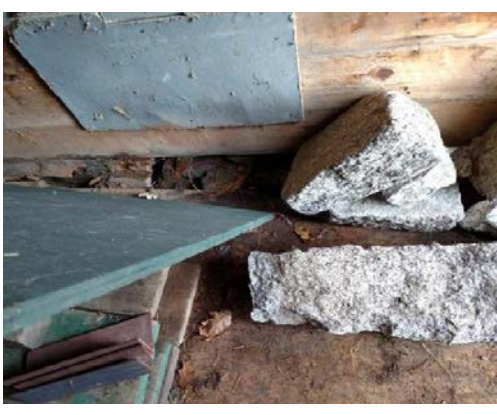
| | equipment | condition | Est remaining<br>Service life | priority | cost | remarks & recommendations | | |
|--|---|---|---|---|---|---|---|---|
| | 816,General Comment: | 5 | | | | Framing is rotted and<br>pulled away from walls. | | |

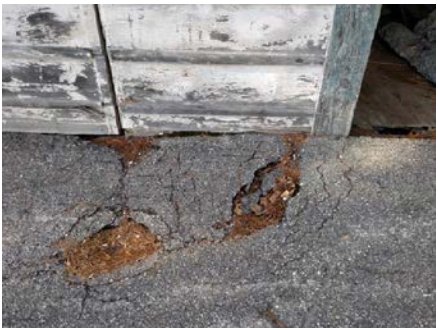
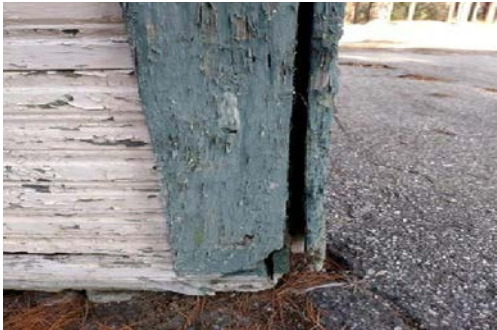
| | equipment | condition | Est remaining<br>Service life | priority | cost | remarks & recommendations | | |
|--|---|---|---|---|---|---|---|---|
| | 815,Exterior Note: | 5 | | | | Building was built on the<br>ground or stones that have<br>vanished, this can be fixed<br>but will be expensive. | | |

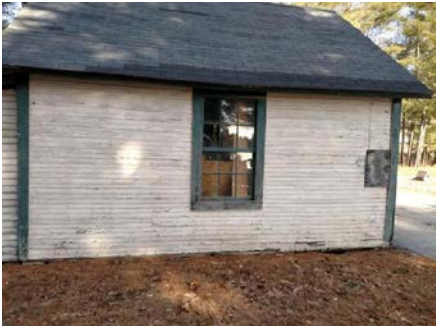
| | equipment | condition | Est remaining<br>Service life | priority | cost | remarks & recommendations | | |
|--|---|---|---|---|---|---|---|---|
| | 814,Exterior Wood Siding | 5 | | | | Painted novelty siding that is not produced, should be painted but only if there is desire to correct other deficiencies | | |

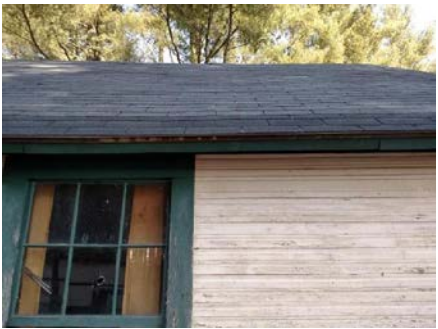
| | equipment | condition | Est remaining<br>Service life | priority | cost | remarks & recommendations | | |
|--|---|---|---|---|---|---|---|---|
| | 813,Asphalt Shingle | 5 | 2-5 | 4 | \$7.00 sq.ft.<br>900 sq.ft<br>\$5,600 | Asphalt roof is at the end of its life and should be replaced. Given the condition of the rest of the building , there is no rush if no work is done to the building. | | |

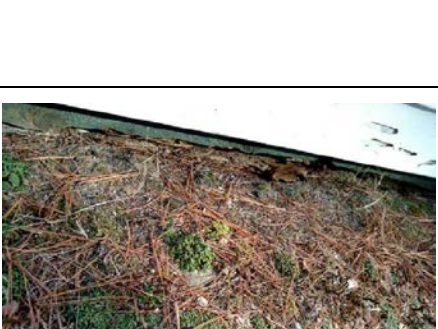
| | equipment | condition | Est remaining<br>Service life | priority | cost | remarks & recommendations | | |
|--|---|---|---|---|---|---|---|---|
| | 812,Exterior Note: | 4 | 2-5y | 4 | \$2,500 | This building has rot in the bottom plate. It appears that a slab was installed and the frame moved on top of it , portions of the bottom plate are rotted and should be repaired. | | |

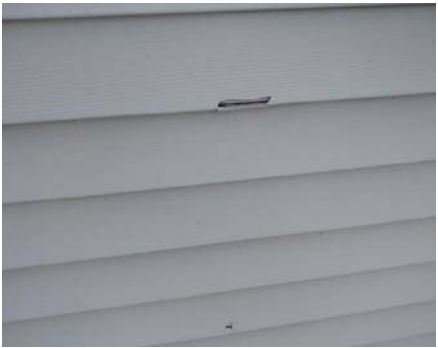
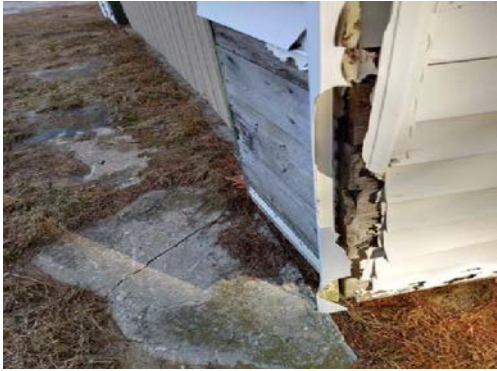
| | equipment | condition | Est remaining<br>Service life | priority | cost | remarks & recommendations | | |
|--|---|---|---|---|---|---|---|---|
| | 811, Exterior Note: | 1 | 20 | 8 | \$300 | Repair vinyl | | |

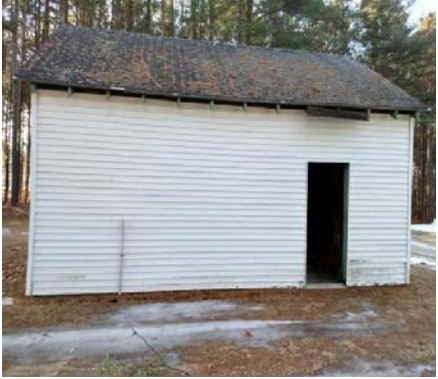
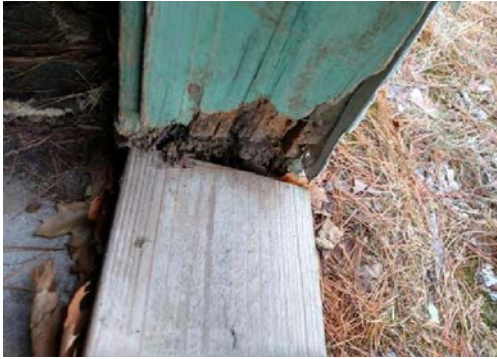
| | equipment | condition | Est remaining<br>Service life | priority | cost | remarks & recommendations | | |
|--|---|---|---|---|---|---|---|---|
| | 810, Exterior Note: | 5 | 2-5y | 6 | \$250 | Repair rot in frame. | | |

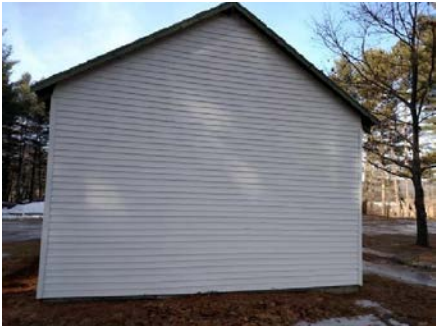
| | equipment | condition | Est remaining<br>Service life | priority | cost | remarks & recommendations | | |
|--|---|---|---|---|---|---|---|---|
| | 809, Exterior Vinyl | | | | | Siding in general good condition. | | |

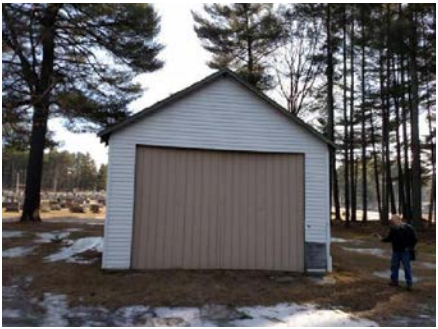
| | equipment | condition | Est remaining<br>Service life | priority | cost | remarks & recommendations | | |
|--|---|---|---|---|---|---|---|--|
| | 808,Paint Surface | 4 | 5 | 4 | \$2.50 sq.ft. | Paint wood surfaces. | | |

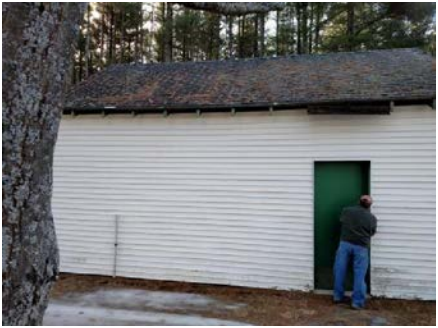
| | equipment | condition | Est remaining<br>Service life | priority | cost | remarks & recommendations | | |
|--|---|---|---|---|---|---|---|--|
| | 807,Asphalt Shingle | 3 | 5 | 6 | \$7.00 sq.ft.<br>1,192 sq.ft.<br>\$8,344 | Asphalt shingle roof looks to be at the end of its service life. While not leaking, plan on replacement within 5 years. | | |

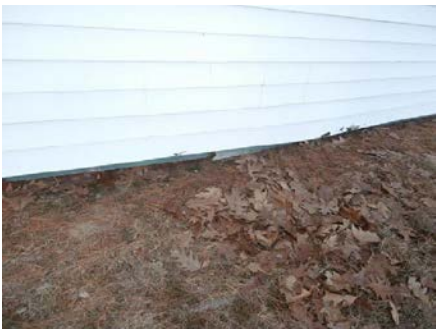
| | equipment | condition | Est remaining<br>Service life | priority | cost | remarks & recommendations | | |
|---|---|---|---|---|---|---|---|--|
| 895,Bearing Wall | | | | | | Rot/deterioration of wall<br>sill plates. | | |

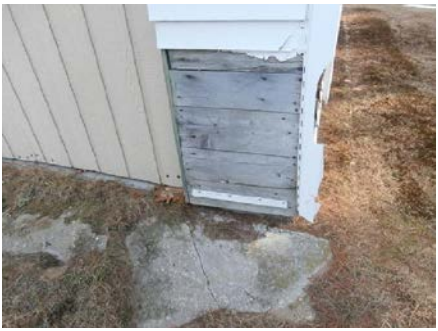
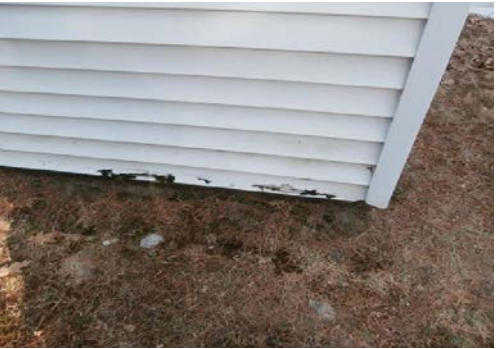
| | equipment | condition | Est remaining<br>Service life | priority | cost | remarks & recommendations | | |
|---|---|---|---|---|---|---|---|--|
| 894,Vinyl | | | | | | Vinyl siding needs repair/<br>replacement on S and W<br>elevations. | | |

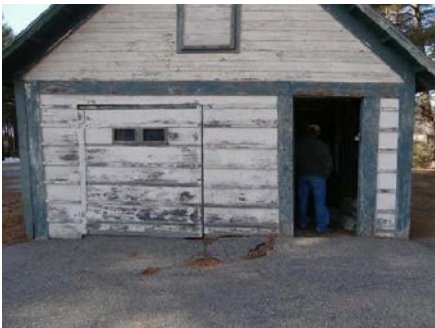
| | equipment | condition | Est remaining<br>Service life | priority | cost | remarks & recommendations | | |
|--|---|---|---|---|---|---|---|--|
| | 892,Paint Touch Up | | | | | Exterior clapboard siding - paint system failure. | | |

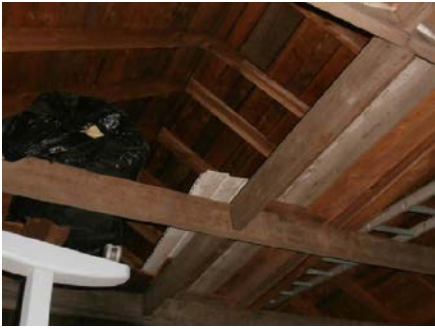
| | equipment | condition | Est remaining<br>Service life | priority | cost | remarks & recommendations | | |
|--|---|---|---|---|---|---|---|--|
| | 891,Rafters | | | | | Roof rafters (2x6) undersized for span condition. | | |

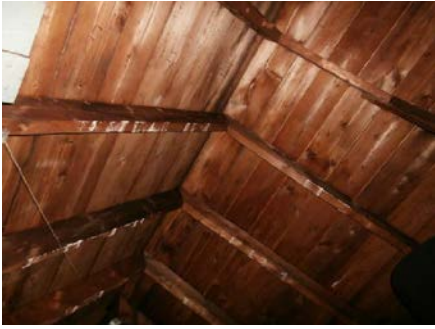
| | equipment | condition | Est remaining<br>Service life | priority | cost | remarks & recommendations | | |
|--|---|---|---|---|---|---|---|--|
| | 890,Rafters | | | | | Roof rafters undersized for span condition, no collar ties or ridge beams. | | |

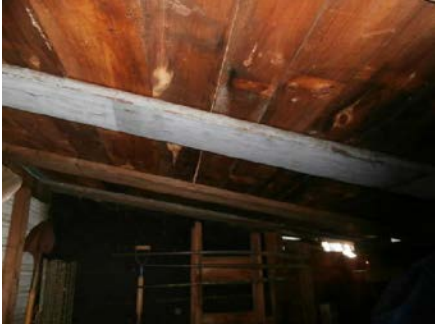
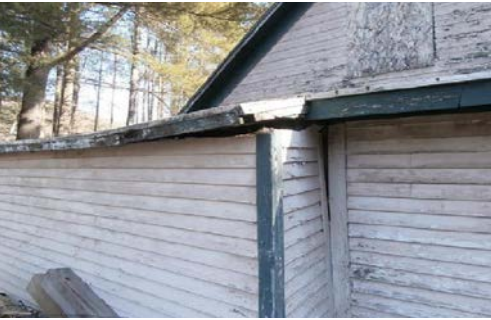
| | equipment | condition | Est remaining<br>Service life | priority | cost | remarks & recommendations | | |
|--|---|---|---|---|---|---|---|--|
| | 889,Rafters | | | | | Rear shed addition roof separating from the supporting walls - rafters installed on weak axis - not structurally sound. | | |

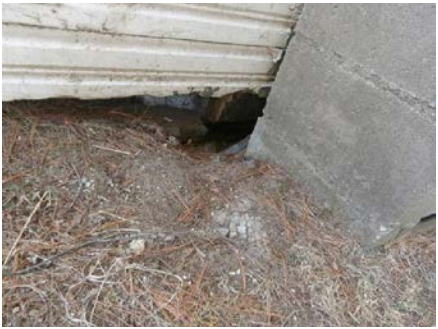
| | equipment | condition | Est remaining<br>Service life | priority | cost | remarks & recommendations | | |
|--|---|---|---|---|---|---|---|--|
| | 888,Foundation | | | | | Foundation collapsed – undermined. | | |

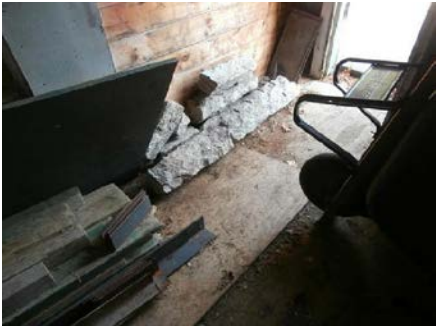
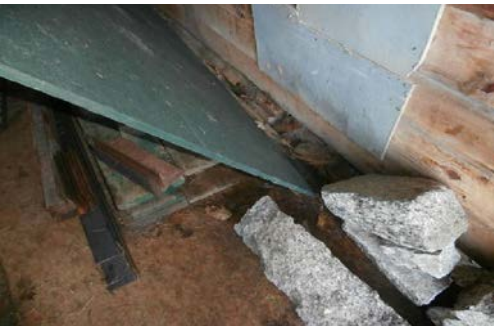
| | equipment | condition | Est remaining<br>Service life | priority | cost | remarks & recommendations | | |
|--|---|---|---|---|---|---|---|--|
| | 886,Floor Framing | | | | | Floor framing is rotted and collapsing along north wall and at east side entry door. | | |

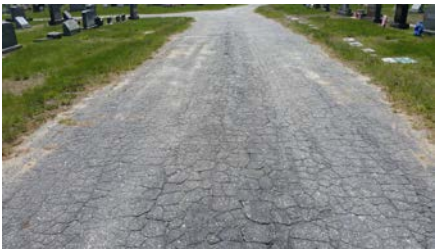
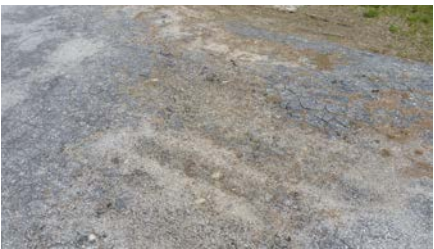
| | Pavement for this cemetery exhibits significant alligator cracking, edge cracking, raveling and aggregate polishing. This appears to be the result of a combination of very old pavement over a poor or non-existent gravel base, which would allow for freeze/thawing cycles to stress the pavement and break it down over time. | | | | | | | |

| | Pavement for this cemetery exhibits significant alligator cracking, edge cracking, raveling and aggregate polishing. This appears to be the result of a combination of very old pavement over a poor or non-existent gravel base, which would allow for freeze/thawing cycles to stress the pavement and break it down over time. | | | | | | | |
|--|---|---|---|---|---|---|---|---|
| | Pavement | 5 | 3 | 5 | PF \$7.17<br>sq.ft.<br><br>61,000<br>sq.ft.<br><br>\$437,370 | • Existing asphalt should be removed, along with sufficient depth of removal of existing base course gravel (if any) and subgrade soil. | | |
