Building: Police Station  
59 Main Street  
Newport, New Hampshire

Town of Newport, Building Assessment July 31,2017

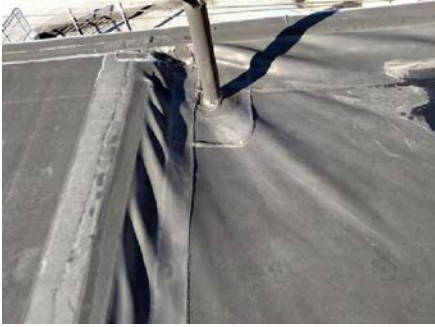
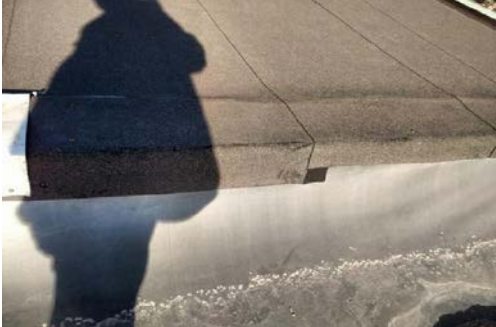
662,Rubber Roof	3	5	4	\$ 18/sq.ft 4,177 sq.ft. \$75,186	Roof should be corrected in relation to transitions, asphalt is not compatible with rubber, there are many repairs needed.  I think a new roof would be more cost effective.

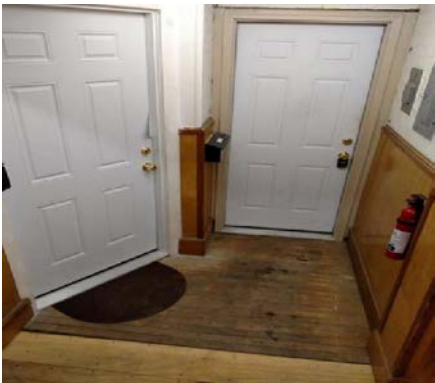
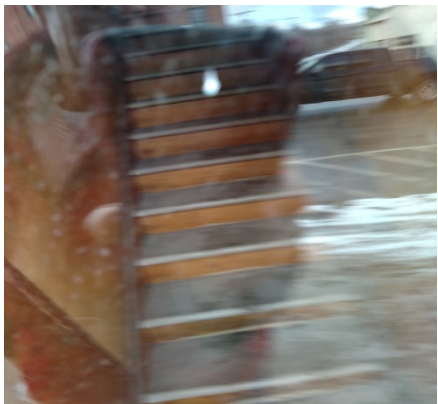
661,Code Issue:					Unusual arrangement For second egress from second floor. Very narrow unrated stair shared with another building. Could not get into stair but suspect there is no fire rating on it.

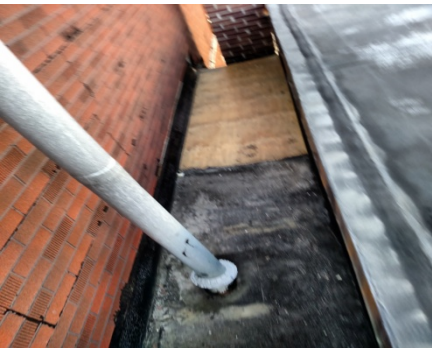
658,Roof				Correct with new roof	Resolve transition between this building and both abutting buildings, now somewhat temporary

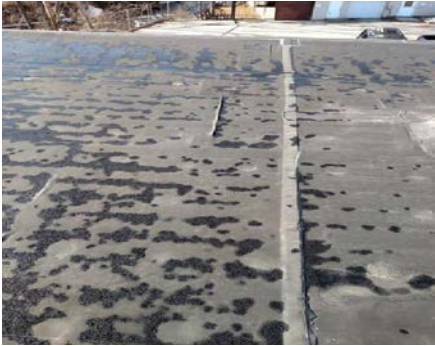
equipment	condition	Est remaining Service life	priority	cost	remarks &recommendations		
	417,Roof				Correct with new roof	Does not appear to slope, 1/4" roof has trouble with seams in places.

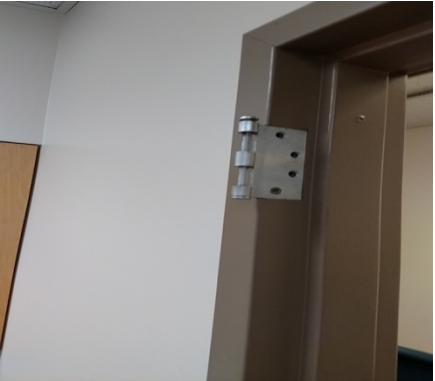
Code issue			1	\$50	While convenient this door from corridor to kitchen is supposed to stay closed . If there is a fire especially in the kitchen the egress corridor is protected from smoke and or fire. Reinstall door

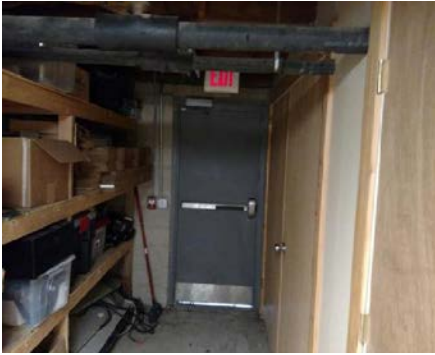
666, Code Issue:					This space was finished off by others and it does not appear the finishes would meet code, this corridor and exit should have fire rated walls and openings and no flammable materials can be stored in an egress corridor.

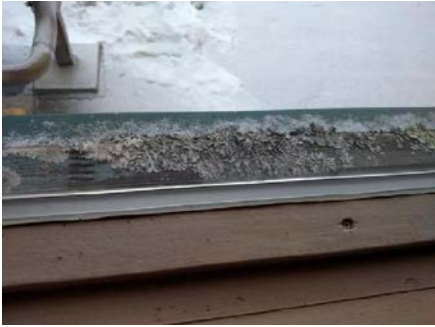
equipment	condition	Est remaining Service life	priority	cost	remarks &recommendations		
	664, Exterior Note:	5	2	5	\$750	Remove lichen ,wood finger-jointing has separated due to lack of repair, may be able to sand, putty, prime and Paint.

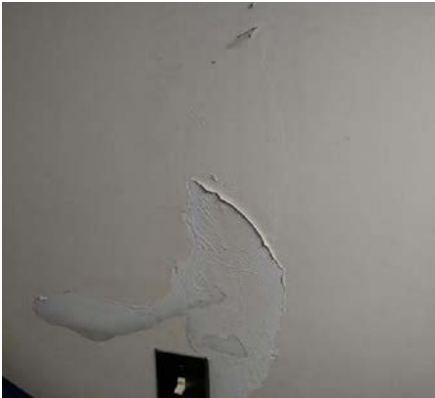
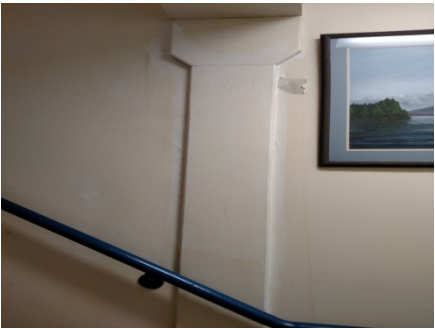
142,General Comment:					Water staining, roof has been patched many times.

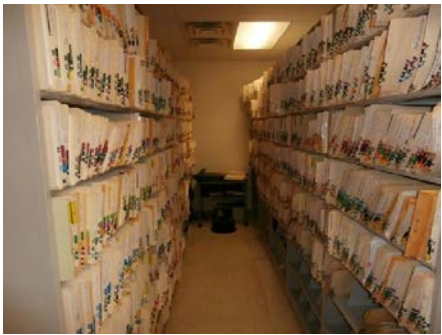
Equipment	Condition	Est. Remaining Service Life	Priority	Cost Estimate			
	204,Load Condition					Floor locally overloaded by records storage.

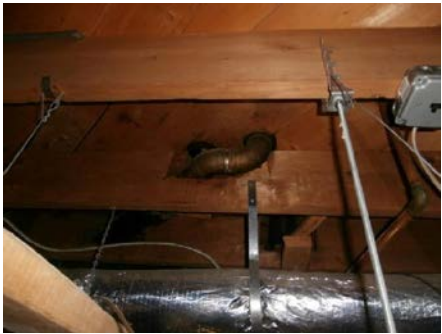
203,Floor Framing					Two consecutive 2x12 floor joists cut for plumbing installation.

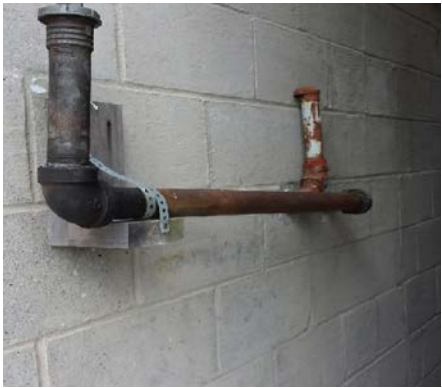
Equipment	Condition	Est. Remaining Service Life	Priority	Cost Estimate			
	129,Oil Fill Connections					Recommend to extend to a more accessible location. Currently located in alley way between buildings.

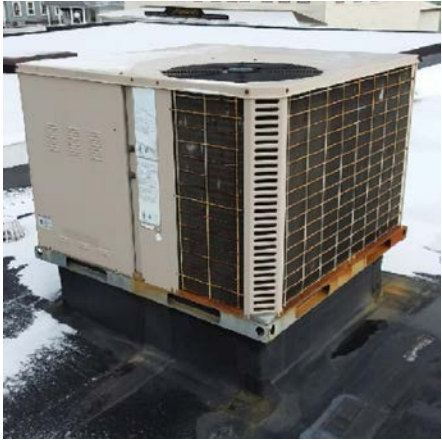
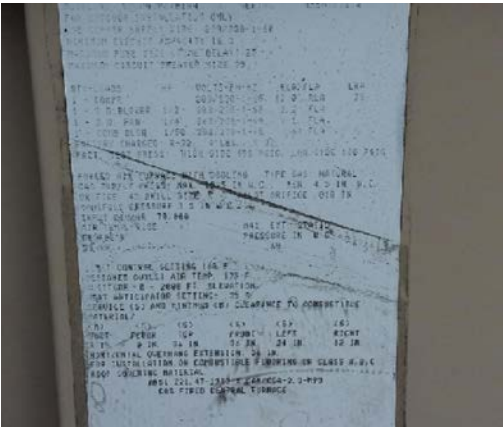
equipment	condition	Est remaining Service life	priority	cost	remarks &recommendations		
	112,RTU for 2 <sup>nd</sup> Floor AC	4 Operational, 50- 75% life expectancy used, occasional problems, frequent repairs needed	5 Years	5	\$7,500	This R-22 refrigerant unit provides air conditioning only for second level.  Name plate has faded which makes it unable to visualize.

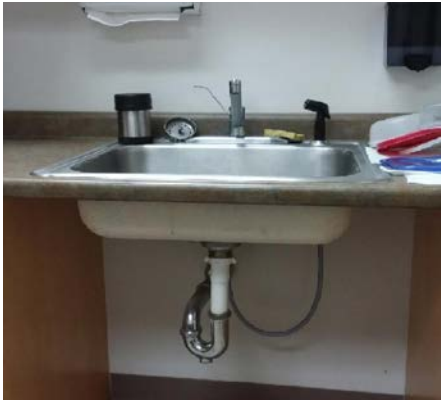
81,Counter mounted lavatory	2 Fully operational, 0-25% life expectancy used, no issues, no concerns	15 Years	10	\$1,000	Lavatory water and drain piping should have ADA under counter water and drain protection.

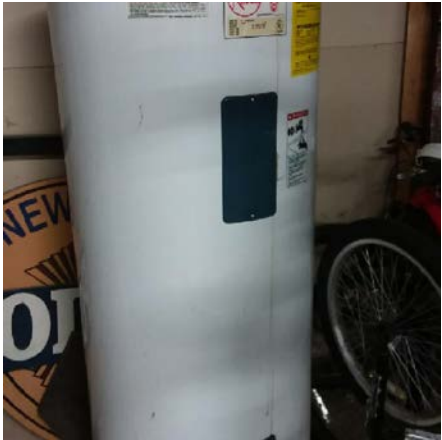
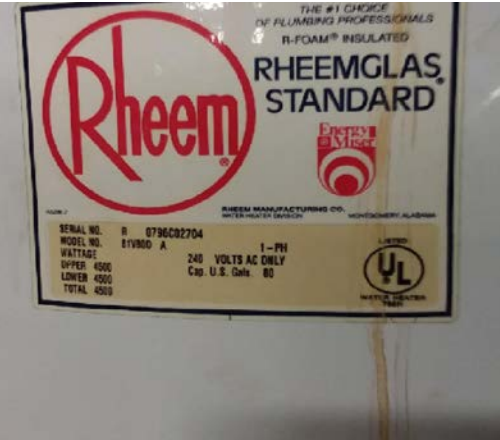
78,Rheem 80 Gallon capacity electric water heater  Model: 81V80D  Unknown install date	4 Operational, 50-75% life expectancy used, occasional problems, frequent repairs needed	2 to 5 Years	4	\$2,000	Provides domestic hot water throughout building through two pipe insulated system.  Tank shows signs of wear at top seam.

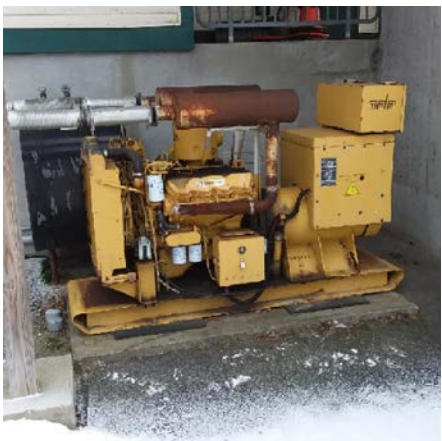
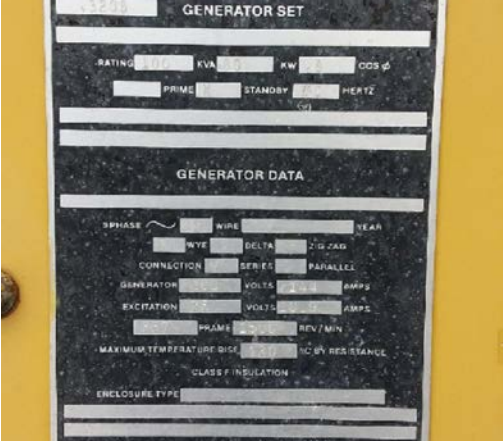
127,Pad mounted 100 KVA diesel fired generator	3 Fully operational, 25-50% life expectancy used, periodic problems	10 Years	10	\$50,000	Provides emergency power for the complete building.  Generator is housed under an overhang which allows it to be exposed to snow/rain and salt from driveway plowing.

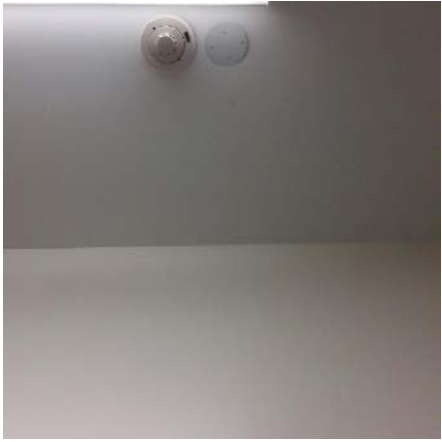
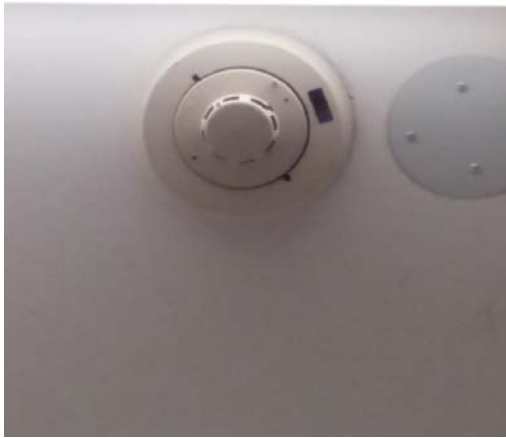
equipment	condition	Est remaining Service life	priority	cost	remarks &recommendations		
	116, Code issue .This is one of two smoke detectors throughout the building	2 Fully operational, 0-25% life expectancy used, no issues, no concerns	15 Years	10	\$250 each	Appears the building has been renovated but not updated with life/safety compliant issues.

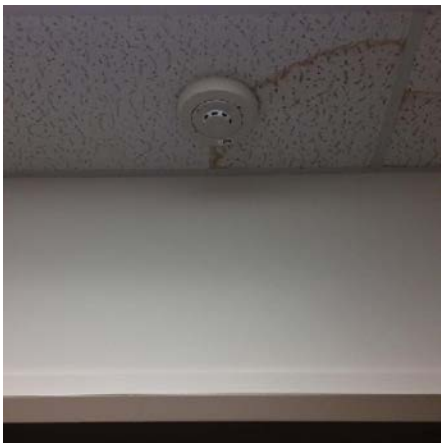
Code issue Smoke Detector	2 Fully operational, 0-25% life expectancy used, no issues, no concerns	15 Years	10	\$250 each	It appeared that the Life/Safety devices throughout the building were limited. Two smoke detectors were all that could be found throughout the building.

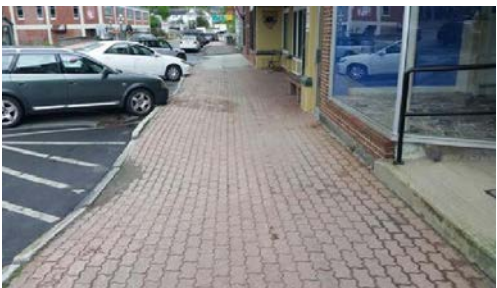
Concrete pavers at the front side of the building are worn, missing in places and have settled forming a gap along the center of the sidewalk. Curbing has shifted out of vertical in places. Pavements at the rear of the building are in relatively good condition with some transverse cracking along the access to the back lot from Main Street.

Equipment	Condition	Est. Remaining Service Life	Priority	Cost Estimate	Remarks & Recommendations	Photos	
884,Pavement	2	20	3	\$1,000	Replace and reset pavers and curb.
