Building: Pollards Well

Newport, New Hampshire

Town of Newport, Building Assessment July 31,2017

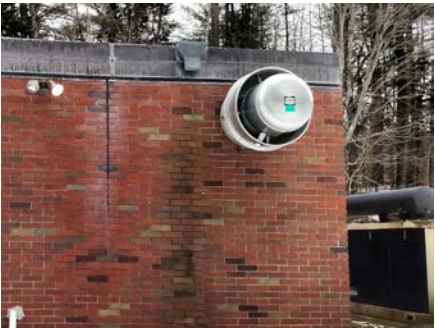
Architectural							
	Brick building housing well pump . Utilitarian, could use some maintenance outlined in the report						
	Equipment	Condition	Est. Remaining Service Life	Priority	Cost Estimate	Remarks & Recommendations	Photos
	751,Exterior Note:	2	50	7	\$250	Install down spout to scupper.

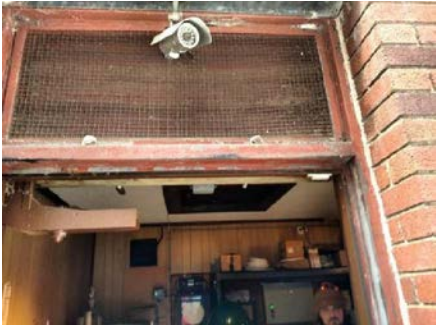
equipment	condition	Est remaining Service life	priority	cost	remarks &recommendations		
	750,Exterior Note:	4	8	3	\$2.50 sq.ft	Paint door and frame, clean vent.

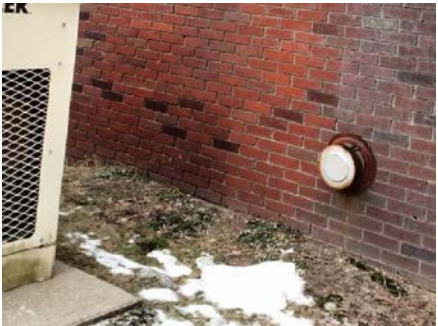
749,Exterior Note:	4	8	4	\$1,000	Remove dirt to show 6" of foundation grade swale to drain to rear.

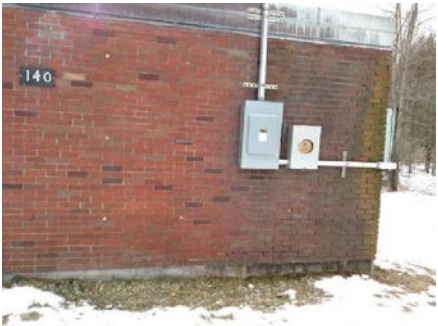
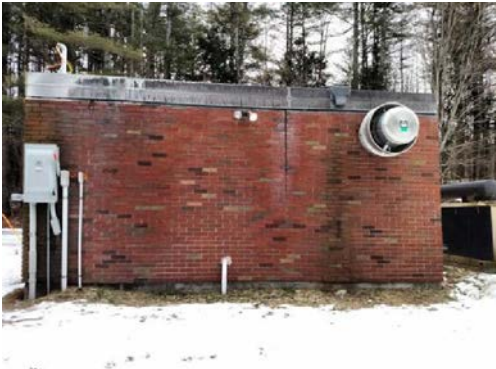
526,Exterior Brick	3	50	5	\$5.00 sq.ft.	Re-point brick. under old electrical service entry at rear corner

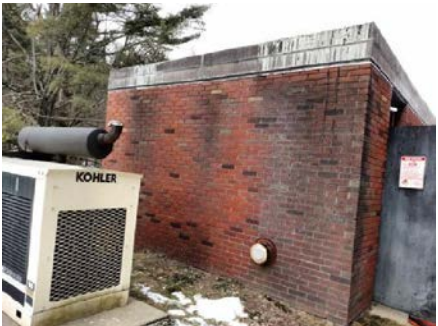
746,Exterior Brick	4	50	7	\$1.50 sq.ft.	Clean brick

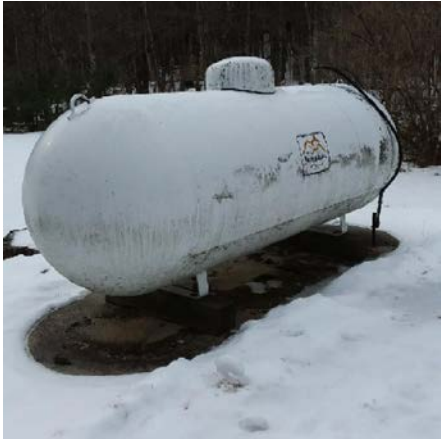
equipment	condition	Est remaining Service life	priority	cost	remarks & recommendations		
	252,1000 Gallon pad mounted LP tank					Supplies gas for generator. Unknown if gas supplier maintains tank or if tank is town owned. Unknown date of install.

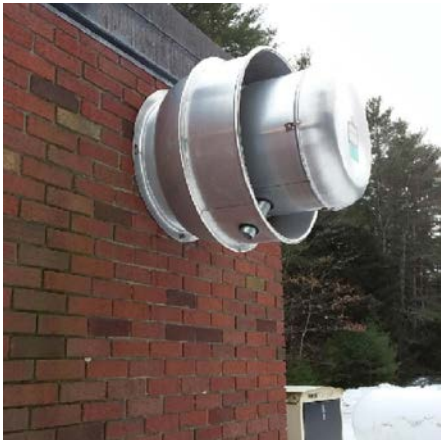
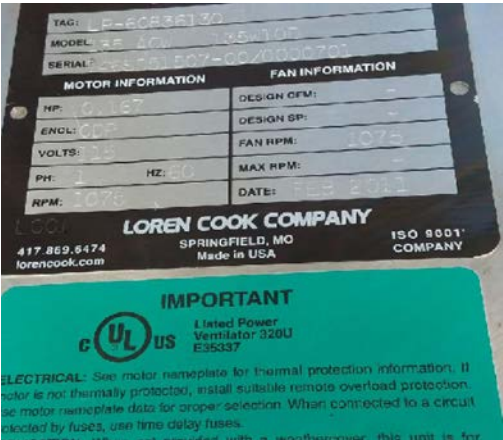
250,COOK Sidewall exhaust fan Model 135ACW Installed in 2011.	2 Fully operational, 0-25% life expectancy used, no issues, no concerns	25 Years	10	\$3000.00	Fan exhausts the general area.

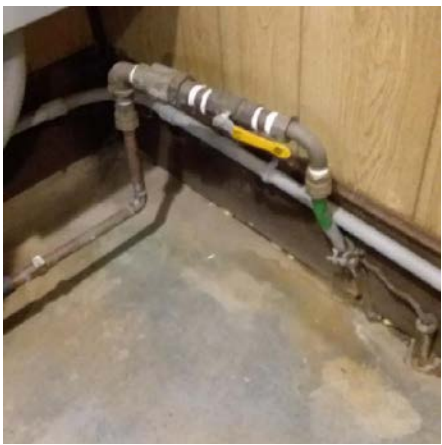
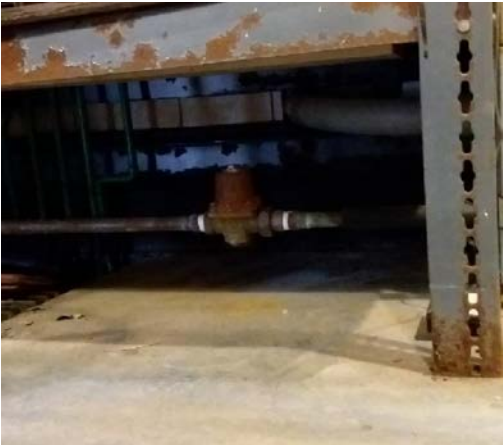
247,Water Entrance	3 Fully operational, 2-50% life expectancy used, periodic problems	15 Years	10		This building does not appear to have a water meter installed but is equipped with a pressure reducing valve.

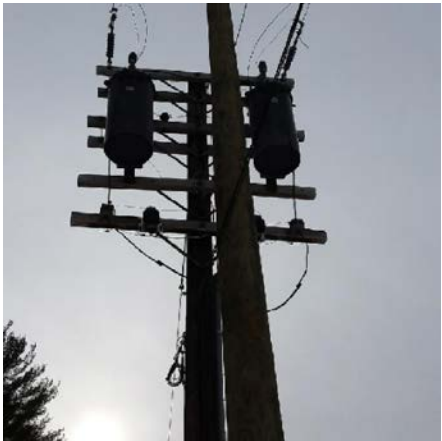
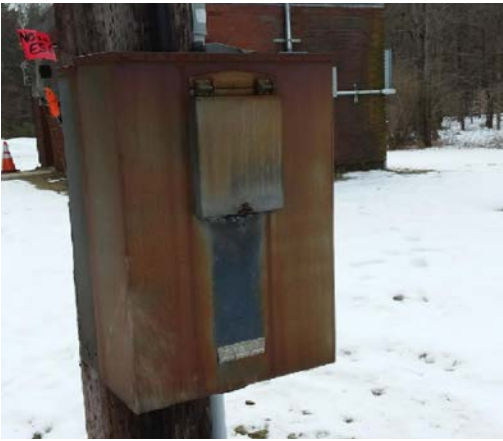
equipment	condition	Est remaining Service life	priority	cost	remarks &recommendations		
	Equipment	Condition	Est. Remaining Service Life	Priority	Cost Estimate	Remarks & Recommendations		
	253,Two - 37 1/2 KVA pole mounted transformers					Provides power to building through underground service. Transformers are maintained by power supplier. Disconnect on pole will be removed as the new service entrance is being currently installed. Maintained by power supplier.

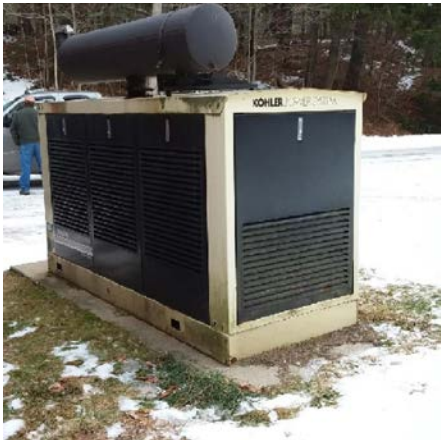
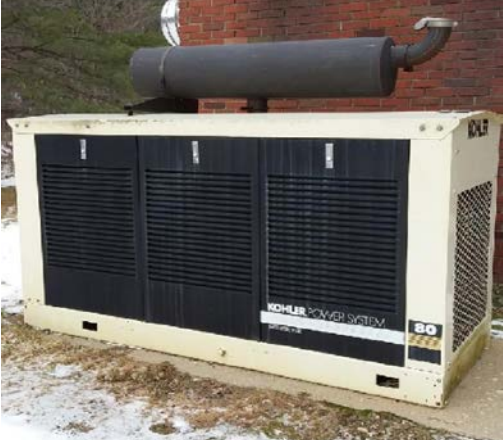
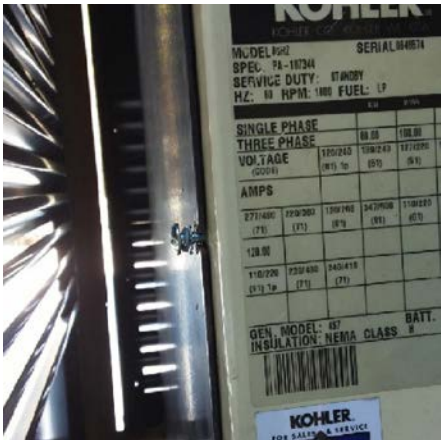
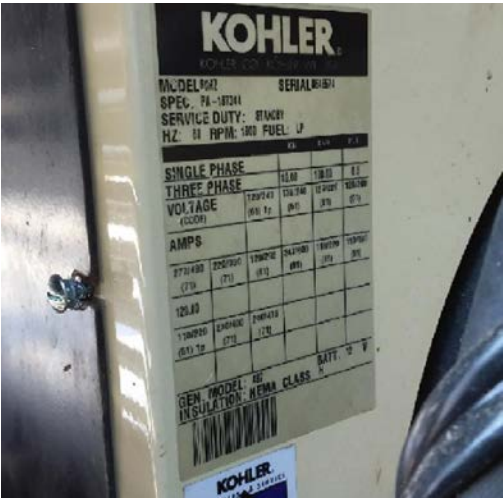
251,Kohler-80 KW LP Gas fired pad mounted generator Installed in 2000	3 Fully operational, 25-50% life expectancy used, periodic problems	15 Years	10	\$55,000

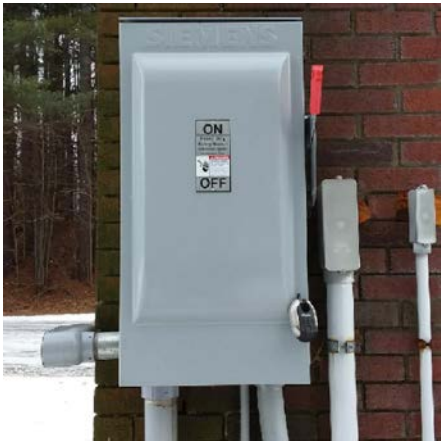
249,Electrical disconnect	1 Fully operational, new, recently replaced	25 + Years	10	\$2,000	Being installed during our visit.

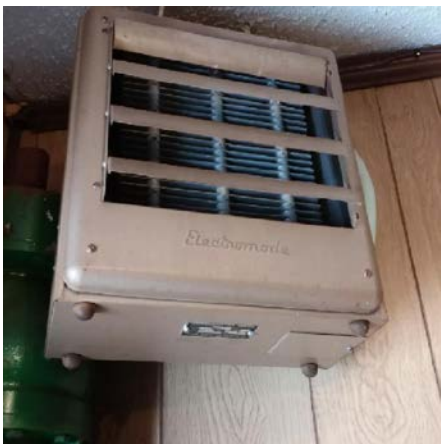
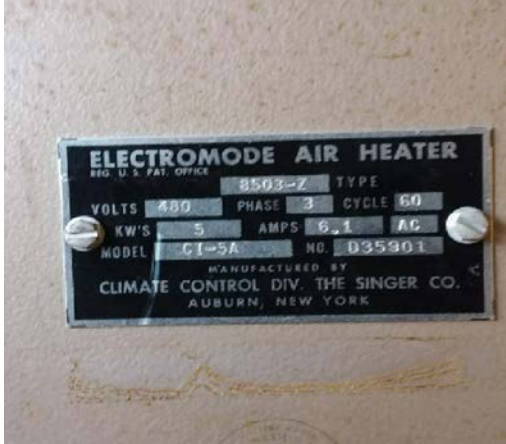
248,Ceiling hung 5 KW electric unit heater Make: Electromechanical Model: CI-5A Unknown date of install	4 Operational, 50-75% life expectancy used, occasional problems, frequent repairs needed	5 Years	5	\$1,500	Maintains heat for this building. Recommend a second source of heat due to water in this building. A gas fired wall/floor mount heater that still produces heat during a power outage is preferable. Although this building is equipped with a generator the current electric heater could fail.

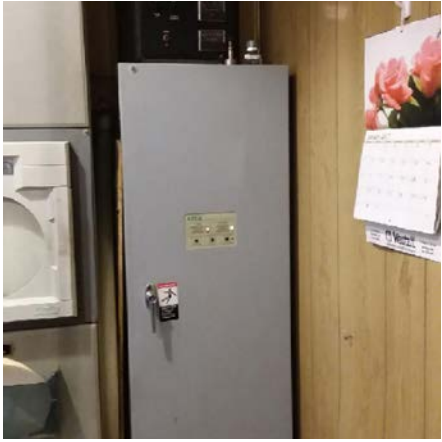
equipment	condition	Est remaining Service life	priority	cost	remarks &recommendations		
	246,Generator switchgear	2 Fully operational, 0-25% life expectancy used, no issues, no concerns	15 Years	10	\$5,000
