Building: Public Works Garage
449 South Main Street
Newport, New Hampshire

Architectural							
	This building was designed and built to house Public Works. Additionally, it serves as bus storage for the school system. There are immediate problems with the roof, rear CMU wall and other overdue maintenance items. If an analysis of space needs was performed; they lack adequate program space and are using every inch they can.						
	Equipment	Condition	Est. Remaining Service Life	Priority	Cost Estimate	Remarks & Recommendations	Photos

Town of Newport, Building Assessment July 31,2017

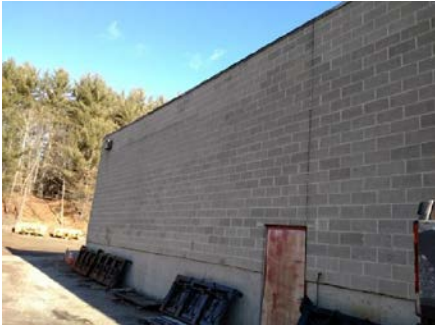
equipment	condition	Est remaining Service life	priority	cost	remarks &recommendations		
	778,Paint Surface	3		8	\$2.50 sq.ft.	While clean, this wall still should be painted.

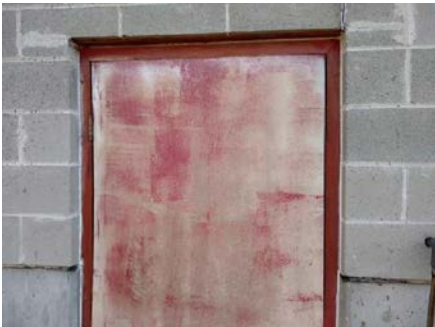
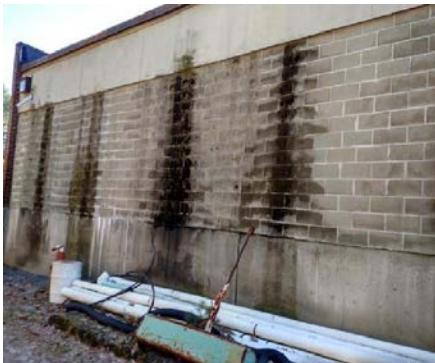
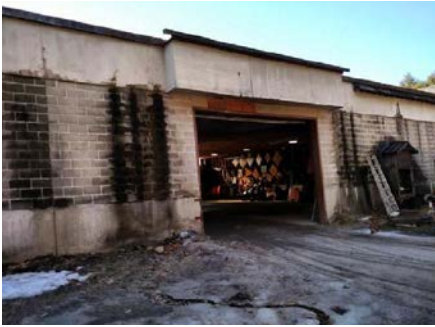
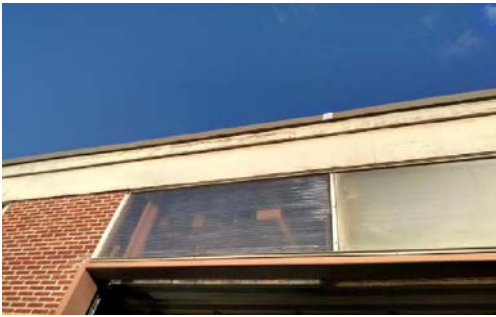
777,Paint Surface	4		8	paint \$2.50 sq.ft. Clean \$1.50 sq.ft. Repair \$1.00 sq.ft.	Paint all painted surfaces, items are degrading and will cost a lot more to replace than paint.

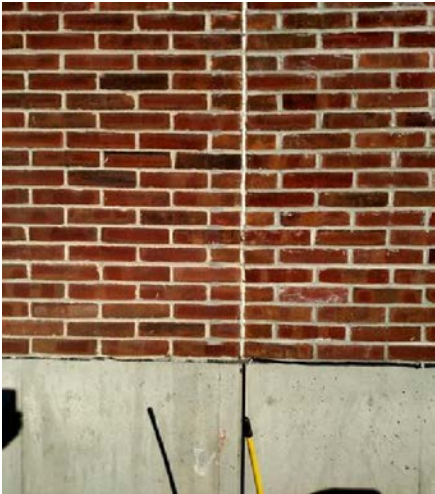
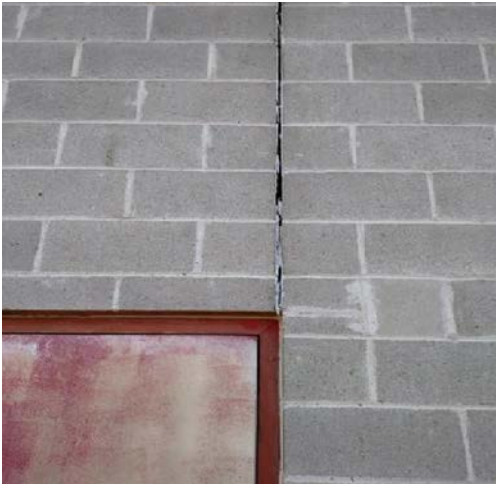
775Control Joint	5	0	2	\$7.00 lineal foot	All control joints need to be dug out and re-caulked typical.

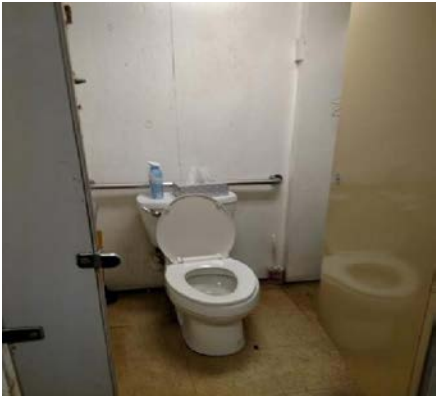
774, ADA Issues:				\$15k per bathroom	Bathrooms do not meet ADA requirements.

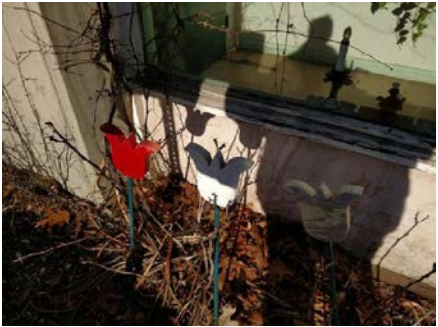
406,General Comment:	5	0	5	\$2000	Grade is over wood sills, lower grade to min 6" below siding, wood, etc.

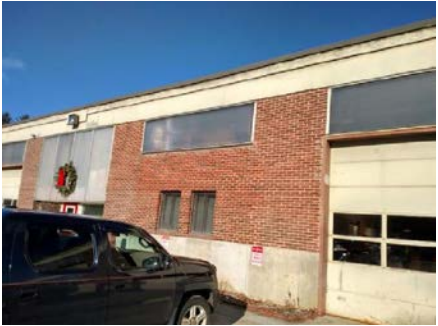
404,General Comment:			10		Foundation not insulated, at some point this wall should be insulated anywhere it is heated.

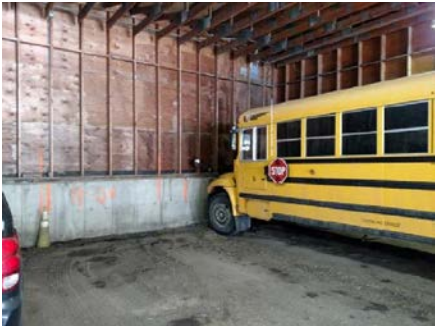
equipment	condition	Est remaining Service life	priority	cost	remarks &recommendations		
	403, General Comment:			5	\$4,000 per opening	Busses back out 2x every day; should install overhead doors for drive thru capabilities.

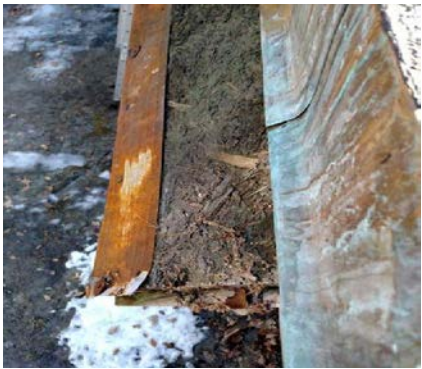
402, Roofing	5	0	3		Small roof dormers have no covering, cover with new roofing. Board has rotted and will need to be replaced.

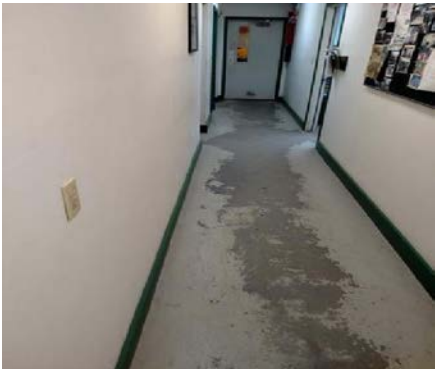
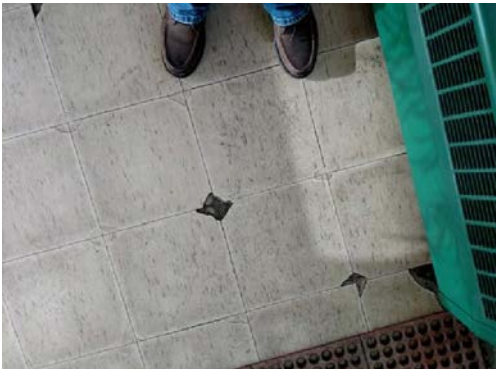
401, Flooring	5	0	3	\$2.50 sq.ft.	VCT? Floor cracked needs replacement, other painted floors worn thru to concrete, should be re-painted or VCT added

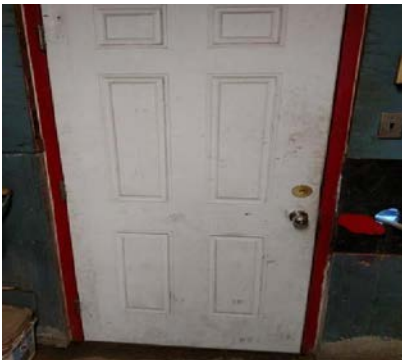
400, Door	4	5	3	\$1,500	Back door should have vision window and sturdier door

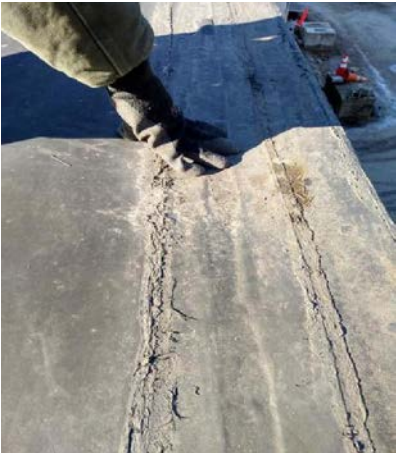
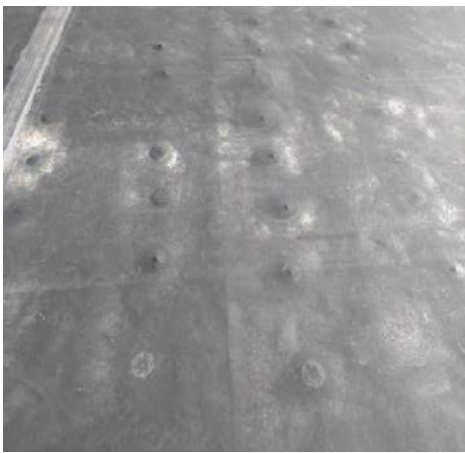
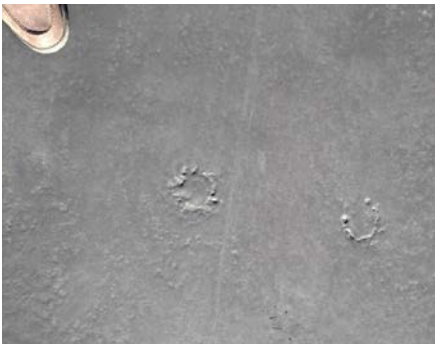
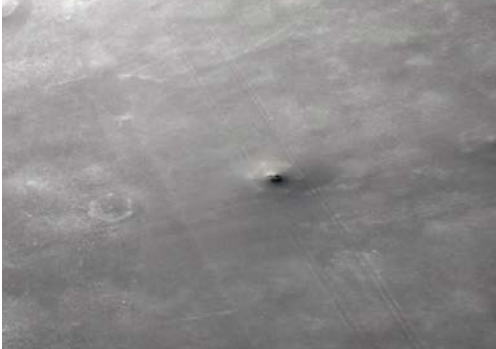
equipment	condition	Est remaining Service life	priority	cost	remarks & recommendations		
	397,Roofing	5	0	1	\$18.00 sq.ft. 19,800 sq.ft. \$356,400	Original tar & gravel replaced with membrane in 1990, poor install, fasteners backing out, last 6' flat and holds water, numerous patches .60 mil membrane, added 2-3 inches of insulation slopes 15" front to back. This roof is 60 mil is usually warranted for 20 years, this roof is 27 years old and should go to the top of the list for roof replacement.

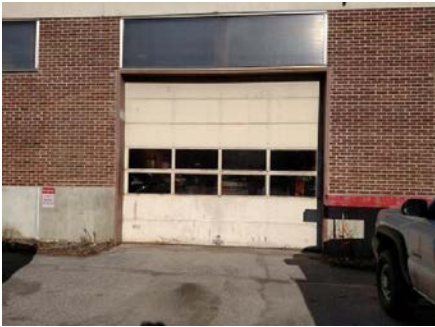
396,General Comment:			7	\$600	Insulated ceiling and roof but gap from lower ceiling to roof. Close gap		
	395,Door	4	0	3	\$500 /door Paint and weather strip	All overhead doors single pane, no weather strip, no insulation and in need of paint

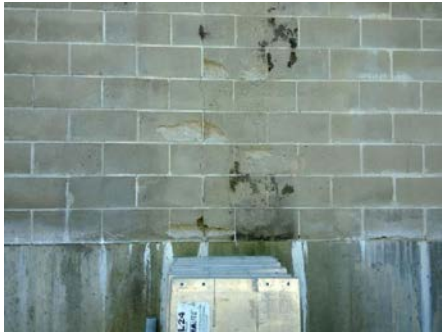
Equipment	Condition	Est. Remaining Service Life	Priority	Cost Estimate		
Control Joint					Control joint needs caulking/ seal-type.	
466, Veneer					Broken, cracked CMU veneer.

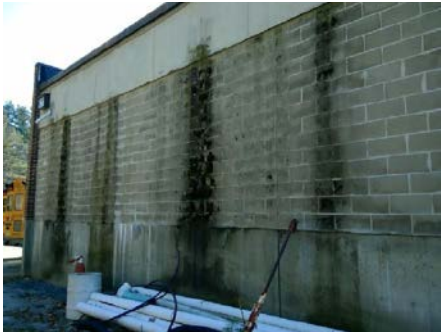
equipment	condition	Est remaining Service life	priority	cost	remarks &recommendations		
	Slab on Grade					No slab in bus bays at east end.		
	463,General Comment:					Water, moss on rear CMU wall.

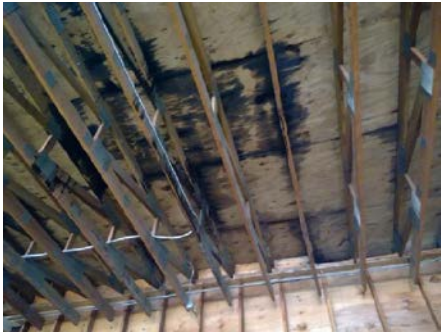
461,Roof					Roof leak, possible truss damage.

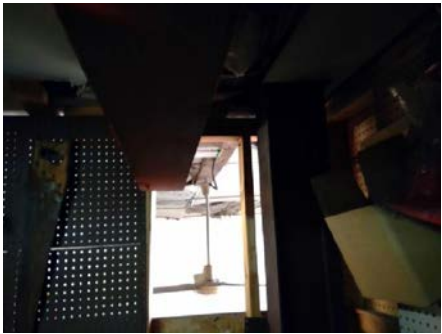
460,Rigging					Crane rail not on column line.

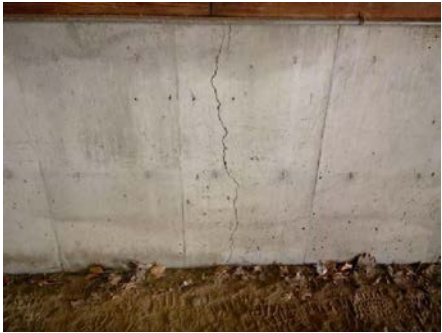
equipment	condition	Est remaining Service life	priority	cost	remarks &recommendations		
	459,Foundation					Foundation wall crack.

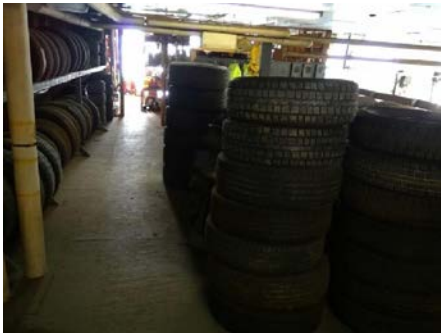
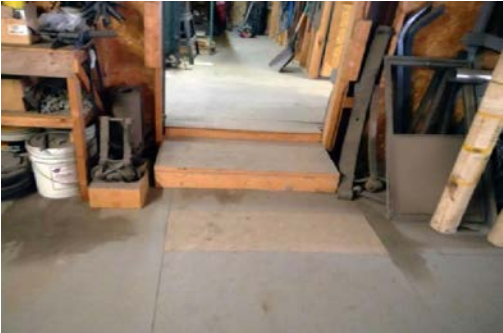
458,Floor Framing					Tire mezzanine may not be original.

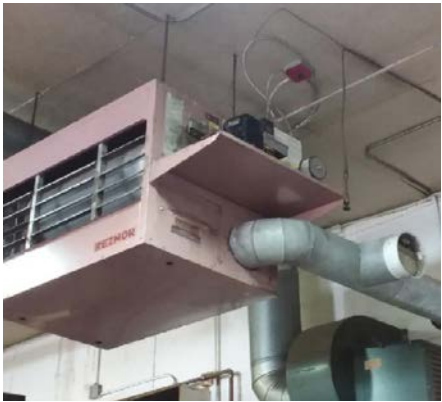
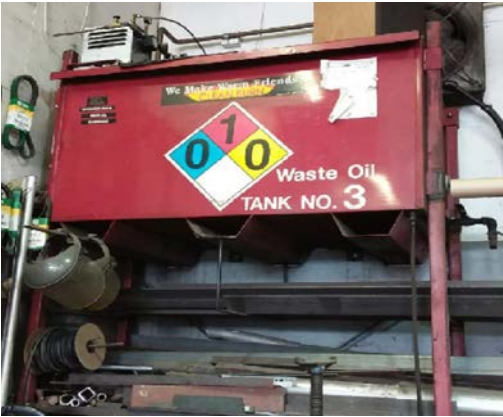
equipment	condition	Est remaining Service life	priority	cost	remarks &recommendations		
	412,235,000 BTU Reznor Model: RA235	3 Fully operational, 25-50% life expectancy used, periodic problems	10 Years	6	\$7,500	Ceiling hung waste oil burner, heats truck bay only. Recommend annual service.

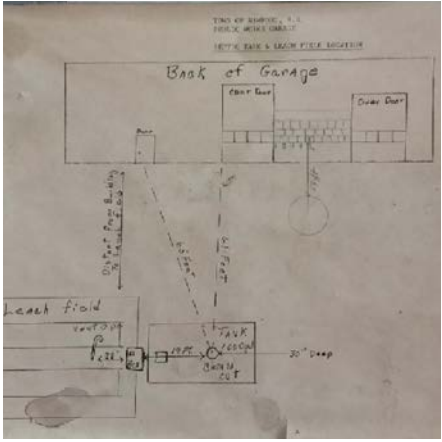
equipment	condition	Est remaining Service life	priority	cost	remarks & recommendations		
	387,1000 Gallon septic tank Unknown date of install					Tank is located approximately 65 feet in back of the garage. Septic tank leaches to an unknown leaching field location. Recommend getting tank inspected.

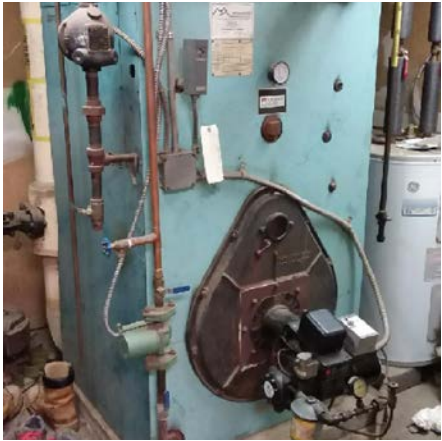
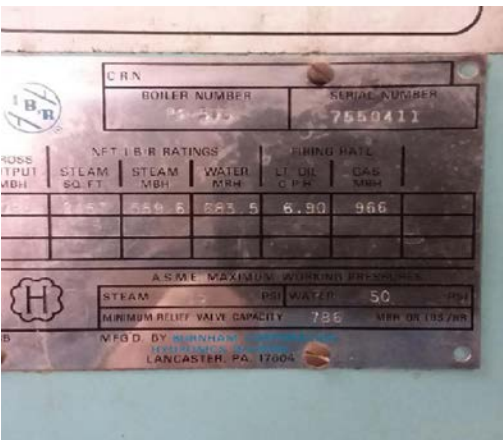
378,780,000 BTU oil fired sectional boiler Burnham model: P4 505 Installed in 1980	4 Operational, 50- 75% life expectancy used, occasional problems, frequent repairs needed	2 to 5 Years	3	\$12,000	Provides heating water for building. Boiler is atmospherically vented through roof. It appears unit has been maintained but has reached its life expectancy.

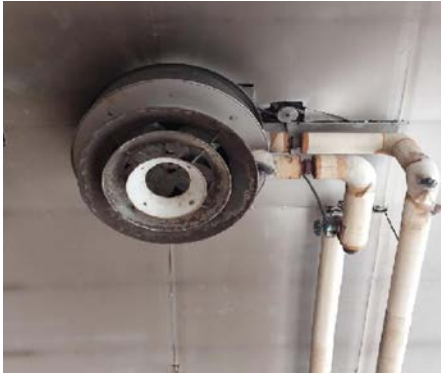
equipment	condition	Est remaining Service life	priority	cost	remarks &recommendations		
	375,Ceiling hung fan powered hot water unit heater	5 Operational only with constant attention, 100% life expectancy used, failure imminent	1 to 3 Years	2	\$2,500 each unit	Only one of the four unit heaters is in operation, Parts are no longer available. All four units need to be replaced.

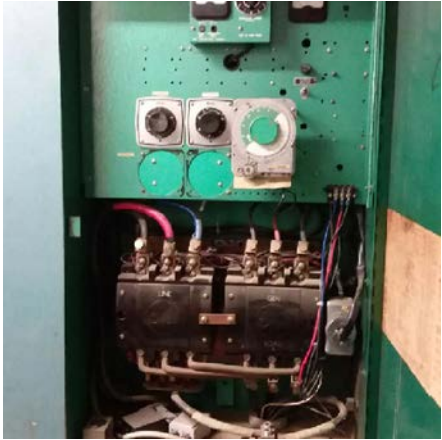
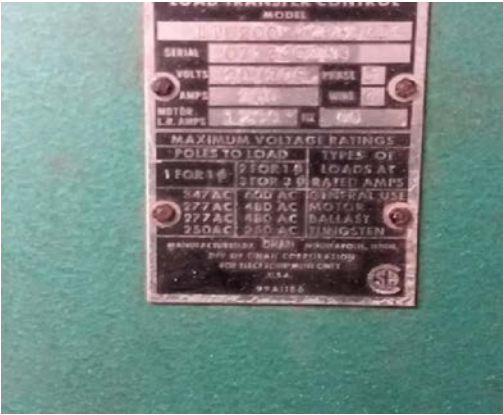
384,Generator switchgear	5 Operational only with constant attention, 100% life expectancy used, failure imminent	1 to 2 Years	2		Currently not in operation. Will need to be interlocked with new generator, if applicable or replaced.

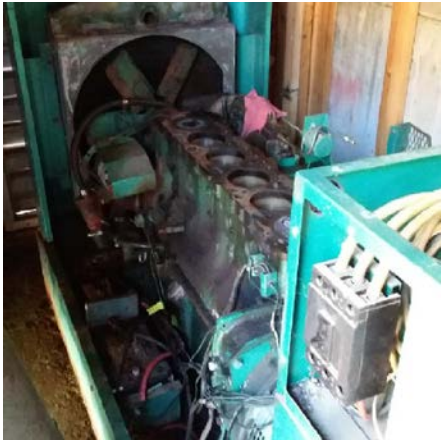
377,Diesel Generator	5 Operational only with constant attention, 100% life expectancy used, failure imminent	1 to 2 Years	2		Currently not in operation. Installation of new generator is in negotiations.

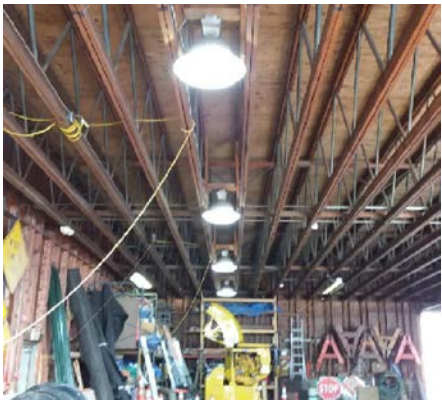
368, Lighting fixtures are a mix of fluorescent, incandescent and HP sodium	4 Operational, 50- 75% life expectancy used, occasional problems, frequent repairs needed	5 Years	5	\$500 eachxs

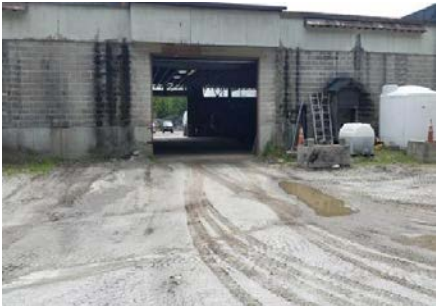
Site								
	This site is unpaved except for an asphalt paved entrance to the site, and an asphalt paved area approximately 150 ft by 30 ft (length x width) at the front side of the building. The entrance to the site evidenced potholes previously filled with asphalt binder, cracking and aggregate polishing. Pavement at building front appeared in relatively good condition. Other areas around the building were unpaved, the surface material appeared to be a fine gravelly silty sand, consistent with other unpaved areas in town.							
	Equipment	Condition	Est. Remaining Service Life	Priority	Cost Estimate	Remarks & Recommendations	Photos	
	879,Gravel			9	50,000 sq.ft	Typical gravel around the rest of the building. Fine gravelly silty sand Could use additional gravel that is processed graded gravel.

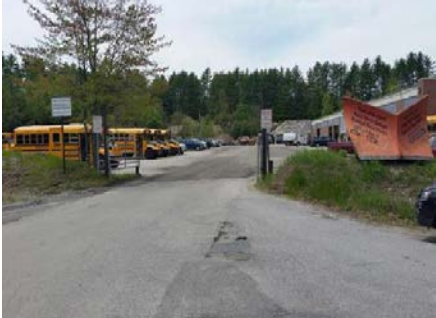
878,Pavement	5	2	3	\$2,500	Pavement at entry to site. The previous patches at the entrance should be cut out (use carbide saw to make square cuts, remove the old pavement and gravel to the subgrade and replace with a full depth asphalt patch to match the elevations in the adjacent cut areas
