Building: Recreation Building
65 Belknap Ave.
Newport, New Hampshire

Town of Newport, Building Assessment July 31,2017

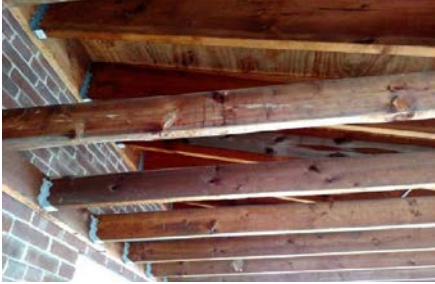
equipment	condition	Est remaining Service life	priority	cost	remarks &recommendations		
	765,Exterior Note:	4	2	4	\$5.00 sq.ft	Install vinyl ceiling.

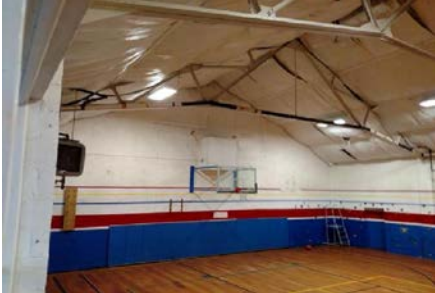
759,General Comment:					At a minimum, tighten up insulation system. Best course would be to replace It.

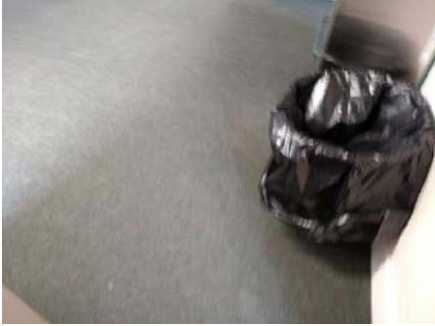
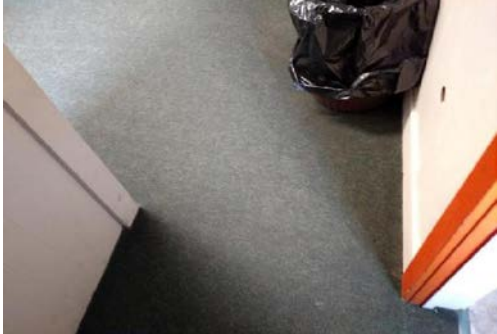
Floor Carpet	5	1	1	\$3.00 sq.ft.	Carpet is tired and should be replaced.

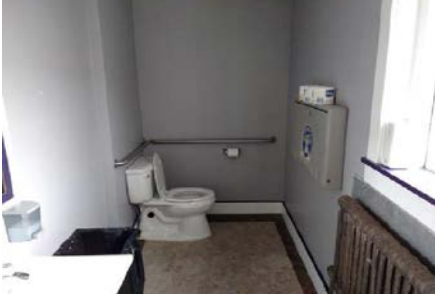
757,Code Issue:					While ADA rails have been added, this bathroom does not meet ADA requirements.

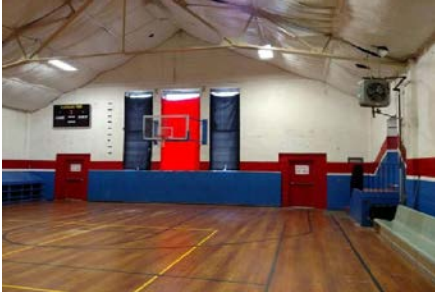
428,Code Issue:					No ADA access without going outside and around. No access to lower floors and even exercise area has step from basketball court level

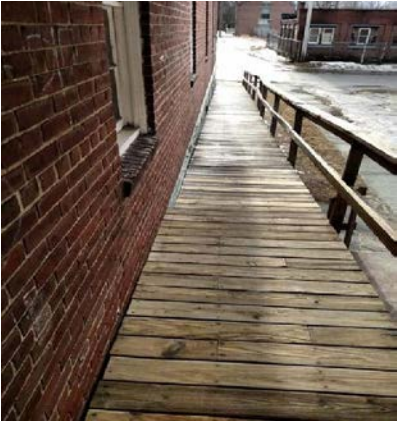
equipment	condition	Est remaining Service life	priority	cost	remarks &recommendations		
	758,Exterior Note: Code Issue:	4	3	4	\$3.50 sq.ft	Suggest wood planks be painted with 'Rescue It' by Olympic and general painting of handrail and walls. Handrail does not meet code

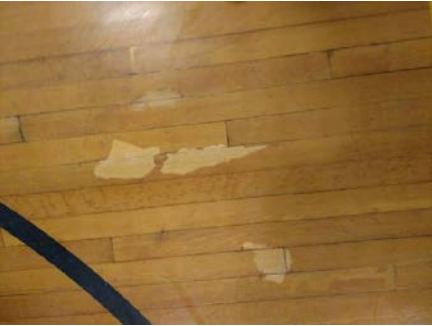
392,Wood floor	4	3	3	\$5.00 sq.ft	Floor in good shape, many coats of poly is chipping in places. Should be sanded down and a program to scrim a coat away and add a coat every year

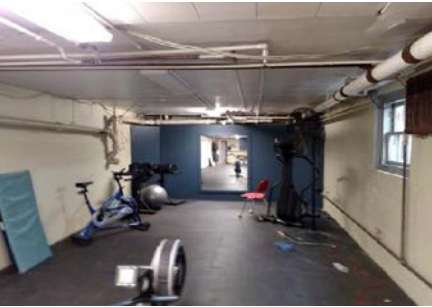
390,ADA					Basement exercise room. No ada access

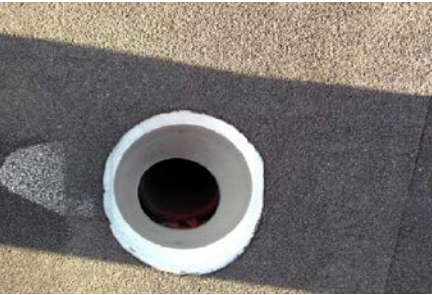
772,Exterior Note:	1	3	4	\$150	Correct vent.

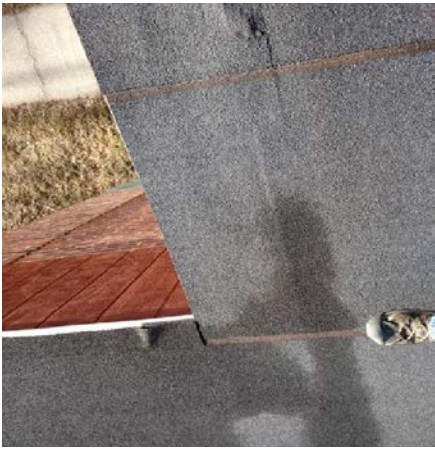
equipment	condition	Est remaining Service life	priority	cost	remarks &recommendations		
	771,Exterior Note:	3	10	4	labor	Secure roofing.

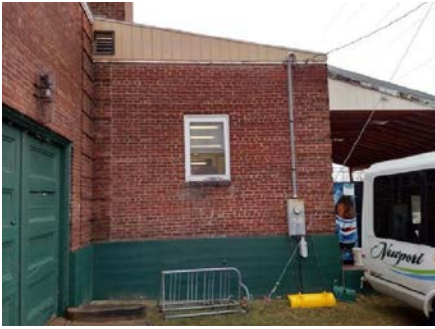
769,Exterior Note:	4	4	4	\$ 2.50 sq.ft	Paint all wood surfaces or cover in aluminum/vinyl.

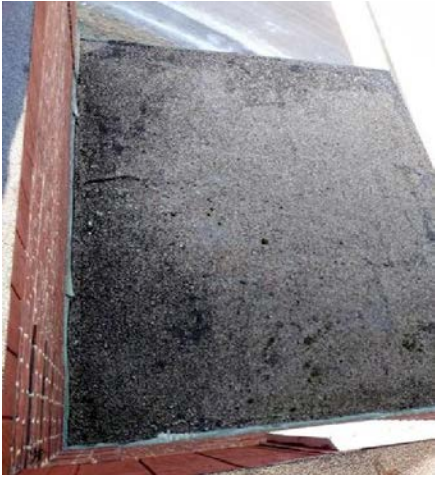
768,Exterior Note:	4	5	5	\$ 18/sq.ft	Budget for re-roof of this shed.

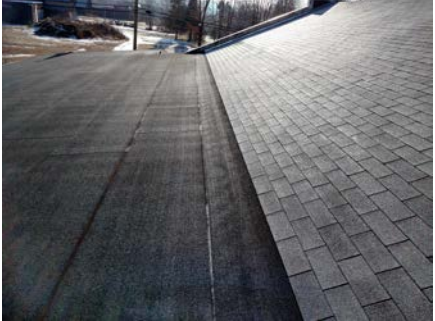
Exterior Note:	1	9	9	\$ 18/sq.ft	Roll roofing Should install rubber roofing

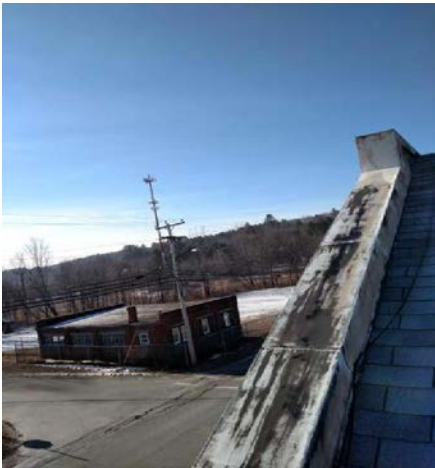
767,Exterior Note:	5	2	2	\$ 2.50 sq.ft	Re-coat flashing.

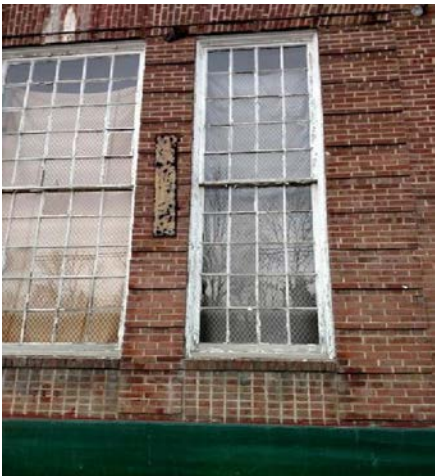
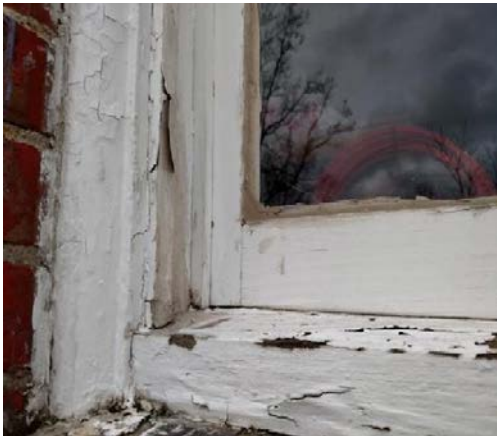
764, Exterior Note:	5	0	1	\$20.00 sq.ft. Storms \$50-60 sq.ft. windows	Windows are single pane and in poor condition. Minimum work should be to add storm windows, best would be to restore windows and then add storms. Maintenance work will be less expensive than replacement.

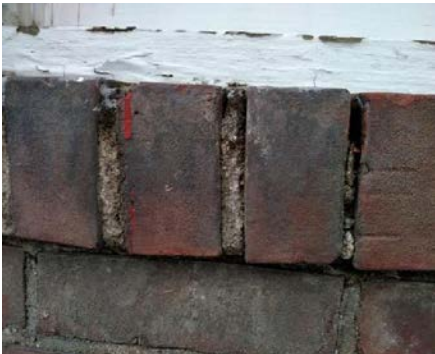
763,Exterior Note:	5	0	1	\$5-10 sq.ft.	Re-point all brick sills.

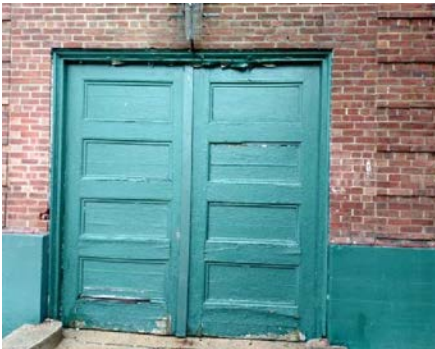
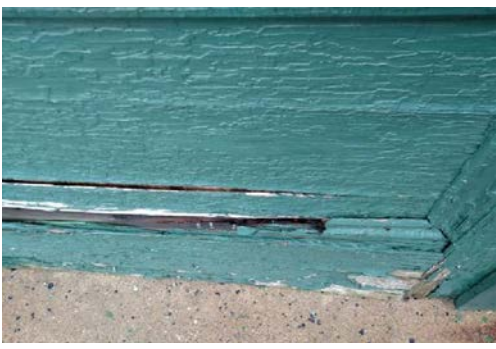
equipment	condition	Est remaining Service life	priority	cost	remarks & recommendations		
	762, Exterior note	5	0	2	\$4,000	Repair or replace these doors. If replaced they should mimic the original style and trim.

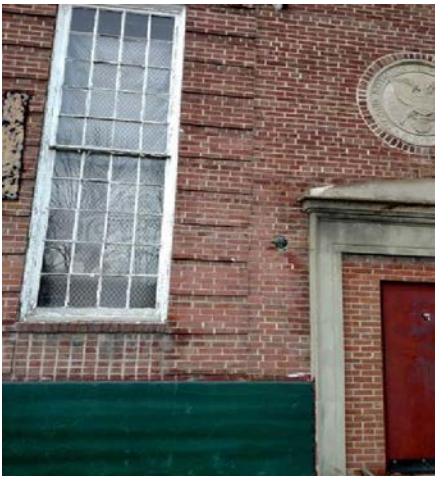
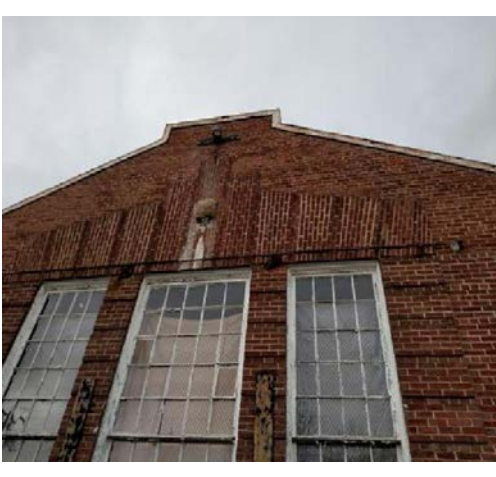
761, Exterior Note:	5	0	1	\$5,500	Repair trim with synthetic concrete repair.

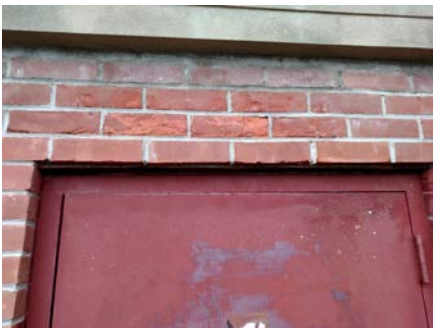
Exterior note	4	3	2	\$ 2.50 sq.ft	Paint all doors, repair frames as necessary

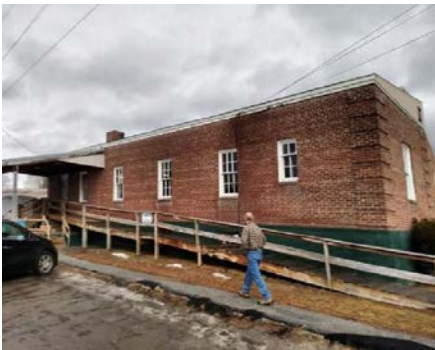
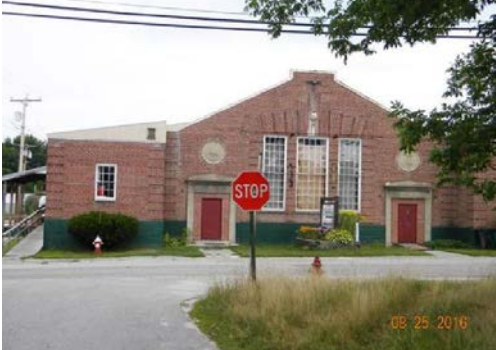
760, Exterior Brick	4	50	4	\$5-10 sq.ft.	Overall in good condition with the exception of re-pointing and some Spalling.

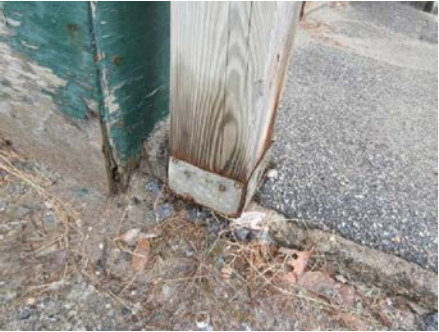
429, Canopy					Canopy column inadequately supported on building foundation.

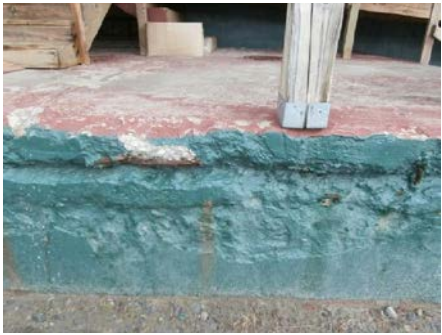
equipment	condition	Est remaining Service life	priority	cost	remarks & recommendations		
						Canopy column inadequately supported on building foundation.

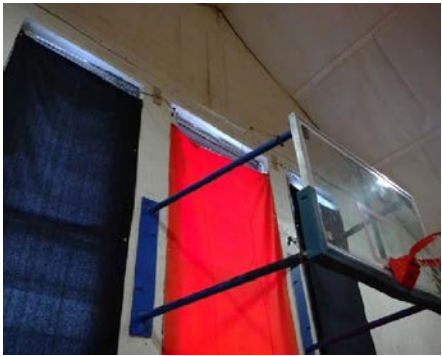
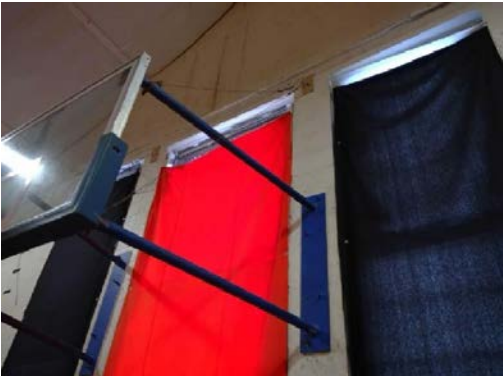
302, Backboard					Backboard attachment to building endwall is inadequate and jeopardizes endwall.

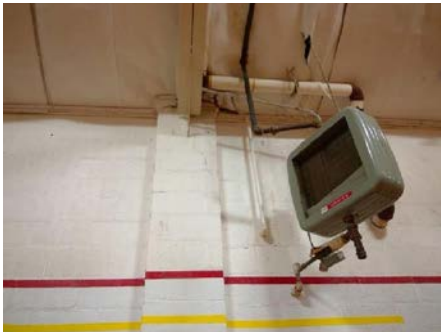
equipment	condition	Est remaining Service life	priority	cost	remarks &recommendations		
	301,Bearing Wall					Crack in masonry pilaster.

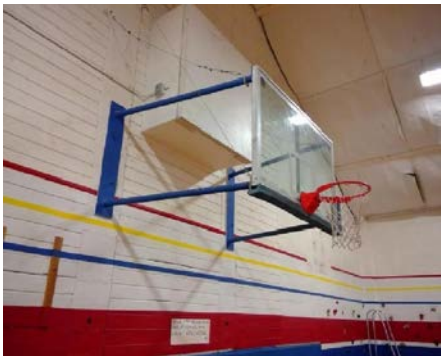
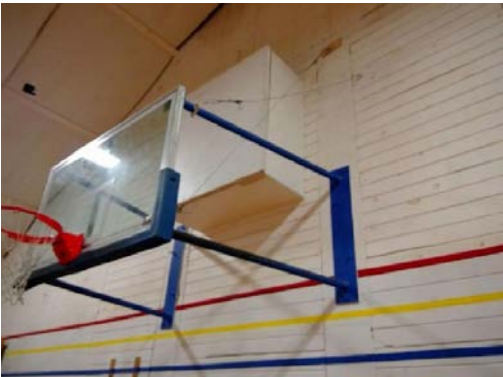
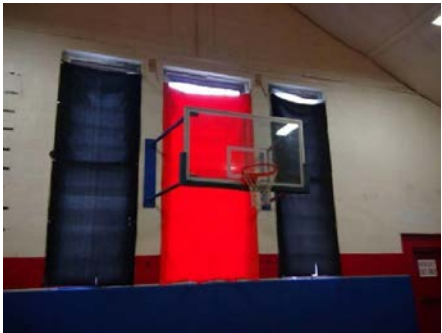
299, Rigging					Backboard attachment to endwall is inadequate (particularly cabling) and jeopardizes stability of endwall.

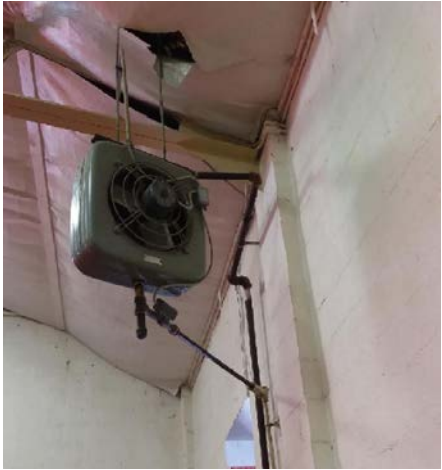
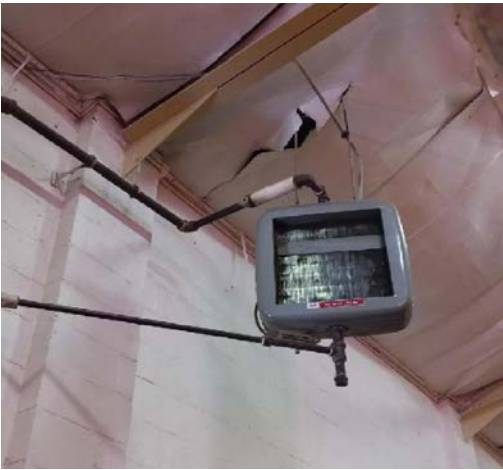
489,Ceiling hung fan powered steam unit heater Make: Modine	4 Operational, 50-75% life expectancy used, occasional problems, frequent repairs needed	5 Years	5	\$2,500	This is one of four units which heat the gym. Some units have been damaged by balls thrown at them.

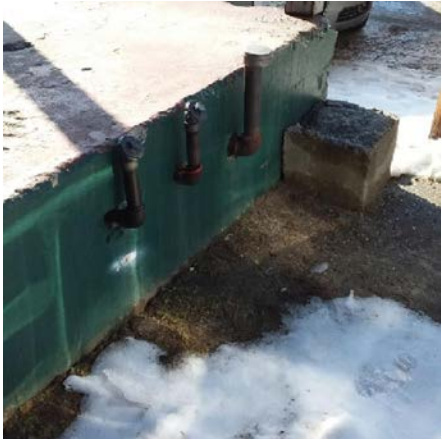
506,Fuel tank fill pipes	3	19	10	\$2,000	Recommend installing bollards to protect from potential vehicle damage

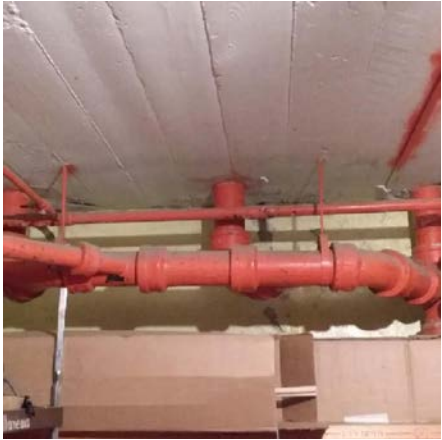
499, Cast iron drain piping					No longer in use from locker room above. Pipes may be removed.

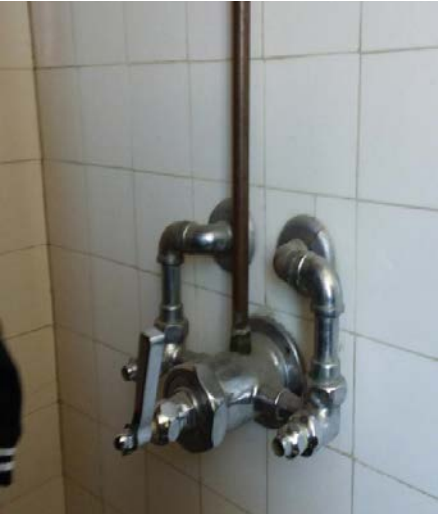
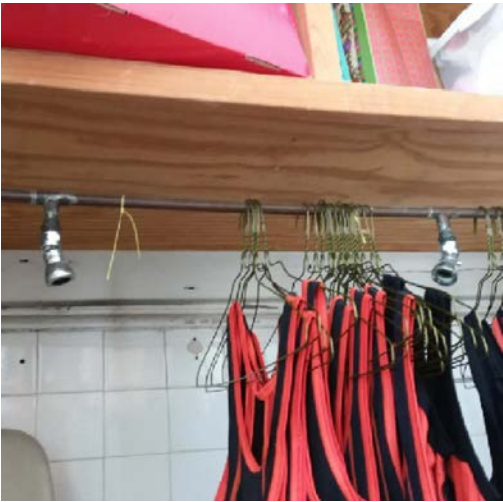
494,Two head shower, single valve faucet	5	0		\$1,000 each	Showers are no longer in use.

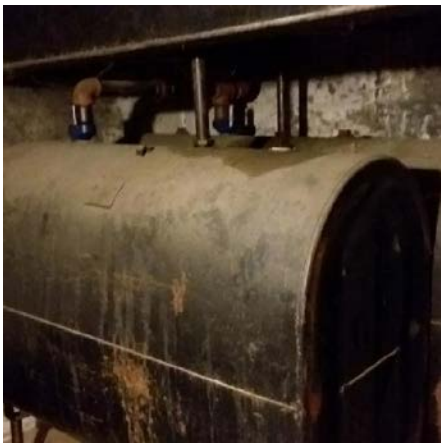
486,Two - 275 Gallon fuel tanks	2 Fully operational, 0-25% life expectancy used, no issues, no concerns	15 Years	10	\$2,000	Provide fuel for heating plant. Tanks are currently installed without containment methods in place.

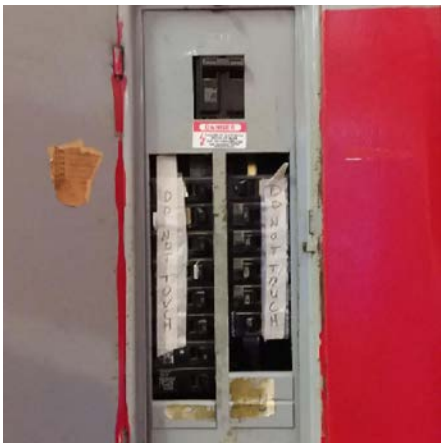
500, 100 - AMP Panel board Unlabeled, no directory	4 Operational, 50- 75% life expectancy used, occasional problems, frequent repairs needed	5 Years	5	\$1,000	Open Spaces. Panel board unlockable and unsafe. Recommend inspection and make safe as the public utilizes this building.

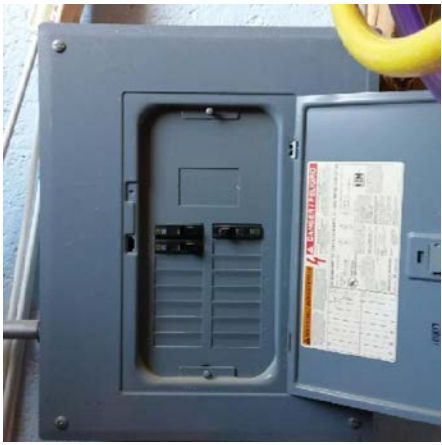
498,Surface mounted Sub panel	2 Fully operational, 0-25% life expectancy used, no issues, no concerns	15 Years	10	\$1,000	Feeds office and soda machine. No identification nameplate installed on panelboard.

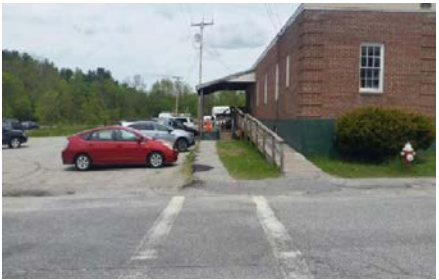
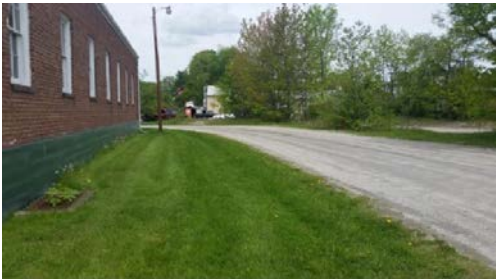
Site								
	This building has an asphalt paved sidewalk at the front and west sides of the building, otherwise the building is surrounded by an unpaved parking area consisting of a fine gravel and silty sand material consistent with other municipal sites examined. Sidewalks had some cracking and uneven settlements likely due to age and inadequate/failed base course gravels.							
	Equipment	Condition	Est. Remaining Service Life	Priority	Cost Estimate	Remarks & Recommendations	Photos	
	Gravel	3	25	7	9,800 sq.ft	Unpaved areas could simply be re-graded and fresh gravel applied to re-level depressed areas

870,Pavement	5	4	3	1,080 sq.ft. PF \$7.17 sq.ft. \$7,743	Pavement and failed base course gravels from the sidewalk areas could be removed and replaced with new gravel base, pavement (asphalt or concrete) and new curbing
