Building: Wilmerth Park-Ski Jump  
500 Cheney Street  
Newport, New Hampshire

Town of Newport, Building Assessment July 31,2017

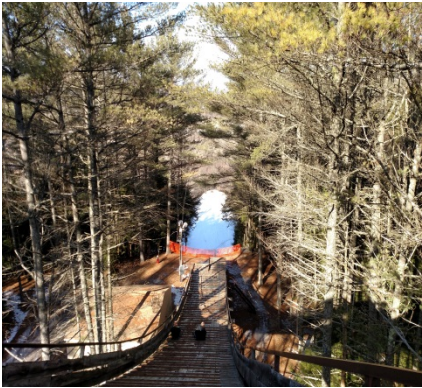
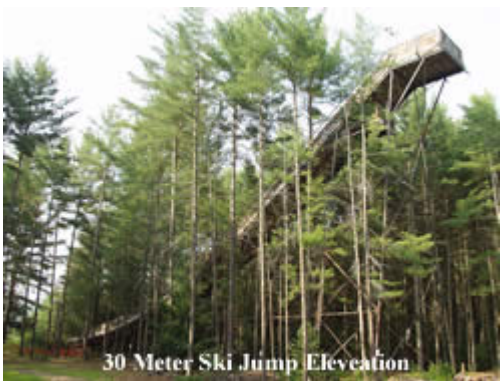
| Architectural | | | | | | | |
|---|---|---|---|---|---|---|---|
| | The ski jump is a landmark for the area and represents a strong historical factor but needs decking, painting and railing work<br>The building was not open and looks in good repair with some maintenance issues that need to be taken care of such as painting and maintaining 8" clear foundation to grade. | | | | | | |

| Architectural | | | | | | | |
|---|---|---|---|---|---|---|---|
| | | | | | | A package should be prepared for competitive Pricing of the various tasks that should be accomplished. | |

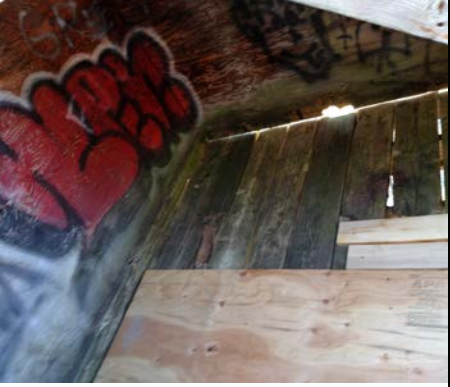
| | equipment | condition | Est remaining<br>Service life | priority | cost | remarks &recommendations | | |
|--|---|---|---|---|---|---|---|--|
| | | | | | | The boards are rotted and should be replaced | | |

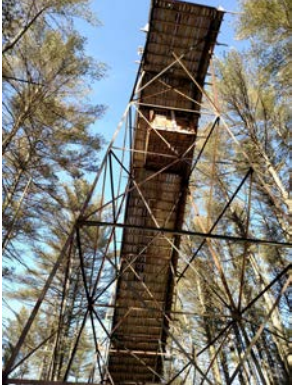
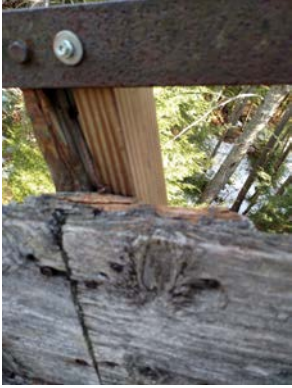
| | equipment | condition | Est remaining<br>Service life | priority | cost | remarks &recommendations | | |
|--|---|---|---|---|---|---|---|--|
| | | | | | | Various guards are rotted and should be replaced<br><br>Connections for metal guards need reinforcement | | |

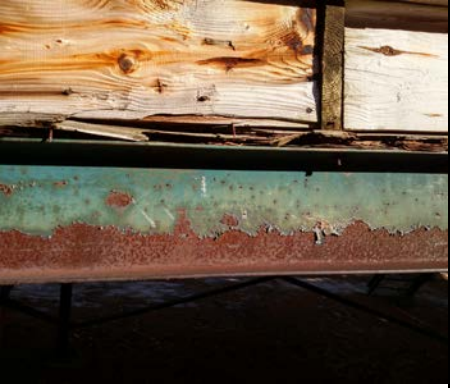
| | equipment | condition | Est remaining<br>Service life | priority | cost | remarks &recommendations | | |
|--|---|---|---|---|---|---|---|--|
| | | | | | | Structure should be prepped and painted or it will continue to deteriorate | | |

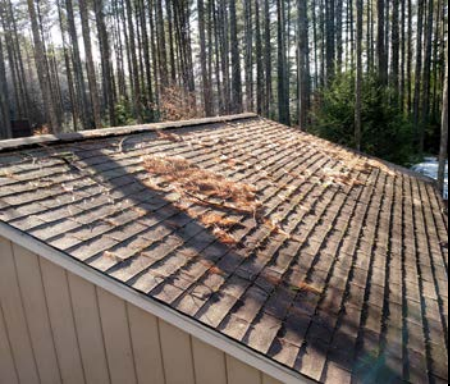
| | equipment | condition | Est remaining<br>Service life | priority | cost | remarks & recommendations | | |
|--|---|---|---|---|---|---|---|--|
| | Exterior Note: | 2 | 15<br>guess | 10 | \$ 7.00<br>sq.ft.<br>\$4,900 | Keep shingles clear of pine<br>needles. Not told the age<br>of this roof; asphalt<br>shingles have a life of<br>around 25 years. | | |

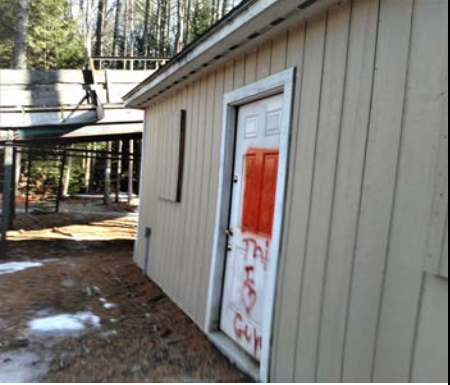
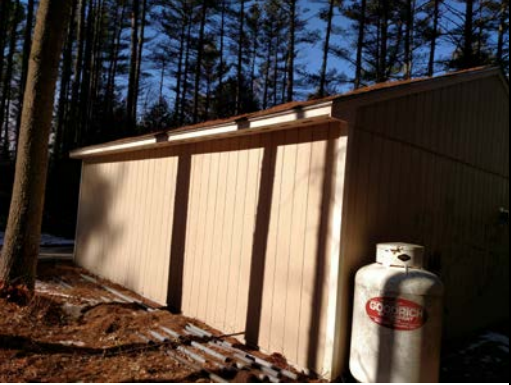
| | equipment | condition | Est remaining<br>Service life | priority | cost | remarks & recommendations | | |
|--|---|---|---|---|---|---|---|--|
| | Exterior note | 2 | | 8 | \$15.00<br>lineal ft.<br>For PVC<br>skirt<br>board<br><br>\$1,500 re-<br>grade | Should re-grade to allow<br>8" of foundation exposed<br>as an alternate to grading<br>add 12" synthetic surface<br>water table in place of T1-<br>11 siding | | |

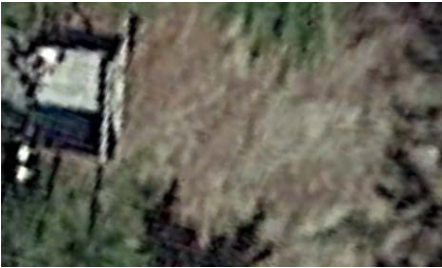
Site access is by a gravel road and given the frequency of use and during winter at that; general gravel maintenance is all that is required.

| Equipment | Condition | Est. Remaining<br>Service Life | Priority | Cost Estimate | Remarks & Recommendations | Photos | |
|---|---|---|---|---|---|---|--|
| road | 2 | | 10 | | Occasional gravel overlay<br>as needed | | |
