Town of Newport, New Hampshire  
Building Assessment | July 31, 2017

Building: Town Hall  
20 Main Street  
Newport, New Hampshire

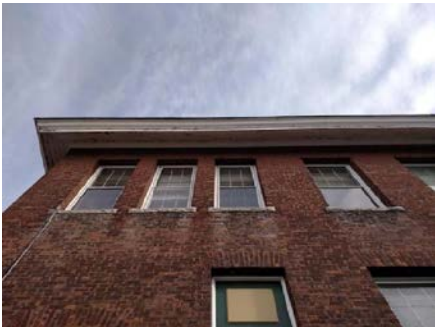
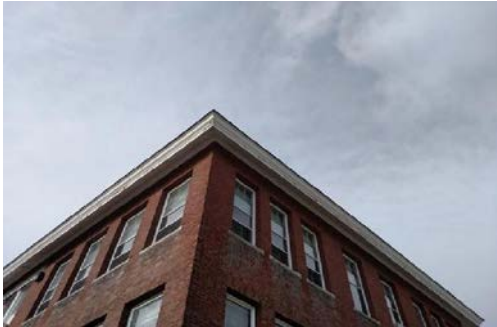
| | equipment | condition | Est remaining<br>Service life | priority | cost | remarks & recommendations | | |
|--|---|---|---|---|---|---|---|---|
| | 715,Paint Surface | 4 | 4 | 3 | \$10,000 | In general, all wood surfaces need to be scraped, sanded, primed and painted. An alternate would be to wrap flat surfaces in vinyl or white aluminum. | | |

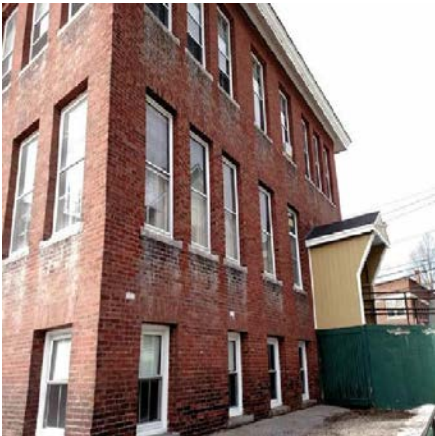
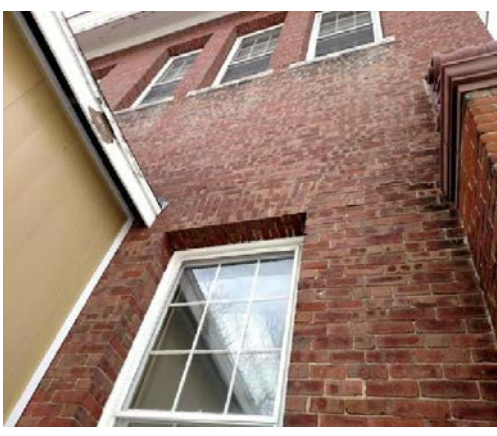
| | equipment | condition | Est remaining<br>Service life | priority | cost | remarks & recommendations | | |
|--|---|---|---|---|---|---|---|---|
| | 714, Window Single Pane | 4 | 10+ | 8 | \$1,200 per opening | Windows in general are original with aluminum storms. Windows should be periodically painted and puttied as well as tightened up to minimize air infiltration. A few windows have been replaced in the basement level; the muntins do not match the rest of the building. Any window replacement should approximate the muntin and original size of window with care to keep/match the trim to brick. | | |

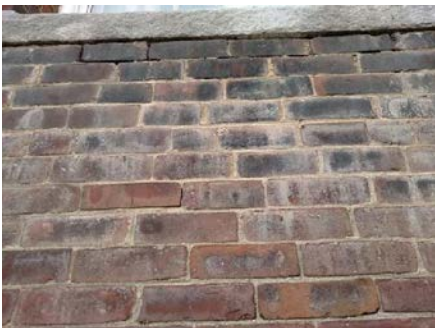
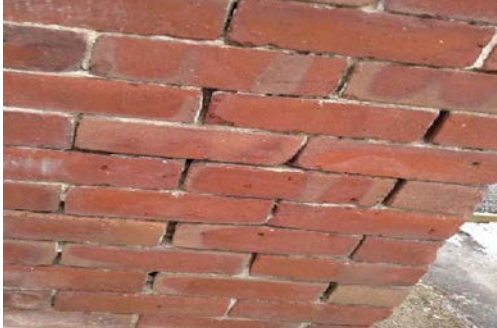
| | equipment | condition | Est remaining<br>Service life | priority | cost | remarks & recommendations | | |
|--|---|---|---|---|---|---|---|---|
| | 713,Brick | 5 | 25+ | 2 | Repoint<br>\$5-10<br>sq.ft.<br>Clean<br>\$1.50 sq.ft | Brick exterior is in good condition, could use a cleaning and a few areas in close proximity to ground/splashing need re-pointing. | | |

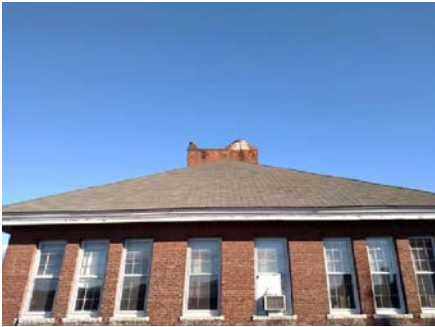
| | equipment | condition | Est remaining<br>Service life | priority | cost | remarks &recommendations | | |
|--|---|---|---|---|---|---|---|---|
| | 712, Asphalt Shingle | 2 | 0 | 4 | \$ 7.00<br>sq.ft.<br><br>\$55,734 | Installed in 1989 - while not leaking, it is at the end of its life and should be replaced. | | |

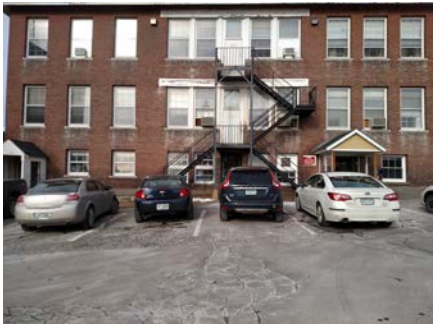
| | equipment | condition | Est remaining<br>Service life | priority | cost | remarks &recommendations | | |
|--|---|---|---|---|---|---|---|---|
| | 721,Fire Escape | 4 | | 4 | \$5,000 | Clean rust and paint with industrial epoxy paint | | |

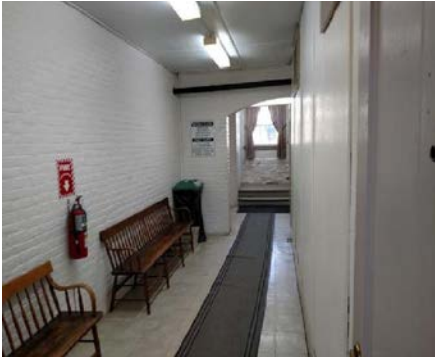
| | equipment | condition | Est remaining<br>Service life | priority | cost | remarks &recommendations | | |
|--|---|---|---|---|---|---|---|---|
| | 711,ADA Issues: | | | | \$250,000 | While a ramp is provided for the first floor (not compliant with ADA), no ADA access is provided for the basement (main entrance for many) or second floor which contains offices and the selectmen's meeting room. | | |

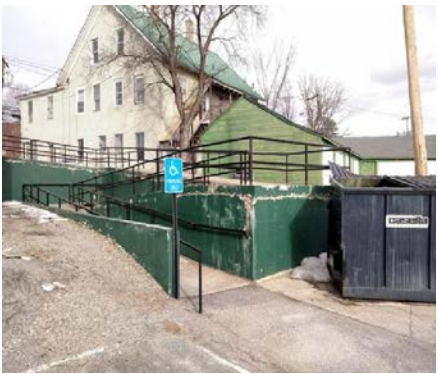
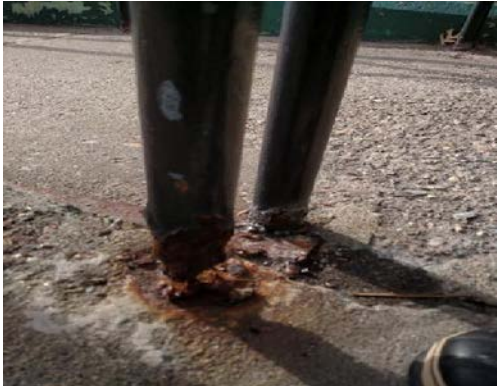
| | equipment | condition | Est remaining<br>Service life | priority | cost | remarks &recommendations | | |
|--|---|---|---|---|---|---|---|---|
| | 710, Exterior Note: | 5 | 0 | 2 | \$25,000 | HC ramp is in poor condition, rails are rusted, concrete has spalled and paint has peeled. I would suggest a comparison between repair costs and a lift be evaluated, or combine with elevator for entire building | | |

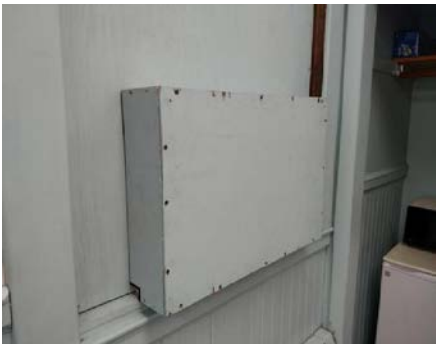
| | equipment | condition | Est remaining<br>Service life | priority | cost | remarks &recommendations | | |
|--|---|---|---|---|---|---|---|---|
| | 726,General Comment: | | | | | Suggest a central A/C system be installed which will be more efficient than window units and can contribute heat more effectively than oil heat. | | |

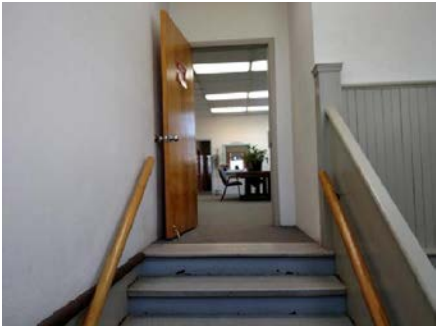
| | equipment | condition | Est remaining<br>Service life | priority | cost | remarks &recommendations | | |
|--|---|---|---|---|---|---|---|---|
| | 724, Code Issue: | | | 1 | \$1,500 | Fire stair door should not be left propped open. If this is desired an electric hold open should be installed tied into the fire alarm. | | |

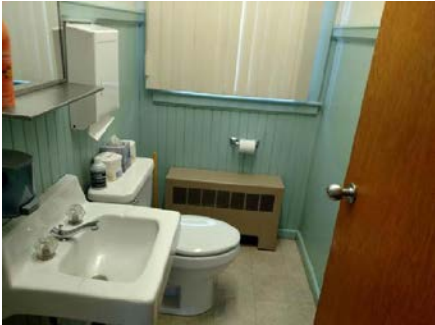
| | equipment | condition | Est remaining<br>Service life | priority | cost | remarks &recommendations | | |
|--|---|---|---|---|---|---|---|--|
| | 723,Floor VCT | 2 | 10 | 9 | \$1.00 sq.ft | Could use a strip and wax. | | |

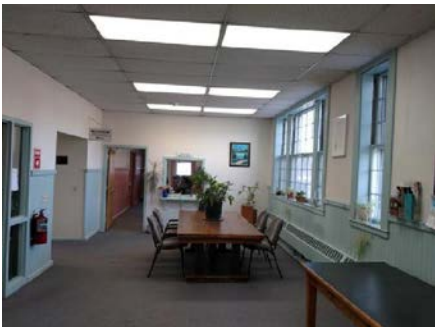
| | equipment | condition | Est remaining<br>Service life | priority | cost | remarks &recommendations | | |
|--|---|---|---|---|---|---|---|--|
| | 722,Floor Carpet | 4 | 2 | 3 | \$3.00 sq.ft. | Carpet has wrinkles and should be replaced. | | |

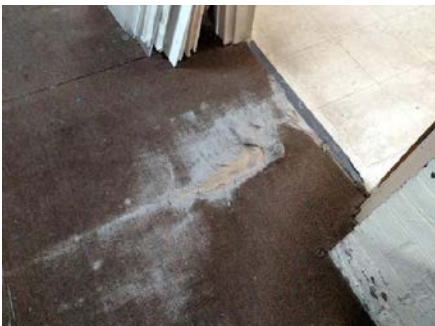
| | equipment | condition | Est remaining<br>Service life | priority | cost | remarks &recommendations | | |
|--|---|---|---|---|---|---|---|--|
| | Floor Carpet | 5 | 0 | 1 | \$3.00 sq.ft. | Replace in kind or remove as this is a safety hazard. | | |

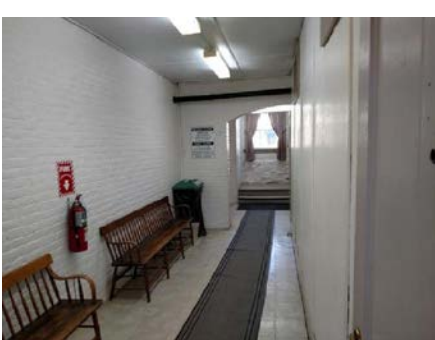
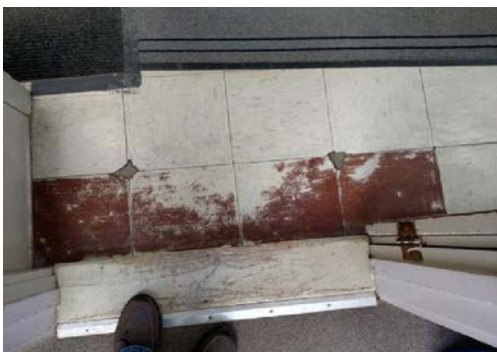
| | equipment | condition | Est remaining<br>Service life | priority | cost | remarks &recommendations | | |
|--|---|---|---|---|---|---|---|--|
| | 720,Floor VCT | 5 | 3 | 4 | \$3.00 sq.ft. | Floor should be replaced, suggest wall to wall matting to control dirt. | | |

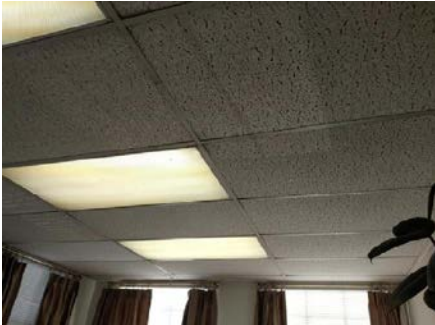
| | equipment | condition | Est remaining<br>Service life | priority | cost | remarks &recommendations | | |
|--|---|---|---|---|---|---|---|--|
| | 719,Acoustic | 4 | 10 | 8 | \$ 3.00<br>sq.ft. | With the exception of the front lobby, ceiling tiles are tired and should be replaced. | | |

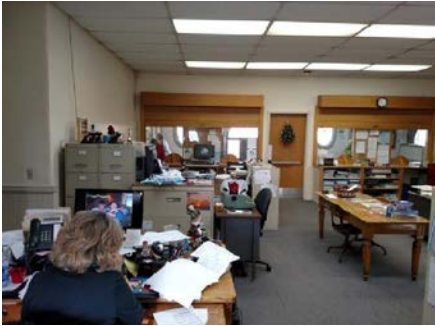
| | equipment | condition | Est remaining<br>Service life | priority | cost | remarks &recommendations | | |
|--|---|---|---|---|---|---|---|--|
| | 718,Floor Carpet | 4 | 2 | 3 | \$3.00 sq.ft. | Carpet has ripples and should be replaced. | | |

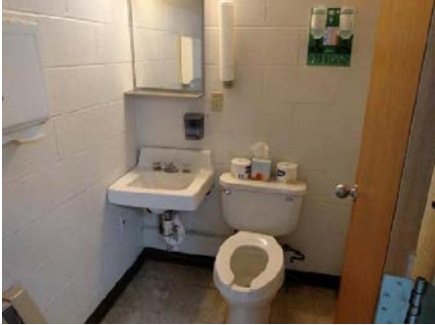
| | equipment | condition | Est remaining<br>Service life | priority | cost | remarks &recommendations | | |
|--|---|---|---|---|---|---|---|--|
| | 717,Floor VCT | 4 | 4 | 8 | \$4.00 sq.ft. | VCT should be replaced. | | |

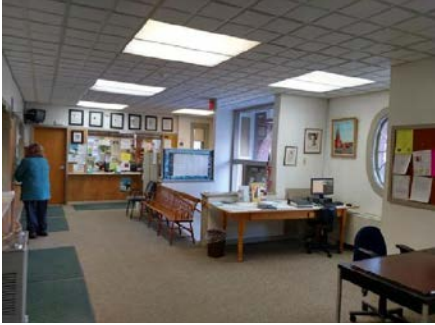
| | equipment | condition | Est remaining<br>Service life | priority | cost | remarks &recommendations | | |
|--|---|---|---|---|---|---|---|--|
| | 716,Floor Carpet | 2 | 10 | 10 | \$3.00 sq.ft. | Generally in good repair. | | |

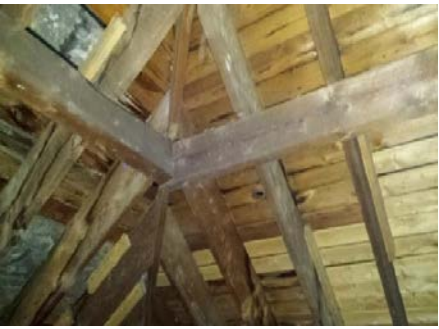
| Equipment | Condition | Est. Remaining<br>Service Life | Priority | Cost Estimate | | |
|---|---|---|---|---|---|---|
| Rafters | | | | | Roof Rafters: 2x12 @ 20” on center, in a two-span condition over purlins.<br><br>Rafters are large, but purlins are undersized, poorly supported and lap spliced at inappropriate locations. | |
| 189, Purlin | | | | | Roof Purlin - inadequate support. | |

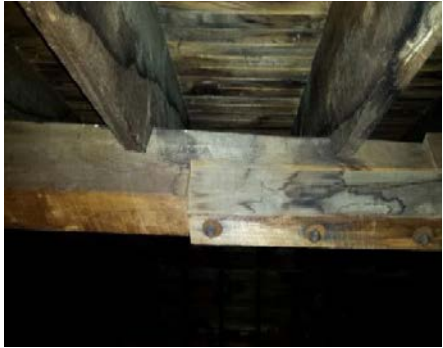
| | equipment | condition | Est remaining<br>Service life | priority | cost | remarks &recommendations | | |
|--|---|---|---|---|---|---|---|--|
| | 191, Purlin | | | | | Roof Purlin - inadequate size, ineffective bolted lap splice. | | |

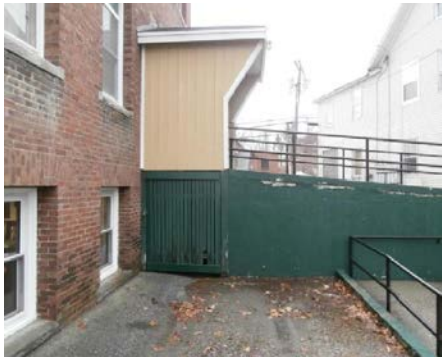
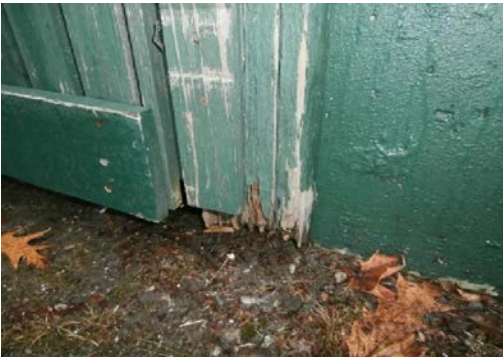
| | equipment | condition | Est remaining<br>Service life | priority | cost | remarks &recommendations | | |
|--|---|---|---|---|---|---|---|--|
| | 186,Post | 5 | 0 | 2 | \$750 | Post beneath access ramp is rotted. | | |

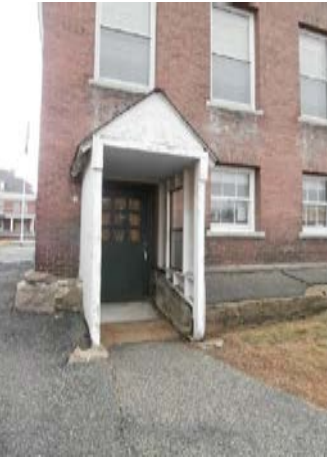
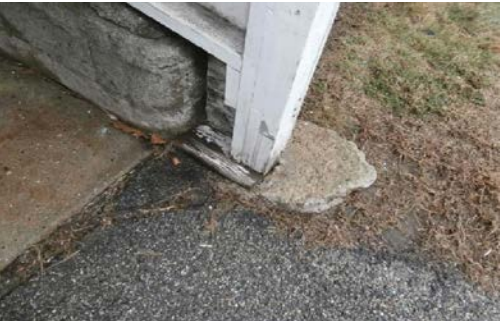
| | equipment | condition | Est remaining<br>Service life | priority | cost | remarks &recommendations | | |
|--|---|---|---|---|---|---|---|---|
| | 185,Post | 5 | 0 | 2 | \$750 | Corner post on "doghouse" entry is rotted. | | |

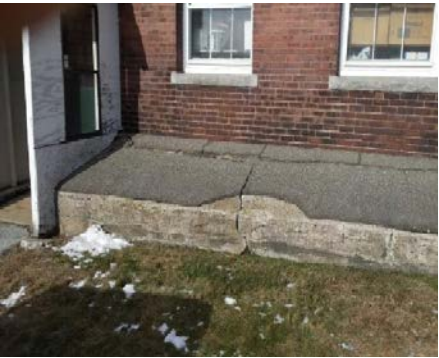
| | equipment | condition | Est remaining<br>Service life | priority | cost | remarks &recommendations | | |
|--|---|---|---|---|---|---|---|---|
| | 184,Foundation | | | | | Concrete/Asphalt wash at grade level is broken into pieces. | | |

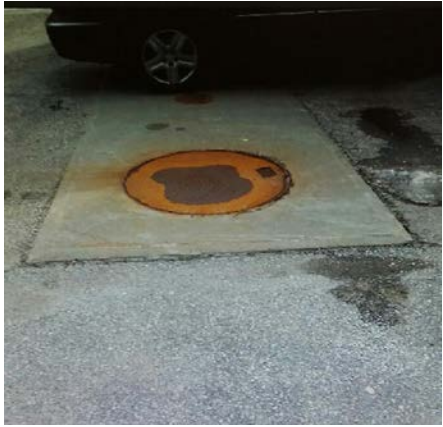
| | Equipment | Condition | Est. Remaining<br>Service Life | Priority | Cost Estimate | | | |
|--|---|---|---|---|---|---|---|---|
| | 225,10,000 Gallon<br>buried tank<br><br>Installed in 1994 | 2<br><br>Fully operational,<br>0-25% life<br>expectancy used,<br>no issues, no<br>concerns | 15<br><br>&<br><br>Per state<br>DES | 10 | \$15,000 | Provides fuel oil for the<br>town office building,<br>opera house and the fire<br>department.<br><br>Tank should be inspected<br>at the 25 year mark. | | |

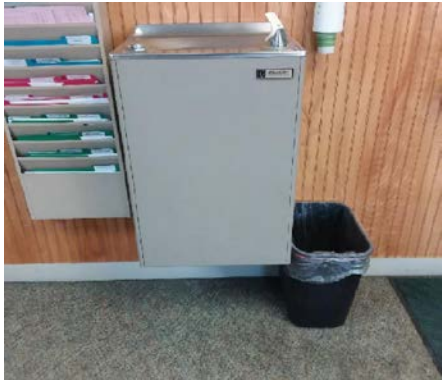
| | Equipment | Condition | Est. Remaining<br>Service Life | Priority | Cost Estimate | | | |
|--|---|---|---|---|---|---|---|---|
| | 27, Wall mounted<br>water bubbler | 3<br><br>Fully operational,<br>25-50% of life<br>expectancy used,<br>periodic<br>problems | 10 Years | 10 | \$2,500 | Not ADA compliant. | | |

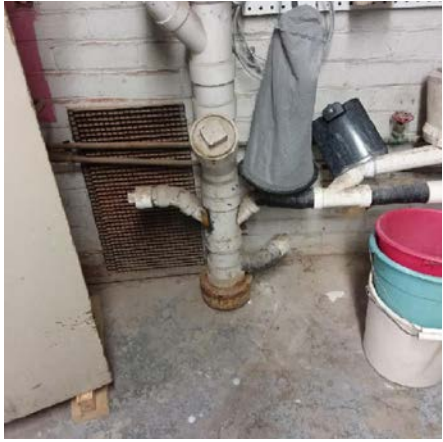
| | equipment | condition | Est remaining<br>Service life | priority | cost | remarks &recommendations | | |
|--|---|---|---|---|---|---|---|--|
| | 24, 4" Sewer Discharge | 3<br>Fully operational,<br>25-50% life<br>expectancy used,<br>periodic<br>problems | 10 | 8 | \$200 per<br>foot | 4 inch cast iron pipe<br>through slab to<br>town sewer . Drain waste<br>and vent<br>piping consists of a<br>mixture of PVC<br>and cast iron. | | |

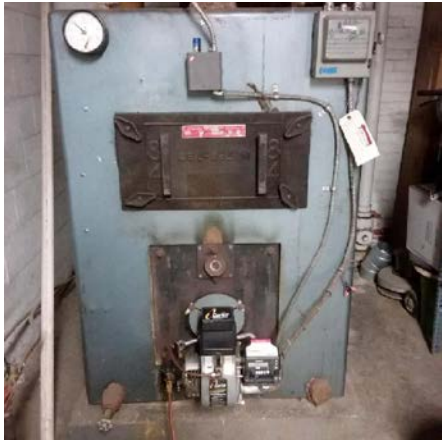
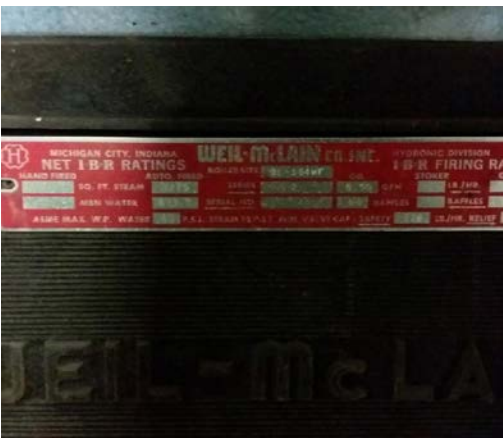
| | equipment | condition | Est remaining<br>Service life | priority | cost | remarks &recommendations | | |
|--|---|---|---|---|---|---|---|--|
| | 21,Pad mounted<br>633,000 BTU oil-fired<br>boiler | 3<br>Fully operational,<br>25-50% life<br>expectancy used,<br>periodic<br>problems | 10 Years | 8 | \$15,000 | Supplies heating hot<br>water to fintube radiation<br>throughout building.<br><br>Boiler is atmospherically<br>vented to chimney. | | |

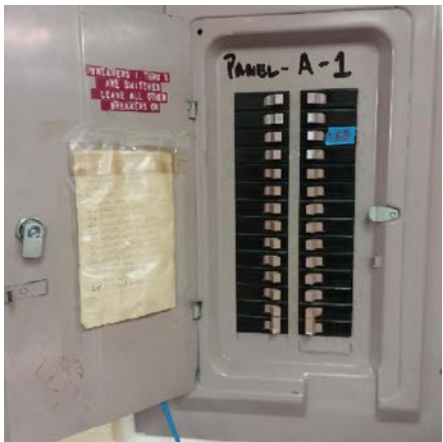
| | equipment | condition | Est remaining<br>Service life | priority | cost | remarks & recommendations | | |
|--|---|---|---|---|---|---|---|---|
| | 31,Electric Panelboard<br>A1 | 2<br>Fully operational,<br>0-25% life<br>expectancy used,<br>no issues, no<br>concerns | 15 Years | 10 | \$2,000 | Flush mounted panel<br>board.<br><br>Unable to determine<br>voltage and amperage. | | |

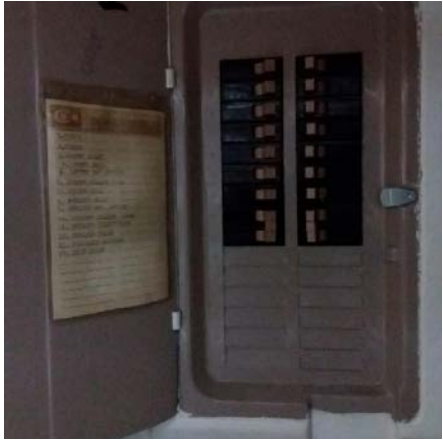
| | equipment | condition | Est remaining<br>Service life | priority | cost | remarks & recommendations | | |
|--|---|---|---|---|---|---|---|--|
| | 30,Electric Panelboard<br>B1 | 2<br>Fully operational,<br>0-25% life<br>expectancy used,<br>no issues, no<br>concerns | 15 Years | 10 | \$2,000 | Flush mounted panel<br>board.<br><br>Unable to determine<br>voltage and amperage.<br><br>Panel board is located in<br>a restricted access area.<br><br>Recommend easier<br>access. | | |

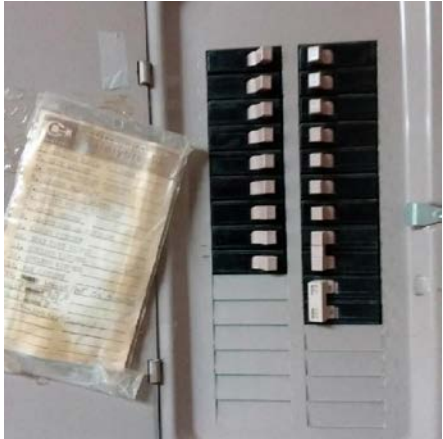
| | equipment | condition | Est remaining<br>Service life | priority | cost | remarks & recommendations | | |
|--|---|---|---|---|---|---|---|--|
| | 26,Electric Panelboard<br>C | 2<br>Fully operational,<br>0-25% life<br>expectancy used,<br>no issues, no<br>concerns | 15 Years | 10 | \$2,000 | Surface mount panel<br>board.<br><br>Unable to determine<br>amperage and voltage. | | |

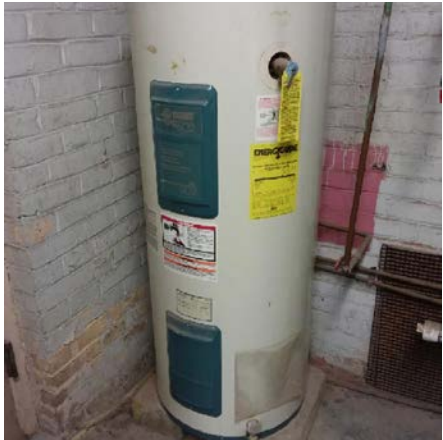
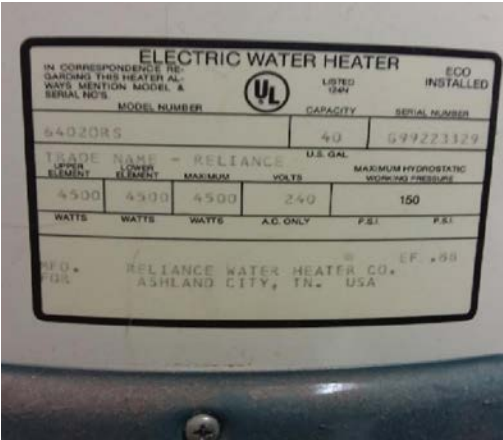
| | equipment | condition | Est remaining<br>Service life | priority | cost | remarks & recommendations | | |
|--|---|---|---|---|---|---|---|--|
| | 32, Reliance 40 Gallon<br>capacity Electric<br>water heater<br><br>Unknown install date | 3<br>Fully operational,<br>25-50% life<br>expectancy used,<br>periodic<br>problems | 10 Years | 10 | \$2,500 | Provides domestic hot<br>water for lower level,<br>first level and one<br>bathroom on second<br>level.<br><br>Provides domestic hot<br>water to fixtures through<br>a uninsulated 2 pipe<br>system. | | |

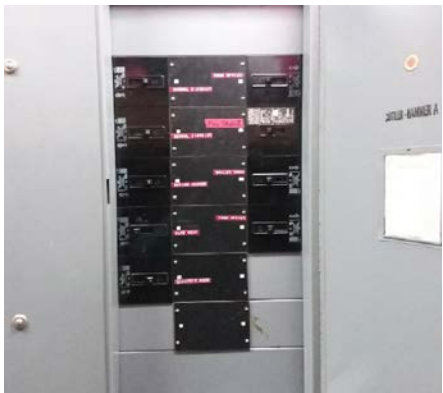
| | equipment | condition | Est remaining<br>Service life | priority | cost | remarks & recommendations | | |
|--|---|---|---|---|---|---|---|--|
| | 20,MDP - 120 / 208<br>Volts 600 - AMP 2<br>phase main distribution<br>panel | 3<br>Fully operational,<br>25-50% life<br>expectancy used,<br>periodic<br>problems | 10 Years | 10 | \$6,000 | Provides power to panel<br>boards in the town office<br>building, Courthouse and<br>the fire station. This<br>panel provides power<br>through a 70 – AMP<br>circuit to slab heater for<br>the handicap ramp which<br>is no longer in service. | | |

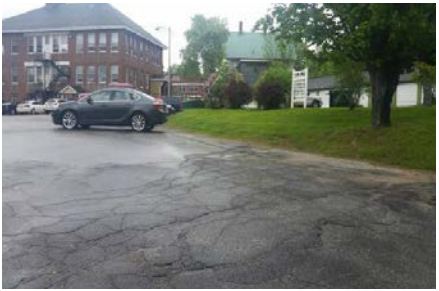
| Site | | | | | | | | |
|---|---|---|---|---|---|---|---|--|
| | Asphalt pavements show typical alligator cracking, settlement and potholing in several areas. It appears that some areas may have had two or more lifts of asphalt applied to correct settlement/drainage issues as well as cracking/wear in the interior parking area behind the Town Hall. | | | | | | | |
| | Pavement | 5 | 3 | 3 | \$7.00 sq.ft.<br>24,000<br>sq.ft<br>\$168,000 | Cracking and<br>deteriorating parking,<br>remove old asphalt,<br>install correct base and<br>new asphalt. | | |
