Building: Unity Springs PRV
 Unity Road
 Newport, New Hampshire

Town of Newport, Building Assessment July 31,2017

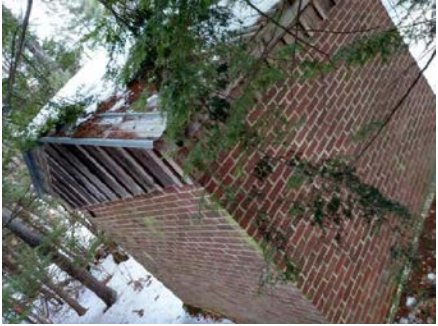
Architectural								
	Brick building housing pressure reducing valve. Utilitarian and could use some maintenance outlined in the report							
	Equipment	Condition	Est. Remaining Service Life	Priority	Cost Estimate	Remarks & Recommendations	Photos	
	785, galvanize roofing	3	15	7	\$10.00 sq.ft.	Clean debris off roof, inspect and coat if there is any rust showing.

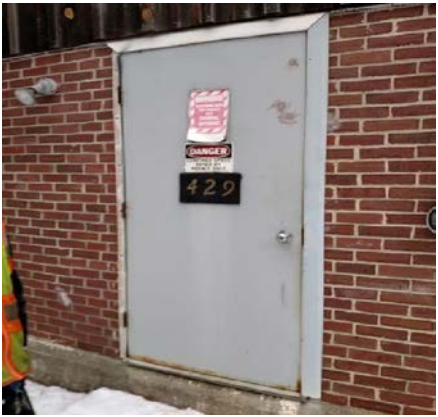
equipment	condition	Est remaining Service life	priority	cost	remarks &recommendations		
	783,Paint Surface	4	4	5	\$2.50 sq.ft.	Paint door and any other exposed wood or metal.

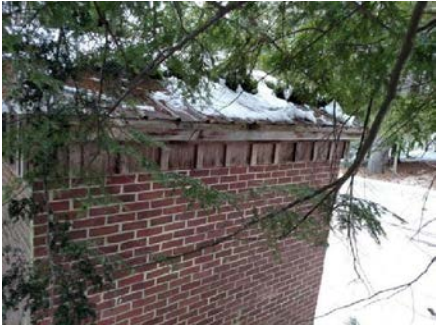
782,Exterior Note:	4	5	5	\$200	Cut back branches that overhang building and roof.

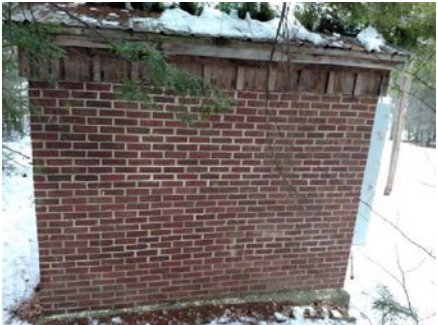
781,Paint Surface	5	5	4	\$2.00 Sq.ft	Stain all wood surfaces.

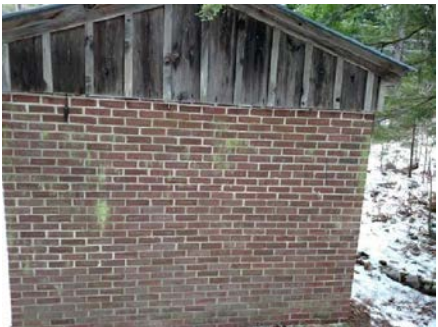
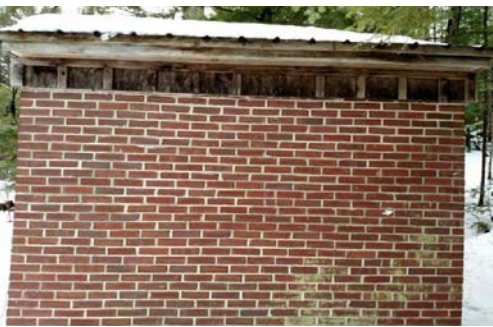
779Exterior Brick	2	50	8		Exterior brick in good condition.

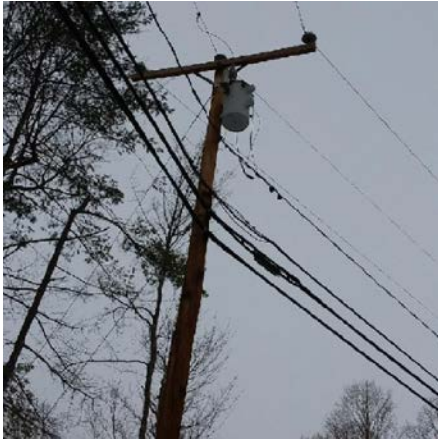
Equipment	Condition	Est. Remaining Service Life	Priority	Cost Estimate	Remarks & Recommendations		
245, One - 10 KW pole mounted transformer	2 Fully operational, 0-25% life expectancy used, no issues, no concerns	15 Years	10		Provides power to building through overhead service.

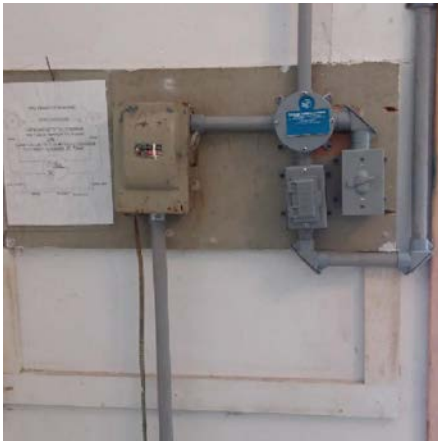
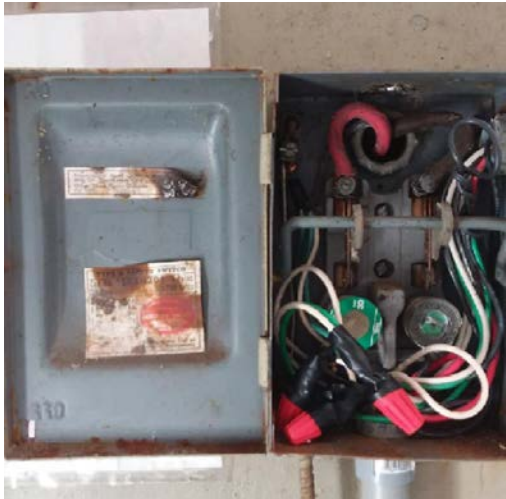
243,Electrical disconnect 30 AMP fuse panel	3 Fully operational, 25-50% life expectancy used, periodic problems	5-10 Years	7		\$600

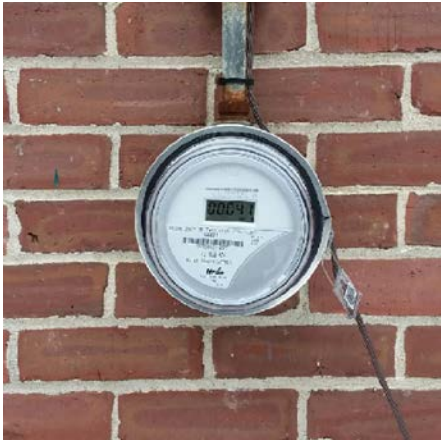
equipment	condition	Est remaining Service life	priority	cost	remarks &recommendations		
	242,Electrical meter	2	12	10	\$250
