Building: Wastewater Treatment Facility  
20 Putnam Road  
Newport, New Hampshire

Town of Newport, Building Assessment July 31,2017

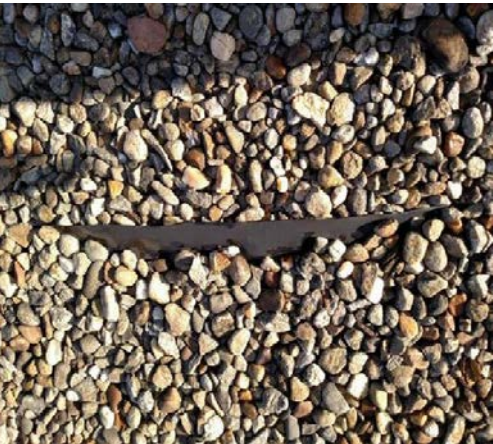
707,Rubber Roof	5	0	1	\$ 18/sq.ft  6905 Sq.ft.  \$124,290	Rubber roof has been a constant problem with leaking. Roof is ballasted stone roof which is difficult to trace leaks from as the stone hides pathways. Suggest this roof be replaced with an adhered membrane roof with additional insulation. Verify with structural engineer quantity of allowed insulation.

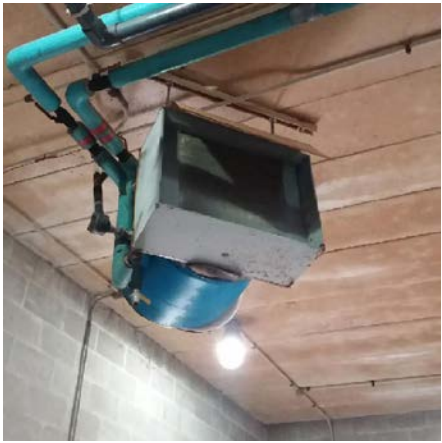
Equipment	Condition	Est. Remaining Service Life	Priority	Cost Estimate	Remarks & Recommendations		
	449,Ceiling-mounted fan powered hot water unit heater  Unknown install date	3 Fully operational, 25-50% life expectancy used, periodic problems	10 Years	10	\$3,500	This unit is in GRIT Building. No access to retrieve make or model.

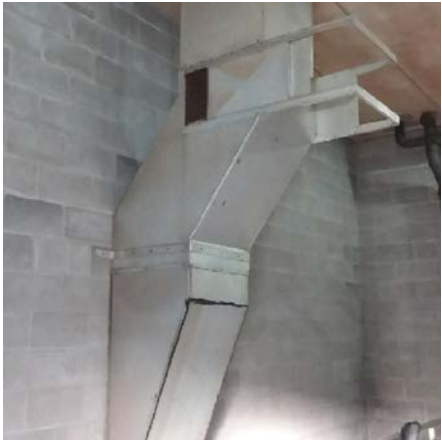
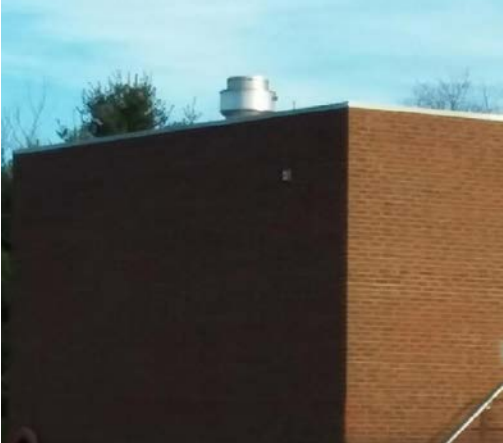
448,Rooftop curb mounted up blast exhaust fan  No access to roof					This fan is mounted on GRIT Building roof.

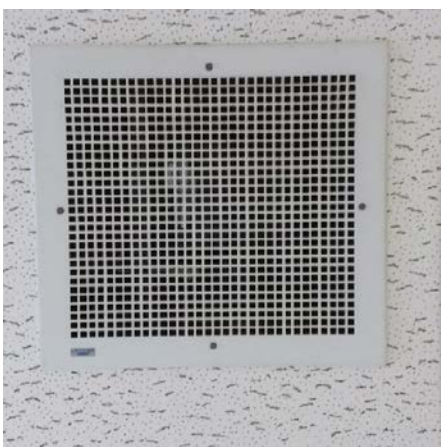
equipment	condition	Est remaining Service life	priority	cost	remarks & recommendations		
	350, ,Ceiling-mounted exhaust fan ducted To Greenheck Model: GRS-10-OD gravity relief hood on roof  Exhaust fan installed in 1987 renovation	5 Operational only with constant attention, 100% life expectancy used, failure imminent	0	1	\$2,500	Unable to retrieve information on ceiling mounted E.F. Office/ lab

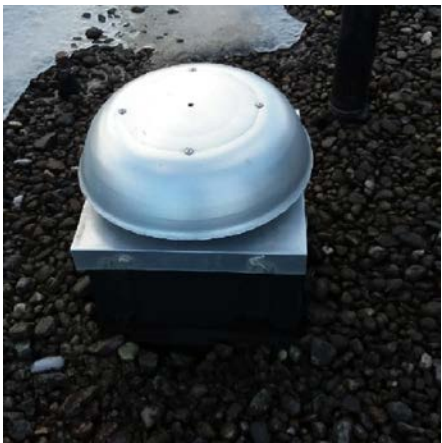
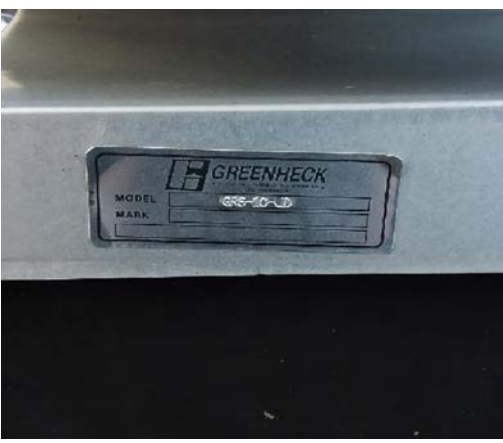
348,Greenheck Model: GRS-10-OD	3 Fully operational, 25-50% life expectancy used, periodic problems	10 Years	10	\$2,500	Original to building.  Exhausts one bathroom. EH#4 near office/lab

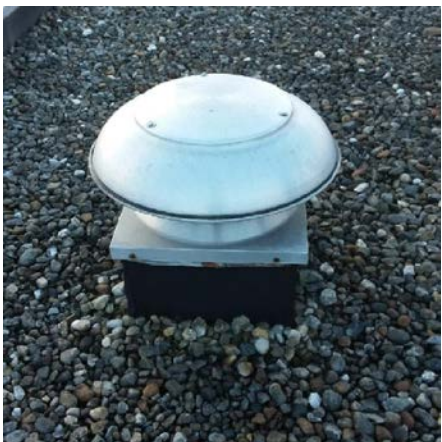
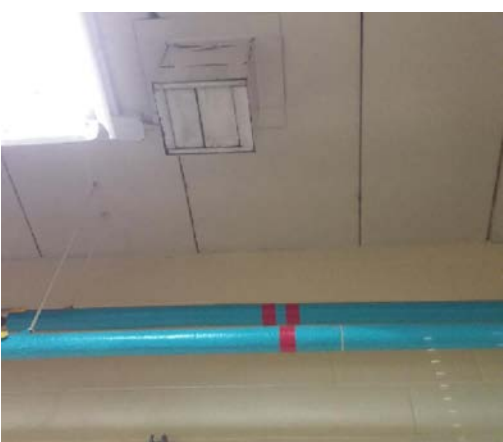
347,Rooftop exhaust fan original to the building  Unable to visualize nameplate	5 Operational only with constant attention, 100% life expectancy used, failure imminent	0	1	\$2,500	Serves to exhaust parts, fan is approximately 40 years old. office lab

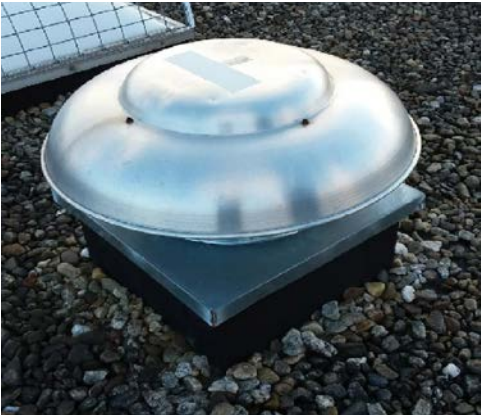
335,Rooftop exhaust fan	1 Fully operational, new, recently replaced	20 Years	10	\$2,500	Replaced within the last 5 years.  No visible nameplate.  Exhausts garage area.

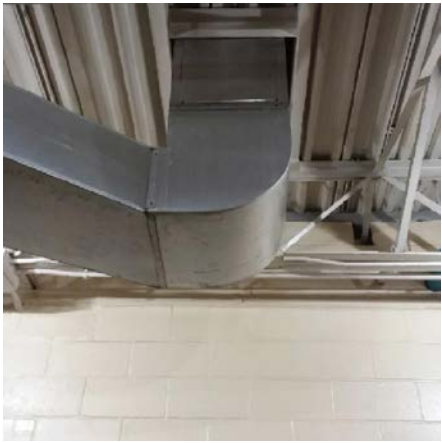
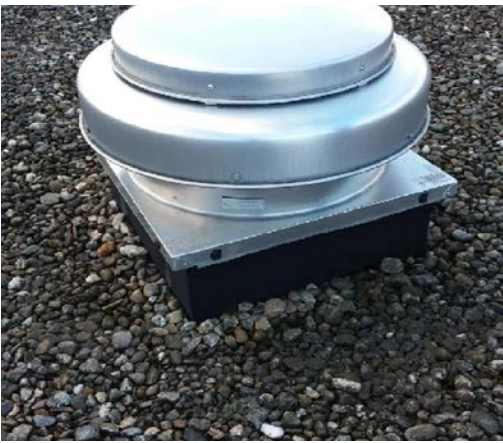
331,Rooftop exhaust fan  Make: Dayton  Model: 4YG506	1 Fully operational, new, recently replaced	15 Years	10	\$2,500	Replaced within the last 5 years.  Serves the filter room.

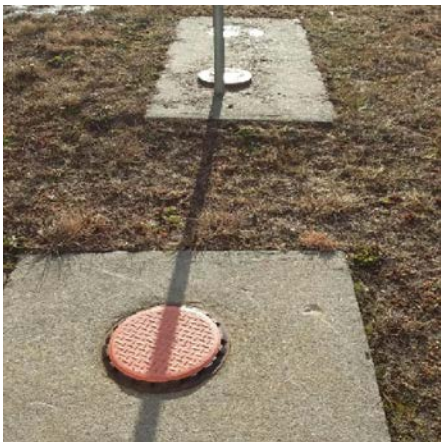
equipment	condition	Est remaining Service life	priority	cost	remarks &recommendations		
	359,10,000 Gallon underground oil tank  Installed 20-plus years ago  Unknown condition of tank			Per state	\$31,000

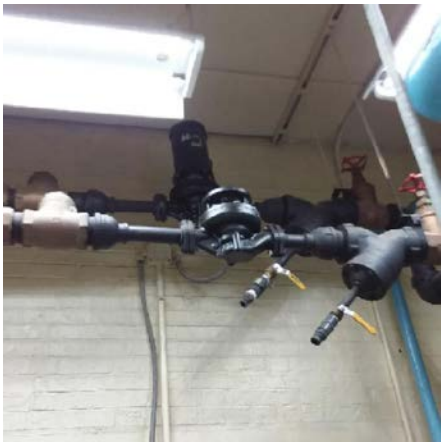
357,Inline circulation pumps	2 Fully operational, 0-25% life expectancy used, no issues, no concerns	15	10	\$3,000	Supplies heating hot water to heating terminals.  Unable to access for nameplate information.

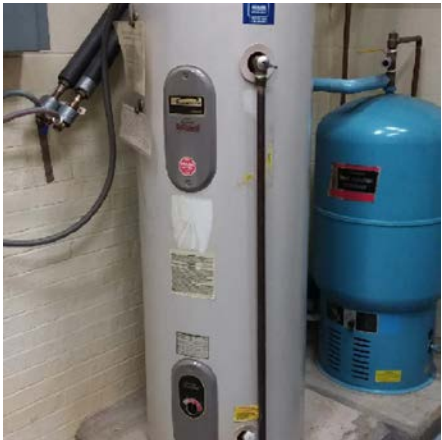
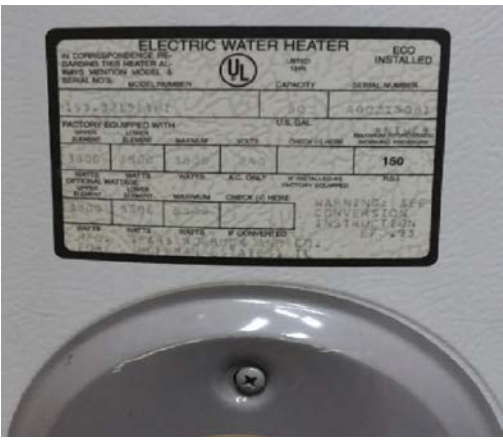
equipment	condition	Est remaining Service life	priority	cost	remarks &recommendations		
	356,Kenmore Model: 153.321511HT  50 Gallon capacity electric water heater  Installed in 2007	2 Fully operational, 0-25% life expectancy used, no issues, no concerns	15 Years	10	\$2,000	This water heater operates during the months that the heat plant is not operating.  The hot water is stored in the adjacent storage tank. Boiler room

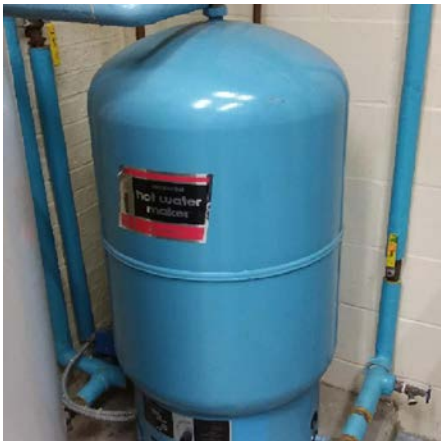
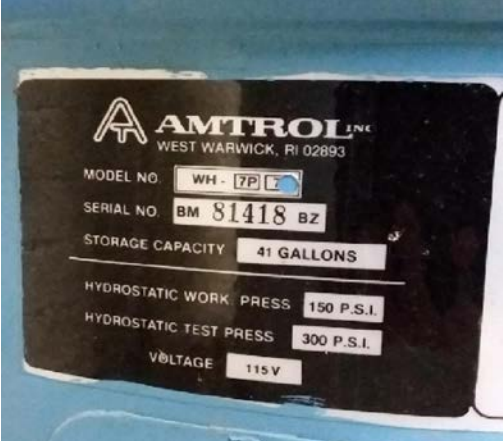
355,41 Gallon domestic hot water storage tank  Installed in the 1987 renovation  Make: AMTROL Model: BM-81418-BZ	2 Fully operational, 0-25% life expectancy used, no issues, no concerns	15 Years	10	\$2,500	Storage for the adjacent electric water heater.  Tank does have ability to heat water. Although tank is 30 years old, it appears to be in good condition. Boiler room

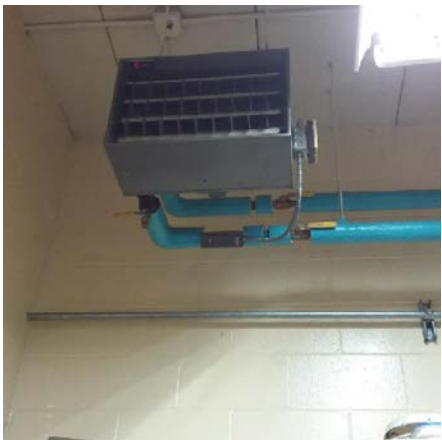
351,Ceiling hung hot water Unit heater  Installed in the 1987 renovation	3 Fully operational, 25-50% life expectancy used, periodic problems	10 Years	10	\$3,500	Provides heat to parts room.

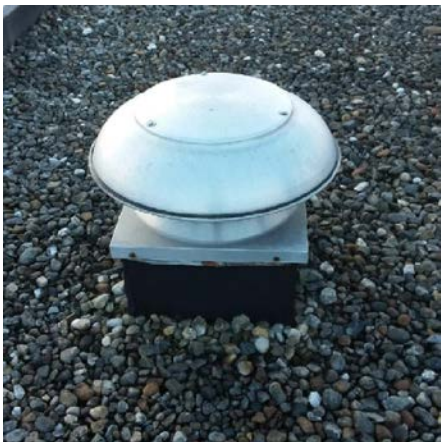
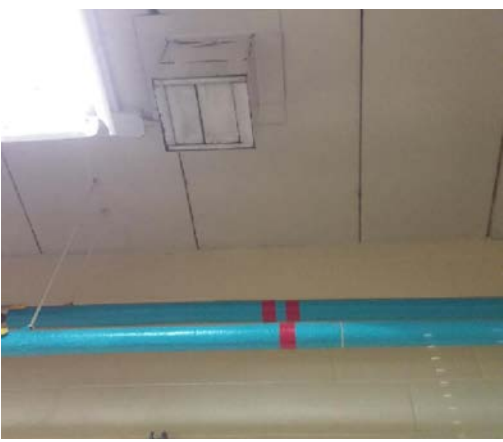
equipment	condition	Est remaining Service life	priority	cost	remarks &recommendations		
	345,Rooftop exhaust fan original to the building  Unable to visualize nameplate	5 Operational only with constant attention, 100% life expectancy used, failure imminent	0	1	\$2,500	Serves to exhaust parts, fan is approximately 40 years old.

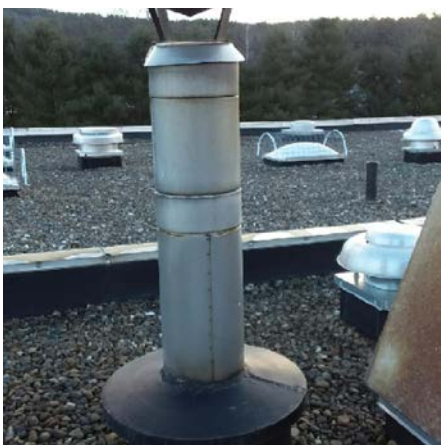
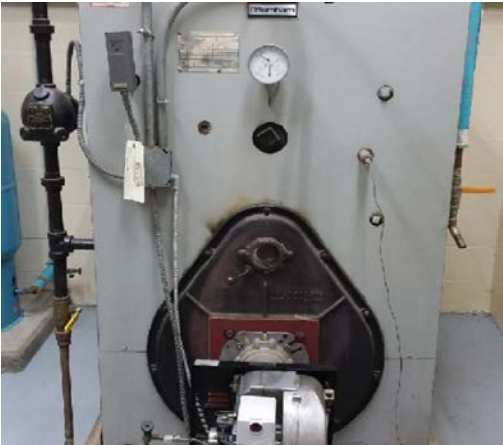
344,970,000 BTU oil-fired boiler  Make: Burnham  Model: PF-507  Boiler was installed in 1986  The oil burner gun was replaced in 2006	3 Fully operational, 25-50% life expectancy used, periodic problems	5 to 10 Years	7	\$10,000	Provides heating water and domestic hot water. Boiler is atmospherically vented through roof  Boiler provides domestic hot water during the heating season only.  Boiler shows sign of burn between boiler skin and burner panel.

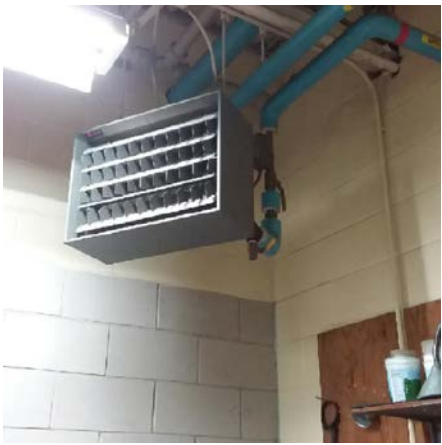
322,Ceiling hung hot water unit heater	3 Fully operational, 25-50% life expectancy used, periodic problems	10	10	\$3,500	Provides heat to blower room

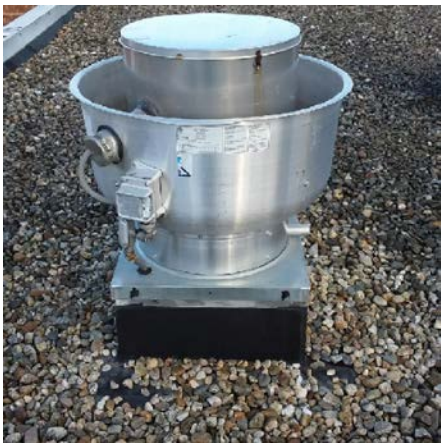
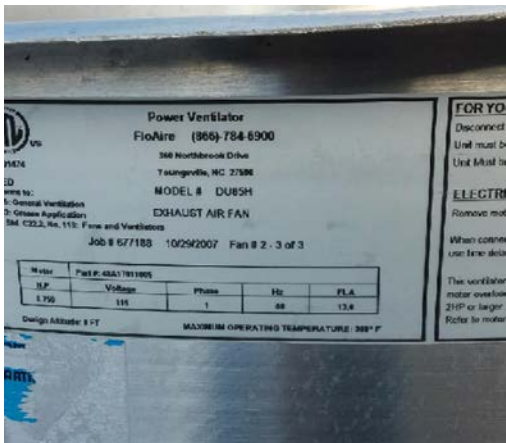
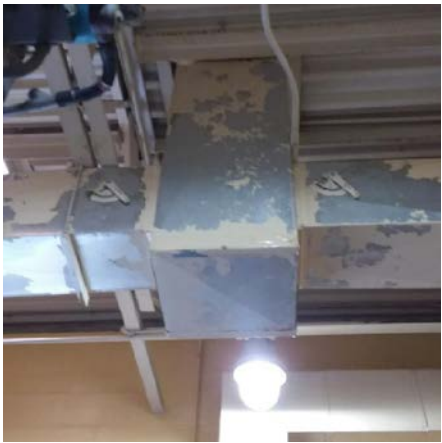
equipment	condition	Est remaining Service life	priority	cost	remarks &recommendations		
	349,Roof mounted upblast exhaust fan  Make: FLOAIRE  Model: DU85H	1 Fully operational, new, recently replaced	20 Years	10	\$4,000	Replaced within the last 5 years, interlocked with fresh air intake hood.  Serves to exhaust screen room.

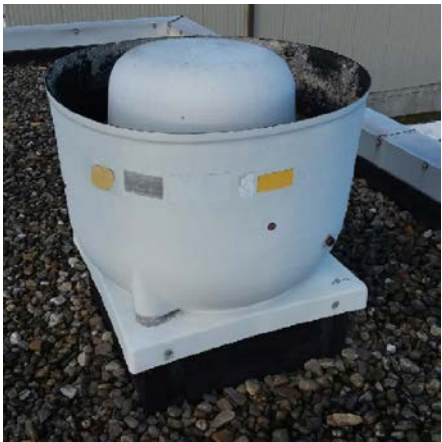
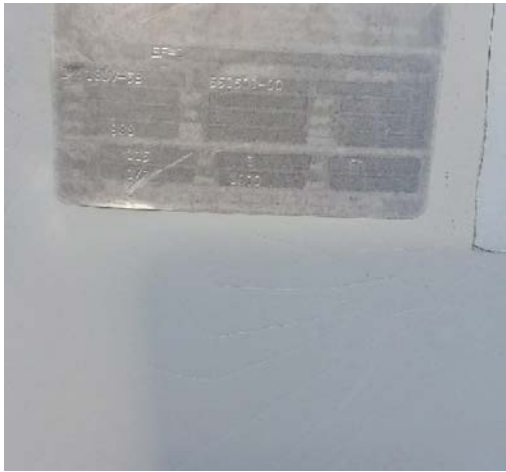
346, Upblast exhaust fan original to building	4 Operational, 50- 75% life expectancy used, occasional problems, frequent repairs needed	5 Years	5	\$6,000	Unable to visualize complete nameplate  Serves to exhaust de- chlorination system room.

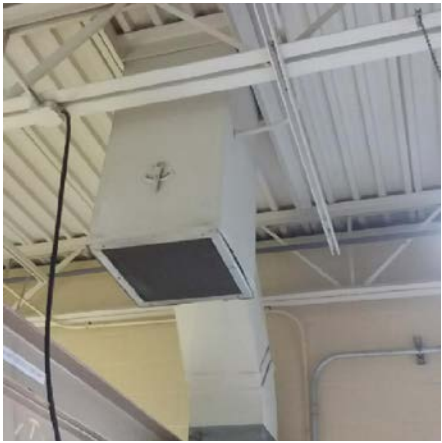
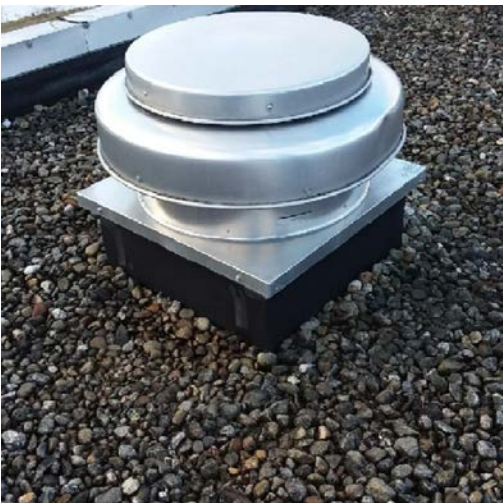
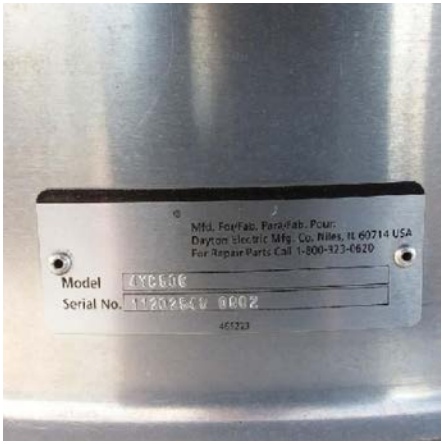
318,Rooftop exhaust fan  Make: Dayton Model: 4YC50G	1 Fully operational, new, recently replaced	25 Years	10	\$2,500	Replaced within the last 5 years.  Serves to exhaust the control room.

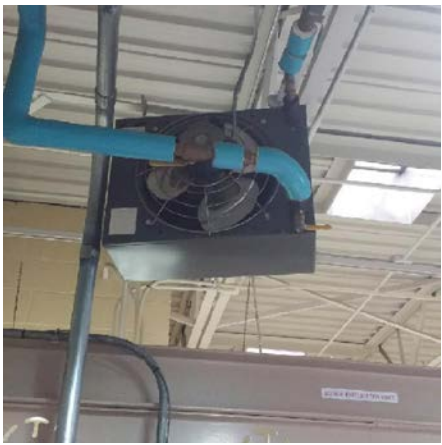
equipment	condition	Est remaining Service life	priority	cost	remarks &recommendations		
	317,Fan powered Hot water Unit heater	3 Fully operational, 25-50% life expectancy used, periodic problems	10 Years	10	\$3,500	Typical throughout building.  Provides heat for control room.

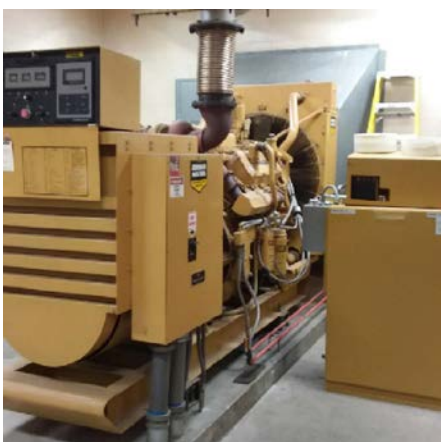
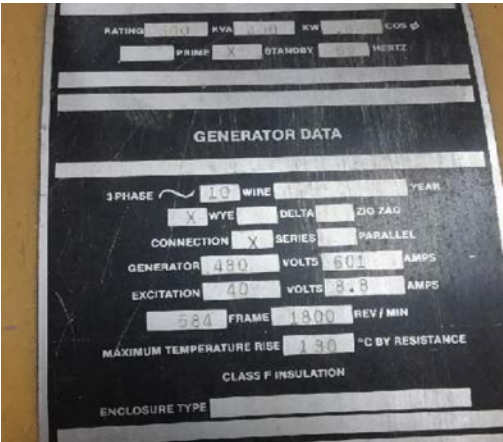
320,400 KW floor mounted diesel generator  Make: CATERPILLAR Model: 3408	2 Fully operational, 0-25% life expectancy used, no issues, no concerns	15 Years	10	\$200,000	Provides power for entire building.  Generator is housed inside the building.  Unknown date of install. Appears to be well maintained.
