Building: Water Filtration Plant
Unity Rd.
Newport, New Hampshire

Town of Newport, Building Assessment July 31,2017

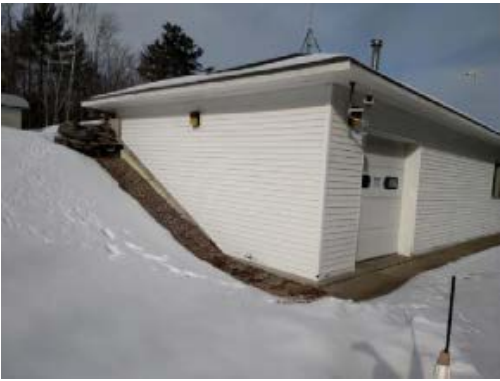
equipment	condition	Est remaining Service life	priority	cost	remarks &recommendations		
	754,Roof	4	0	4	\$7.00 sq.ft. 1,800 sq.ft. \$12,600	Roof installed in 1992 is nearing end of life

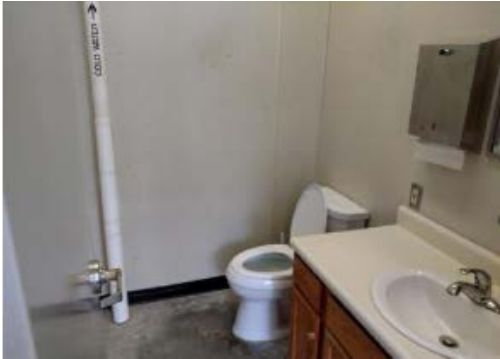
753,Law					Facilities do not meet ADA

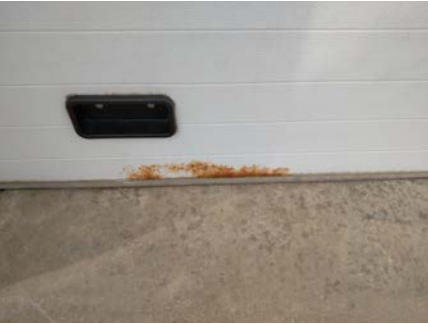
756, Repair	4	3	4	\$2.50 Sq.ft	Repair rust on OH doors and man doors

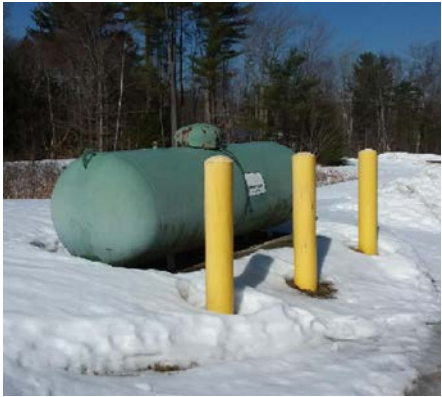
Equipment	Condition	Est. Remaining Service Life	Priority	Cost Estimate			
	Water Entrance with remote read meter					Water is provided from Gilman Pond.		
	608,1,000 Gallon above-ground propane tank	1 Fully operational, new, recently repaired	25 Years	10		Tank provides propane for building. Tank is newly installed and well protected.

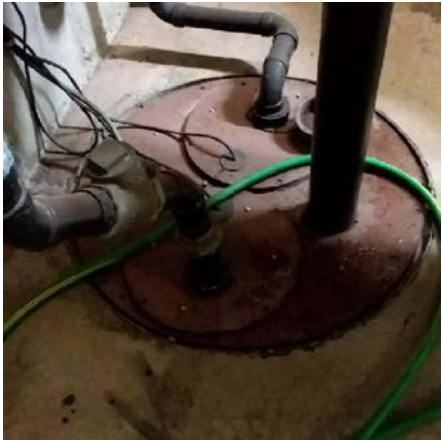
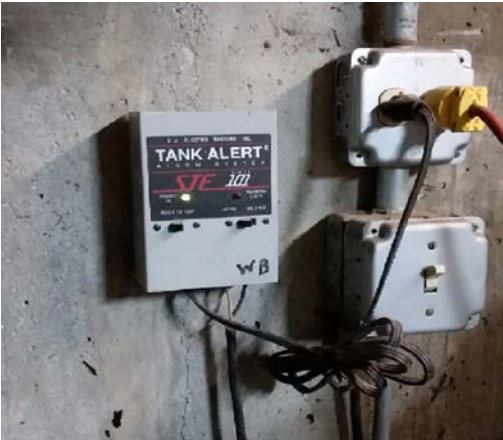
590,1000 Gallon Septic Tank & leach field	1	15	10	\$10,000-\$15,000	Located by the entry point to the building from the road. Recommend site survey to document exact location.		
	235,Sewer Ejector Pump w/tank alert alarm	Cannot see pump			\$5000	Ejects sewage to 1000 Gallon septic tank. Installed with original construction of building in 1992.

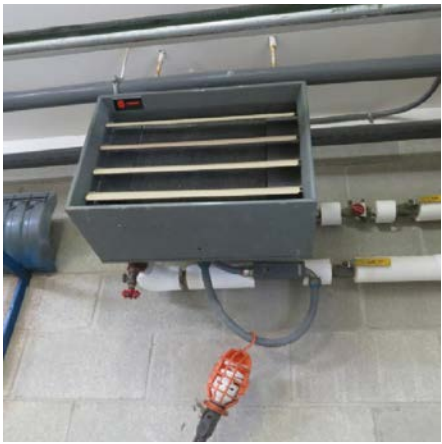
equipment	condition	Est remaining Service life	priority	cost	remarks & recommendations		
	605,UH-1 Trane ceiling mounted fan powered unit heater	3 Fully operational, 25-50% life expectancy used, periodic problems	15 Years	10	\$2,500	Heater provides heat for upper level area. Typical heater throughout building in open areas		
	604,UH-2 Trane ceiling mounted fan powered unit heater	3 Fully operational, 25-50% life expectancy used, periodic problems	15 Years	10	\$2,500	Heater provides heat for upper level area. Typical heater throughout building in open areas

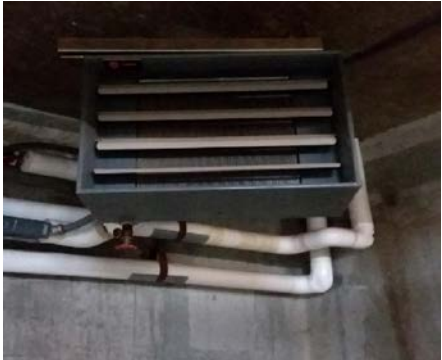
234,UH-3 Trane ceiling mounted fan powered unit heater	3 Fully operational, 25-50% life expectancy used, periodic problems	15 Years	10	\$2,500	Heater provides heat for lower level area. Typical heater throughout building in open areas.

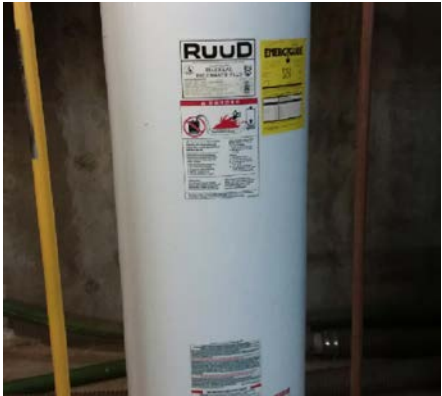
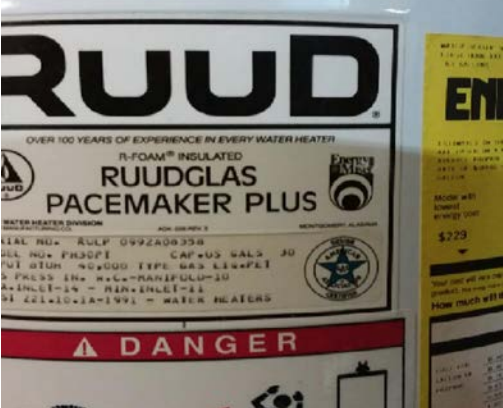
233,40,000 BTU gas fired water heater 30 Gallon capacity Make: RUDD Model: PH30PT	3 Fully operational, 25-50% life expectancy used, periodic problems	10 Years	10	\$1,000	Water heater is atmospherically vented to the boiler vent pipe up through the roof. During our visit, the gas was turned off to this appliance. Recommend inspection of five piping and review connection into five riser.

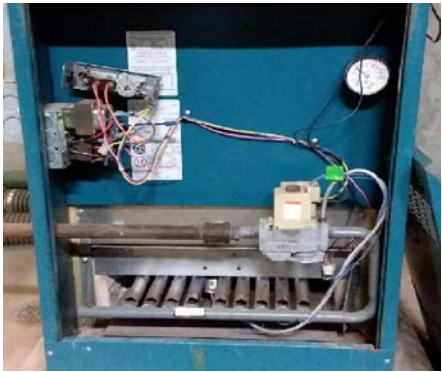
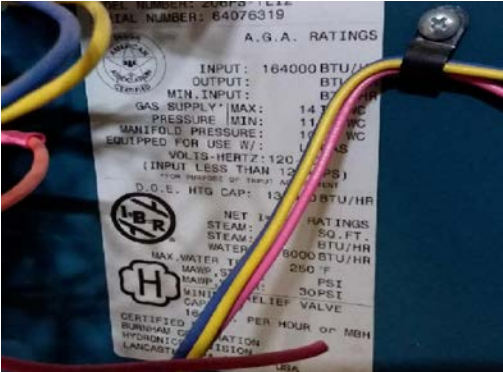
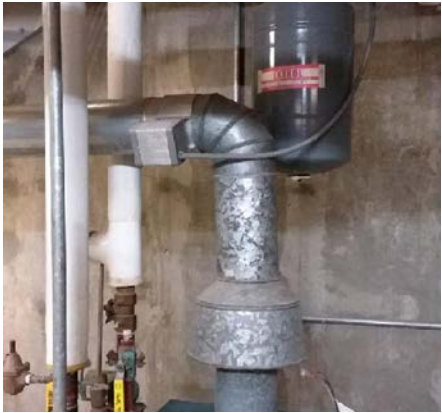
equipment	condition	Est remaining Service life	priority	cost	remarks &recommendations		
	232,164,000 BTU oil fired boiler MAKE: Burnham Model: 206PS-TEI2 MFG: 12/1998	3 Fully operational, 25-50% life expectancy used, periodic problems	10 Years	10	\$8,500	Boiler provides heating water to fin tube radiation and ceiling hung unit heaters throughout building through two pipe insulated system. Boiler is atmospherically vented with B vent piping up through the roof. Maintain annual cleaning.

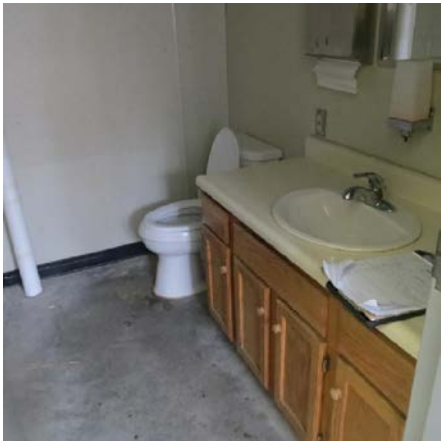
606,Floor mounted tank type toilet, counter mounted lavatory with single handle faucet	3 Fully operational, 25-50% life expectancy used, periodic problems	15 Years	10	\$1,000 per fixture

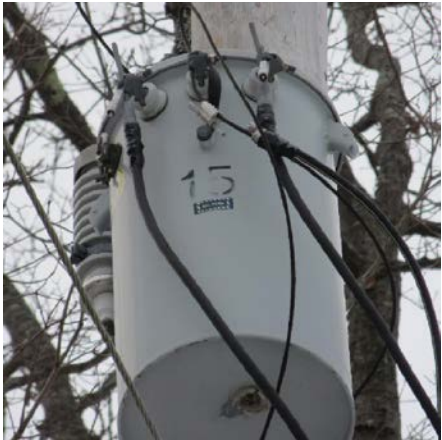
Equipment	Condition	Est. Remaining Service Life	Priority	Cost Estimate	Remarks & Recommendations		
	609,15 KW pole-mounted transformer	2 Fully operational, 0-25% life expectancy used, no issues, no concerns	15 Years	10		Provides power through underground service to the building. Maintained by power supplier.

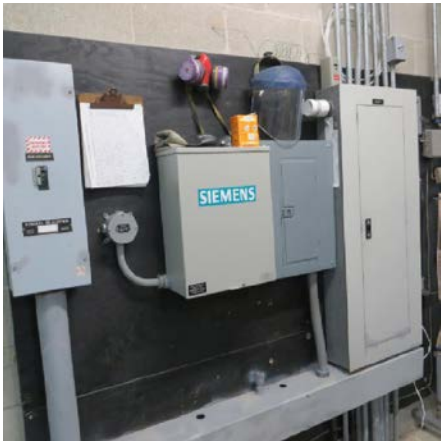
611, 120/240-volt 200 AMP single phase surface mount panelboard with main disconnect switch and generator transfer switch	3 Fully operational, 25-50% life expectancy used, periodic problems	15 Years	10	\$3,000

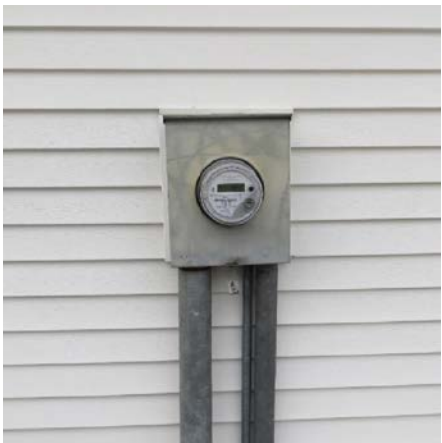
610,Electrical Meter For the complete building					Maintained by the power supplier.

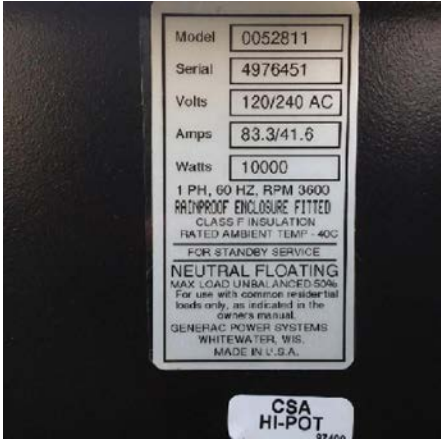
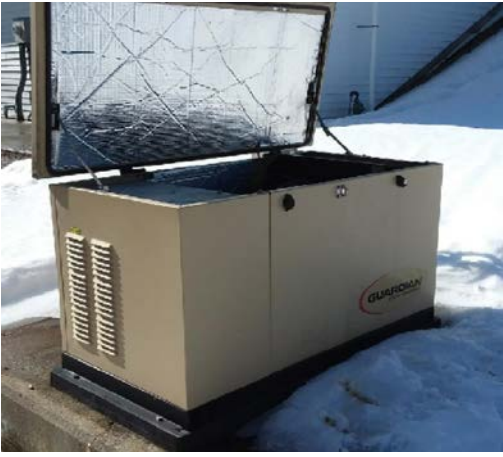
equipment	condition	Est remaining Service life	priority	cost	remarks & recommendations		
	607,10 KW LP gas fired pad mounted generator Make: GENERAC Model: 0052811	2 Fully operational, 0-25% life expectancy used, no issues, no concerns	15 Years	10	\$6500	Unknown date of install.
