Building: Water Tanks  
2360 Summer Street  
Newport, New Hampshire

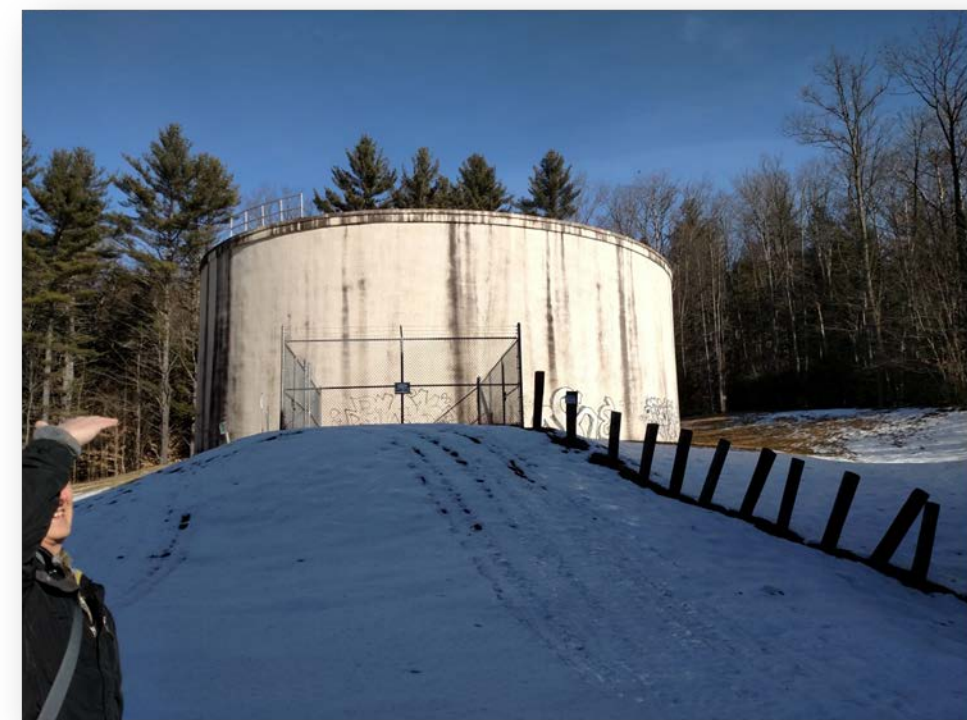
This installation consists of two above-ground waterworks storage tanks, sited on top of a hill. We were advised in subsequent discussions with town officials that the larger, southerly tank is out of service. The smaller, northerly tank is reported to be still in operation as part of the municipal water system. Both tanks were reviewed from the outside only. Town officials indicate that the interior of the tanks are periodically accessed by divers to inspect their condition. The southerly tank has a painted (green) steel exterior surface that presently exhibits extensive paint system failure, with resultant corrosion of the surface. The northerly tank has an exterior, white cementitious finish. The composition of the exterior walls of this tank could not be determined by visual inspection.

**Structural concerns:**  
Southerly tank: Paint failure and resultant corrosion. Viewed from the outside, the corrosion of the perimeter tank walls does not appear to be more than superficial as of the time of this inspection. Further inspection of the roof and the interior tank surfaces is recommended, but requires specialized personnel and equipment.  
Northerly tank: Structural composition of the tank walls should be ascertained and its condition should be verified by divers. The causes and significance of the crazing evident in the exterior cementitious finish should be determined
