Historic Building Assessment

Town Hall and Courthouse

Newport, New Hampshire

Prepared by: Scully Architects 17 Elm Street,
Keene, New Hampshire 03431 603-357-4544

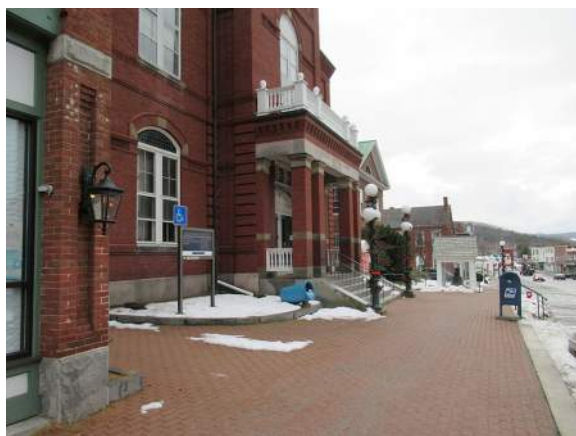
The west side of the building faces Main Street. The sidewalk along Main Street is made of interlocking concrete pavers. Main Street and the sidewalk slope downwards towards the south. The reddish colored pavers are generally in good condition. There are some slight undulations in the surface of the pavers at the base of the stairs that held up to the Town Hall & Courthouse and more significantly at the ramped area adjacent to the Revere Bell enclosure.

Photo 19— West side of building along main Street, looking south

- 5 - The remaining knob and tube wiring in the building should be removed and replaced with proper wiring, junction boxes and devices.
- 6 - The half round stain glass transoms above the second floor windows should be reinstalled (see photos 31, 38, 45 & 46).
- 7 - The exterior woodwork needs to be repainted; This includes windows, doors, frames, adjacent trim and transoms. All wood trim and louvers at the bell tower. The wood railing above the west main entrance. The first floor entrance on the south side of the building. As part of this work the clock faces should be repainted and the numerals, clock dials and minute markers re-gilded in gold. The weathervane should also be repainted and directional letters re-gilded in gold (see photos 19 through 25, 31 through 45). The perimeter of window and door opening need to be caulked.

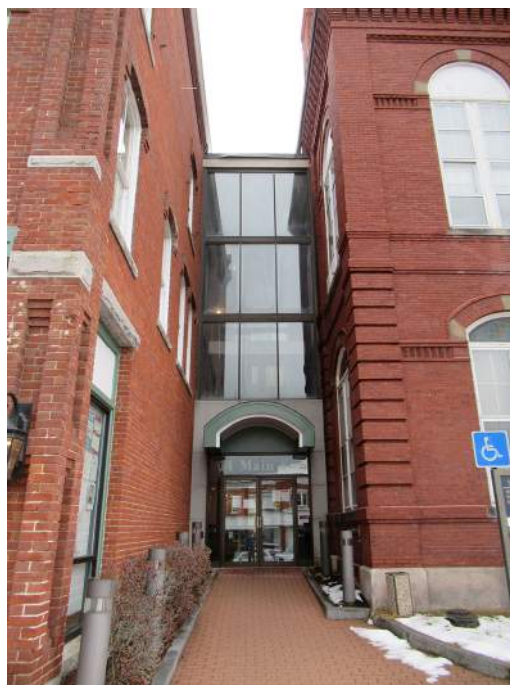
Photo 20— West side of building looking east at entrance to 1986 courthouse

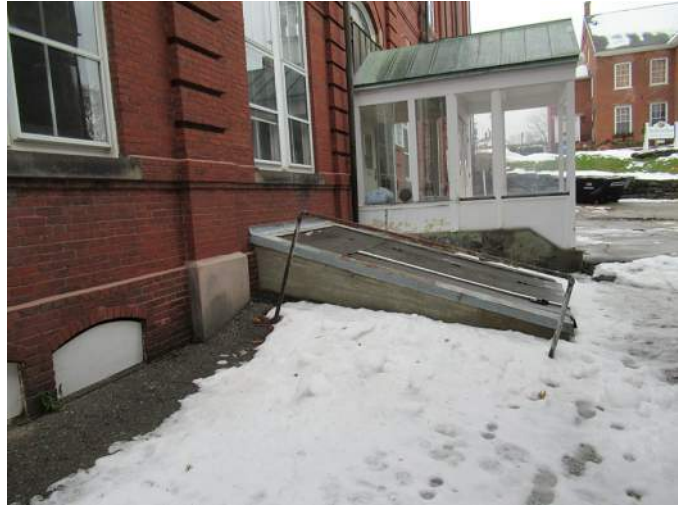
Photo 24—South side of building looking east

There is limited exiting from the basement. There are the two stairs at the west end of the building. There is the bulkhead door on the south side of the building (photos 24 & 87), and a ladder from the east end of the basement to a hallway leading to the first floor mechanical room (photo 86). The bulkhead and ladder access could not be classified exits from a code standpoint and the stairs at the west end are not completely code compliant.

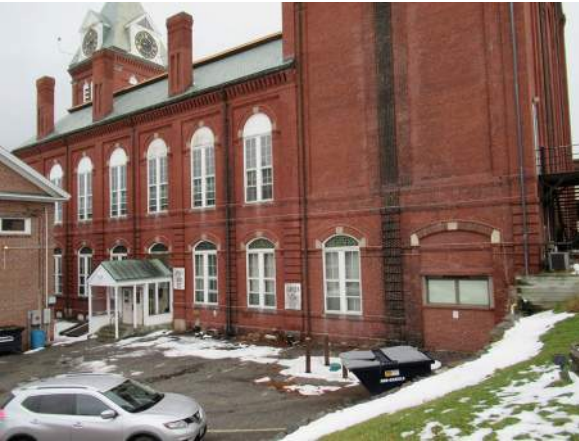
Photo 25—South side of building looking north at Town Hall & Courthouse

- 11 - The paving adjacent to the south and east sides of the building should be replaced or resurfaced and sloped away from the building. Prior to this, the area adjacent to the south side of the building should be excavated down to the top of the stone portion of the exterior foundation walls (approximately 2') and any soft mortar joints should be repointed (see photos 25 & 29).

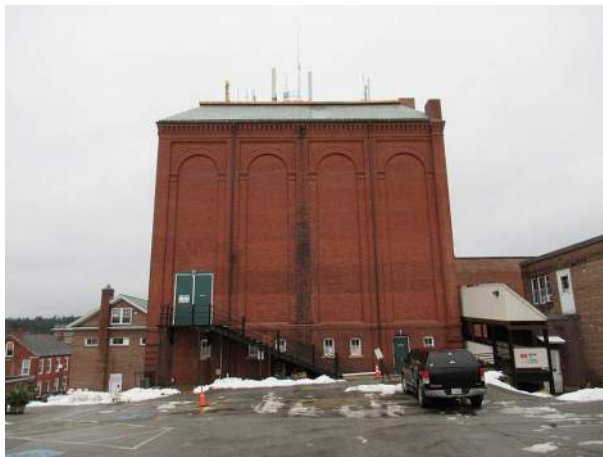
Photo 28—East side of Town Hall & Courthouse at looking west. Metal and wood stairway lead to back of stage (double green doors). Single green door leads to dressing rooms.

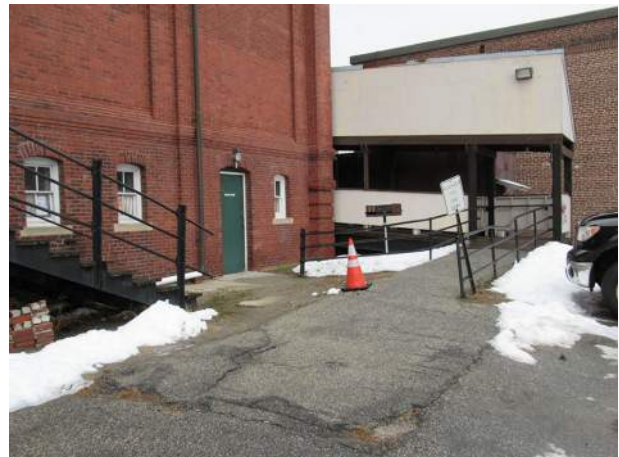
Photo 29—East side of Town Hall & Courthouse at looking north west. Covered walkway provides accessible route to Opera House on second floor and to elevator installed in 1986.

The paving adjacent to the building is in fair to poor condition. There are undulations in the paving, most likely caused by frost action, that have created potential tripping hazards. The area under the stairway that leads up to the stage is paved with concrete. This was

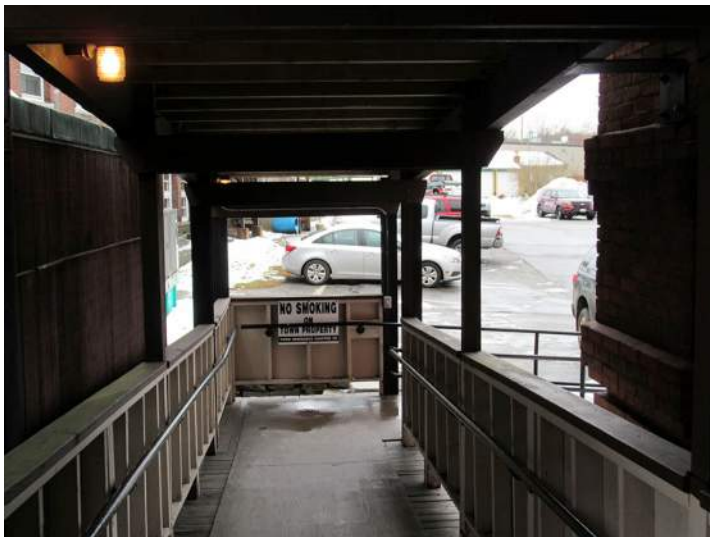
Most of the north side of the building is occupied by the Courthouse Annex built in 1986. Part of that annex was a covered walkway that leads from the second floor eastward to the parking lot. The floor of the walkway is ramped to provide accessible access to the opera house and elevator which connects the first and second floor of the annex as well as the Town Hall & Courthouse. The floor of the ramp is 2x6 decking with a small spacing between the boards. The center of the walkway was later cover with a ½ inch thick layer of plywood. Condition is fair.

Photo 30—Ramped covered walkway on north side of building looking east.

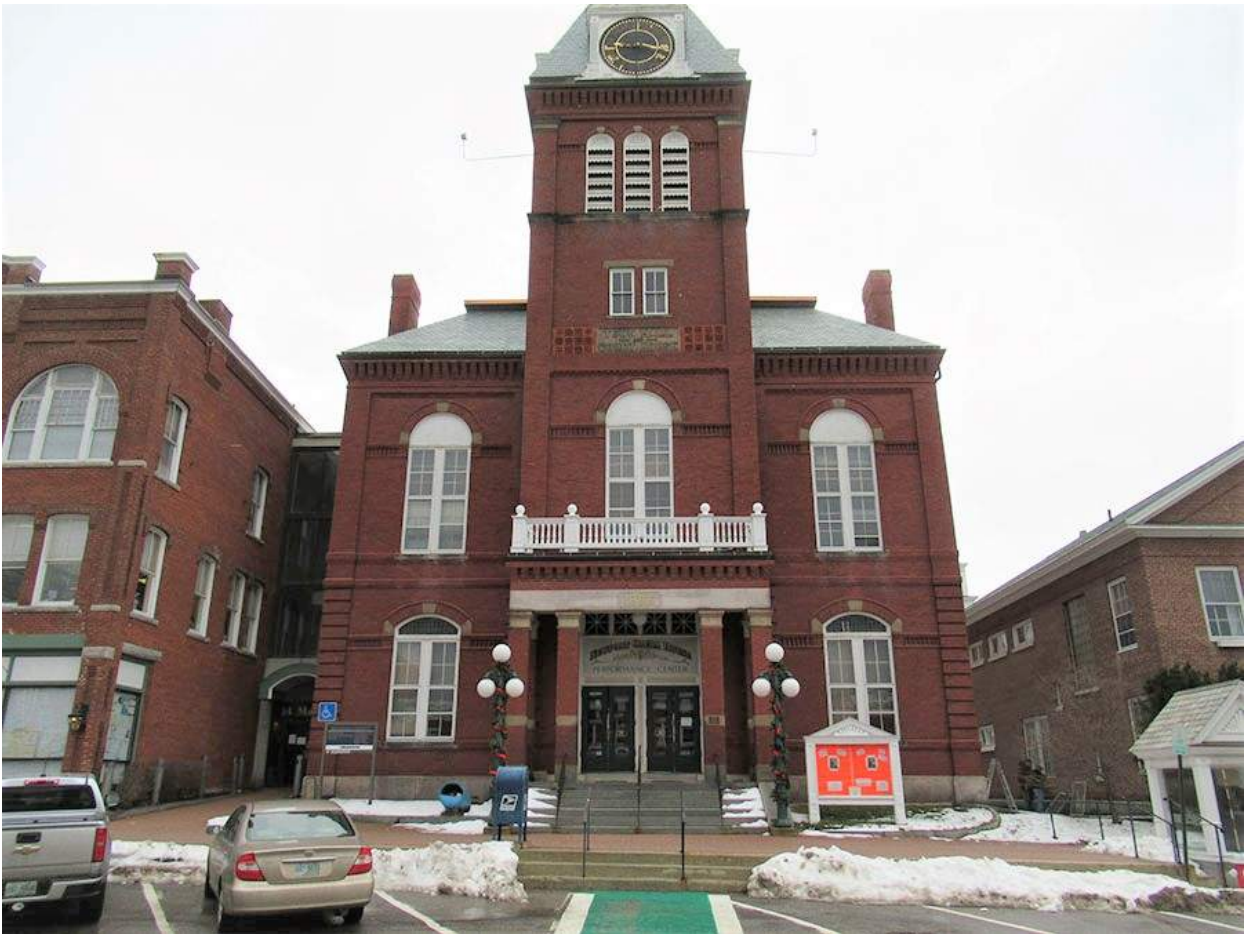
Photo 31 — West side of building

At the perimeter of the building there is a mansard roof that slopes up to the low sloping roof. These roofs are covered with slate roof shingles (see photos 31, 38, 39, 41 & 42). These slate roofs and the copper flashings were replaced between 1996 and 1999. These roofs and flashings are in good condition.

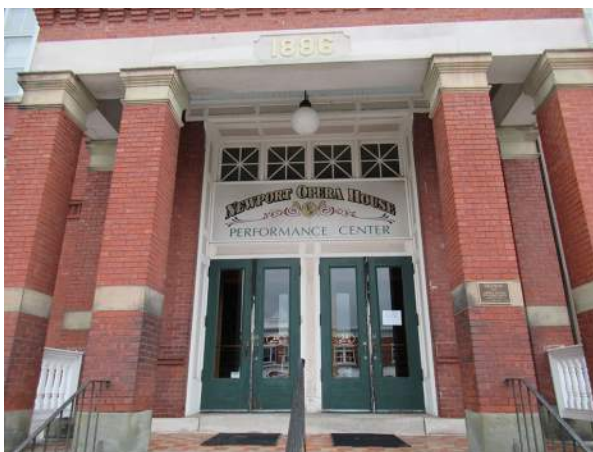
Photo 32 — Main entrance at west side building

There are two pair of wood doors with glass vision panels at the main entrance to the first floor on the west side of the building (see photo 32). These doors and frames are in fair condition they need some minor repairs, painting, replacement of weather-stripping and adjustments to the remaining hardware. There is evidence that this doorway was modified sometime in the past (see photo 48). There were modifications made to the door sill and exterior jamb

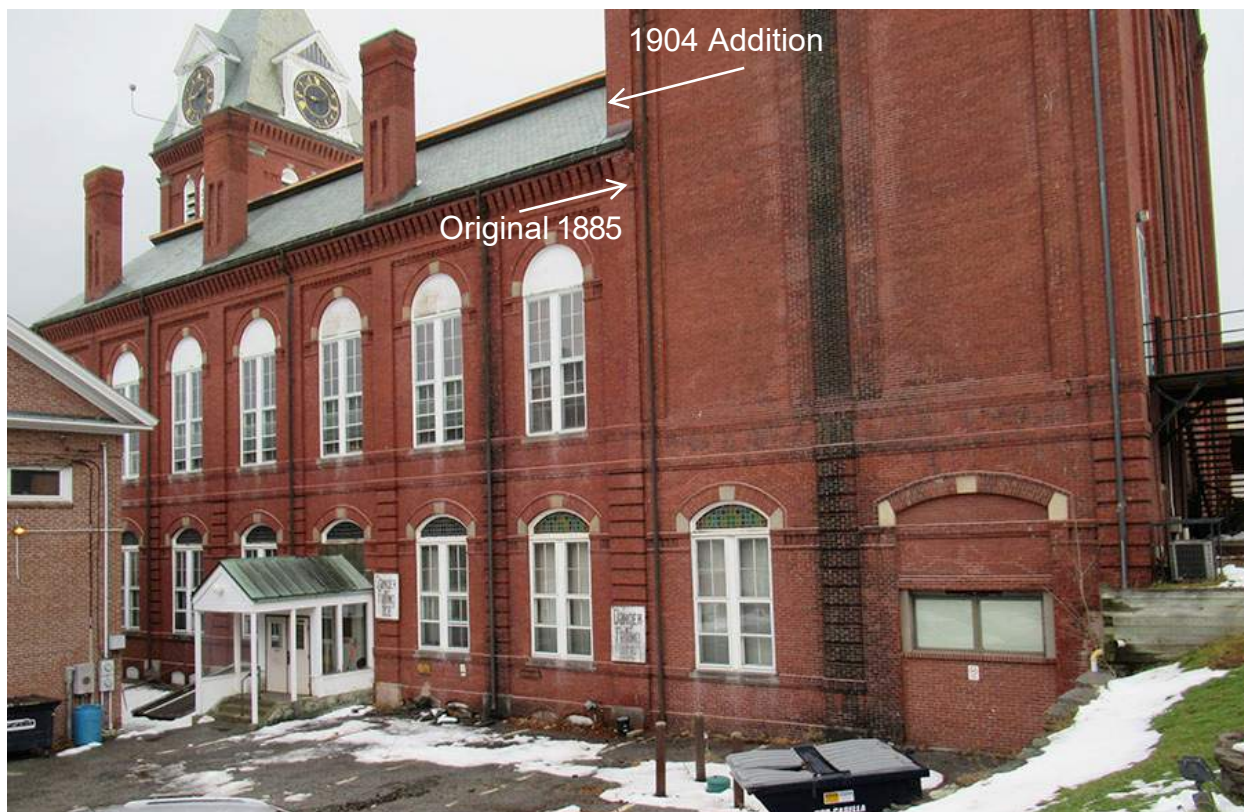
Photo 38—South façade of building. Sheriff's department building at left of photo

While some repointing work has occurred over the preceding years, it does not appear as if the brickwork or stone accent have ever been cleaned. There is some staining of the brick, mostly on the vertical pilaster. These can be seen in photos 38, 40 and 41. This was most likely caused by faulty gutters and downspout prior to their replacement in 1996 - 1999. No current wet spots were observed.

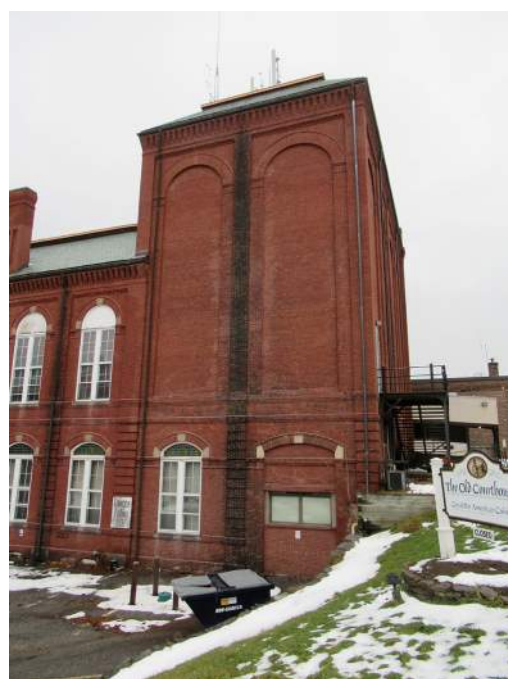
Photo 40—South side of stage fly

At the east end of the south wall there is a pair of windows that were installed as part of the 1986 courthouse renovations (see photo 40). These are common to the jury room. These vinyl clad wood windows are in fair condition.

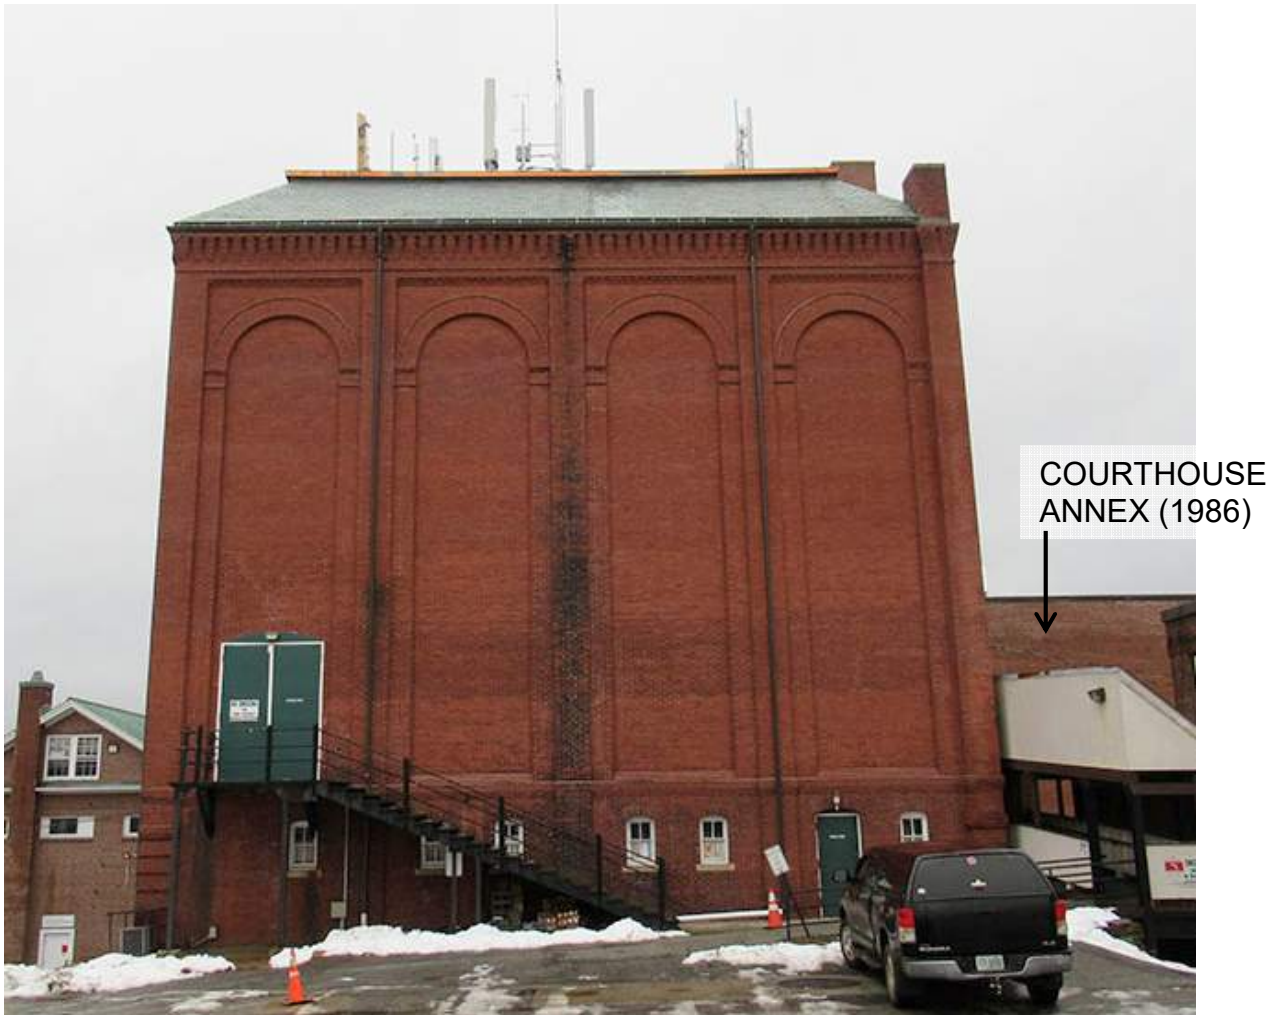
Photo 41— East side of building

There are six small double hung wood windows on the first floor of the east exterior wall (see photos 41 and 47). These windows have stone sills but do not have any storm windows.

- 8 - The three exterior wood doors at the east side of the building should be replaced (see photos 41, 54 & 55). The exterior doors at the main entrance on the west of the

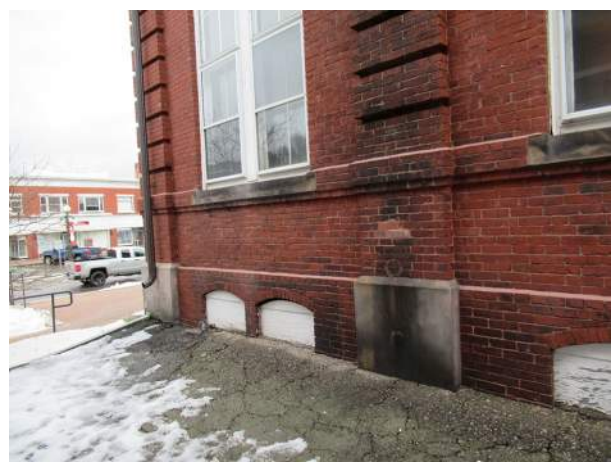
Photo 49—Basement windows covered with plywood at west end of south exterior wall

There were originally a series of small window sash at the base of the building that opened to the basement. All of these sashes have either been removed or covered over with plywood. What remains of the original window sash and frames, as well as the plywood coverings are in poor condition. In many locations the pavement is in contact with the wood. There are pathways for water to enter the building.

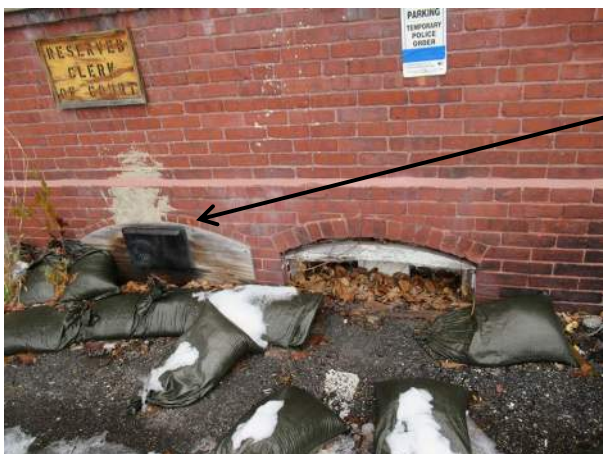
VENT FOR COURTHOUSE
PROPANE BOILERS LOCATED IN
BASEMENT

Photo 50—Basement windows below first floor court room south exterior wall

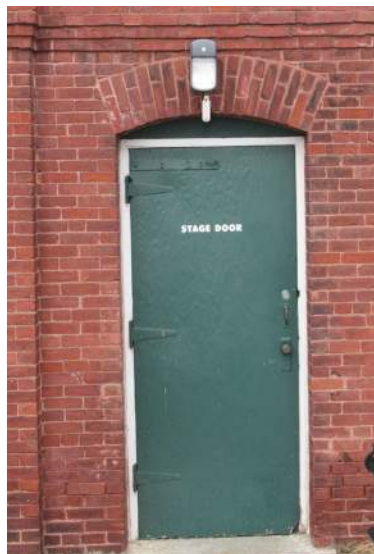
On the east side of the building there is a single door at grade that leads to the dressing rooms. It is labeled 'Stage Door'. This is a wood door with a wood frame. The door has been covered with a layer of plywood. The door is in poor condition. The frame is in fair condition.

Photo 54—Stage Door at east exterior wall

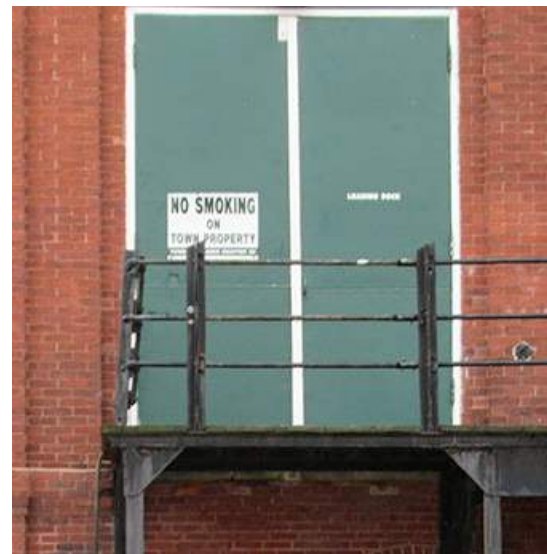
Photo 55—Loading Doors at east exterior wall, leading to stage

At the south end of the east side of the building there is a pair of doors at the top of the exterior stairs that leads to the back wall of the stage. It is labeled 'Loading Door'. These are wood doors with a wood frame. The doors have been covered with a layer of plywood. The doors are in poor condition. The frame is in fair condition.

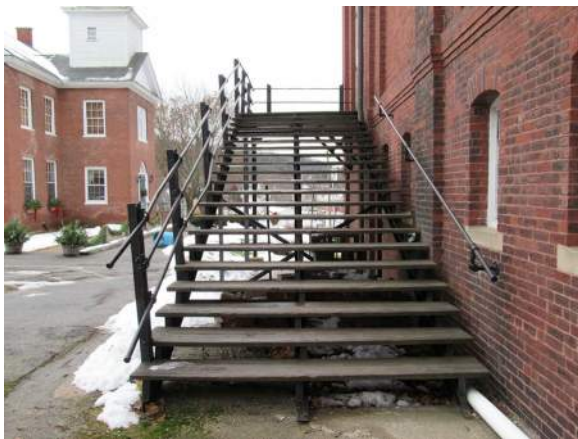
There is an exterior stairway on the east side of the building that leads up to the back of the stage. This is a steel structure with a nominal 2 inch wood deck and stair treads. These are in fair condition. The handrails are steel pipe supported on steel angle posts. The hand rail mounted to the wall and the guard and handrail at the open sides of the stair and landing are in poor condition and would not comply with current codes.

Photo 57— Exterior stair at east end of building looking south

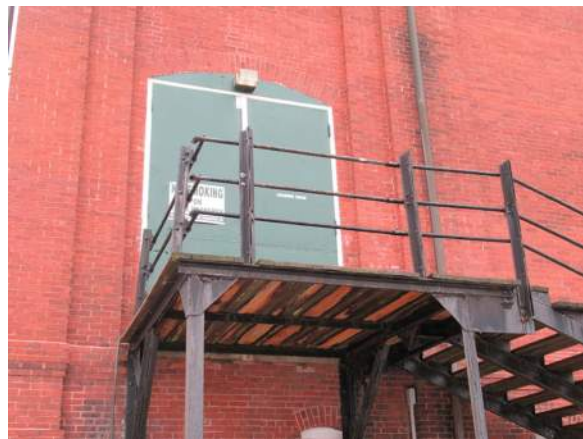
Photo 58— Exterior stair at east end of building looking west

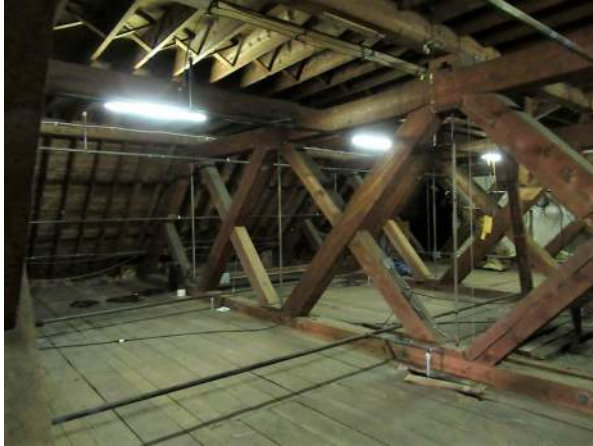
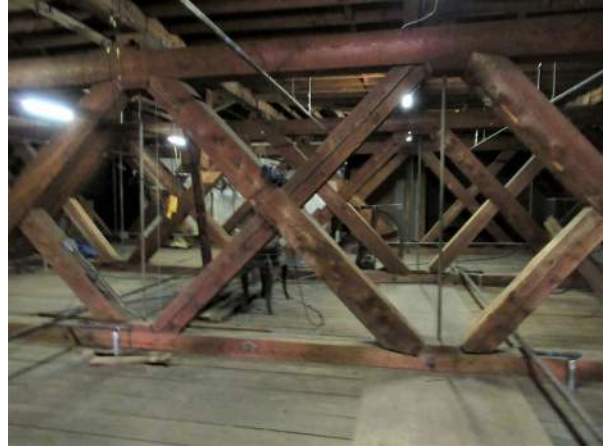
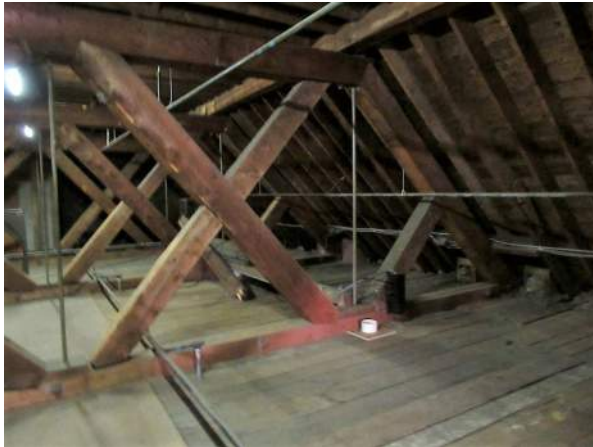
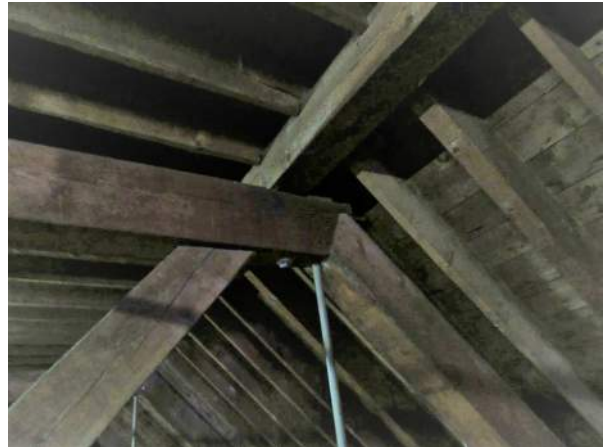
Overall the trusses are in good condition, there is some checking of individual timbers and some shrinkage in the length of some of the diagonal members. This has provided for some open joints between the diagonal members which are not in compression and the horizontal members.

I used a 4' long level and checked the bottom chords of the trusses in 12 locations. Over the 4' length the bottom chords varied from level to 1/4" out of level. Based on the age and span of these trusses that would be considered acceptable.

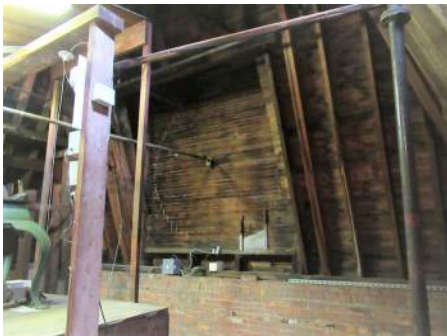
Photo 71—Roof of bell tower looking north

At the top of the masonry wall of the bell tower there are some minor open brick joints on the interior of the north east corner (see photo 71). No open joints can be seen on the exterior of the same area.

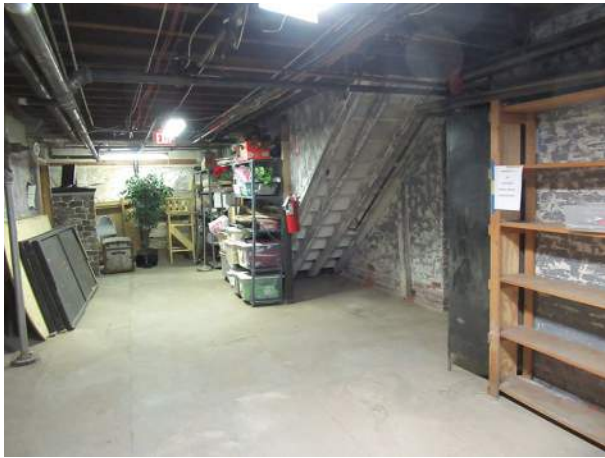
Photo 79 — West end of basement looking west.

- 3 - The stair stringers that support both stairs that run from the first floor lobby, at the west end of the building, to the basement need to be reinforced (see photo 79). This can be corrected by building a wood framed knee wall below the stringer at mid-span.

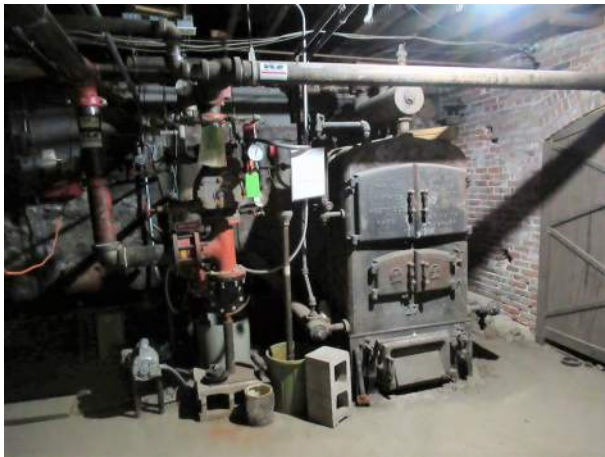
Photo 81 — North center of basement looking north, sprinkler system to left and old boiler (discontinued) at right.

SPRINKLER SYSTEM – The building is protected throughout by a sprinkler system that was install as part of the 1986 renovations. The sprinkler piping is threaded steel pipe. The main control valves for the system are located in north central area of the basement (see photo 81). The system is tested and inspected yearly by Vermont Life Safety LLC located in Bolton, Vermont.

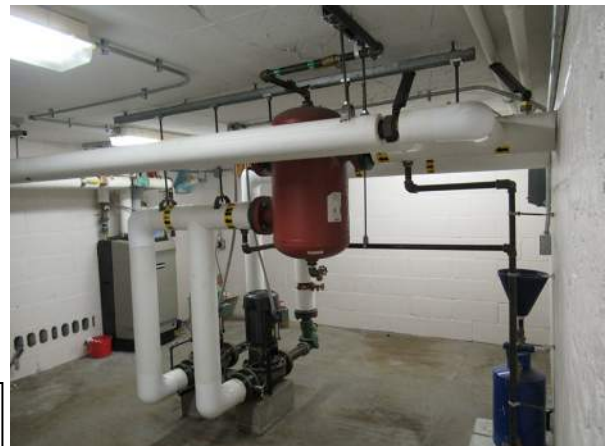
Photo 83 -Mechanical room looking west.

At the center of the basement is an interior room constructed of concrete masonry units. This is believed to have been constructed in the 1950's as a jail when the police department was housed within the building. This room is now used as a mechanical room (photo 83) for the courthouse. There is a concrete floor, exposed brick walls and piers and exposed wood framing above. This space seems adequate for its use.

Most of the first floor courthouse is heated with a propane fired boiler that is located in the basement mechanical room (see photos 83 & 146). The boiler, circulating pumps and expansion tank all appear to be recently installed and in good condition. This system has direct PVC vent that extend to the south wall (see photos 50 & 147). There is an underground propane tank located under the parking area to the south of the building.

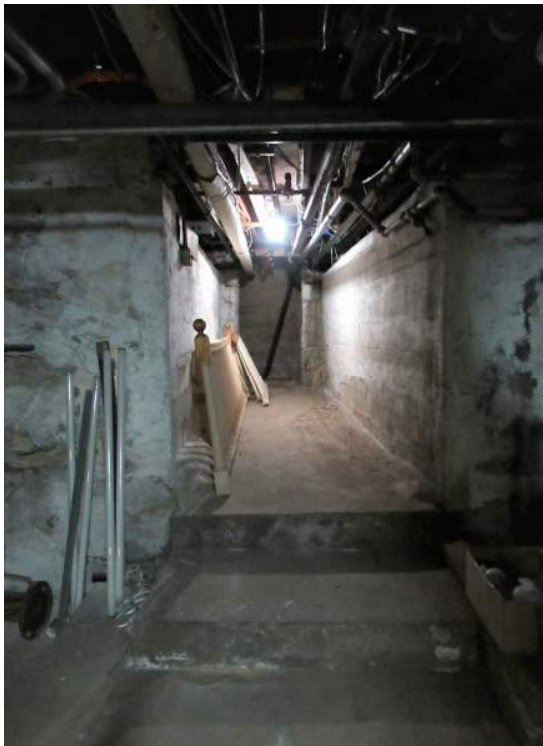
Photo 86 — East end of basement looking east. Ladder to first floor at end of hallway.

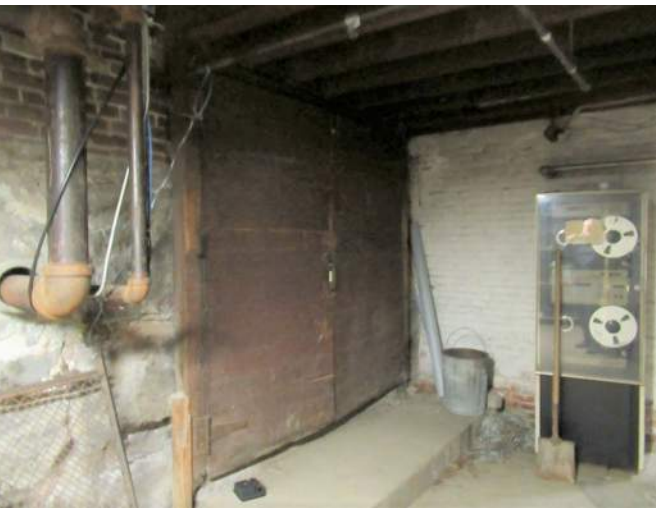
Photo 87 — Doors leading to bulkhead at south side of the building.

- 9 - The bulkhead door, frame and wood surround at the entrance to the basement on the south side of the building needs to be rebuilt (see photo 52). The large pair of doors inside the bulkhead at the basement also need to be rebuilt or repaired (see photo 87).
- 10 - If the downspouts are not extended and run underground as suggested in Item 2, the bottom of the downspouts should be examined verify they are sufficiently opened (see photo 156). The PVS receiving pipe need a bell type fitting so that the bottom copper downspout is not pinched too tightly.

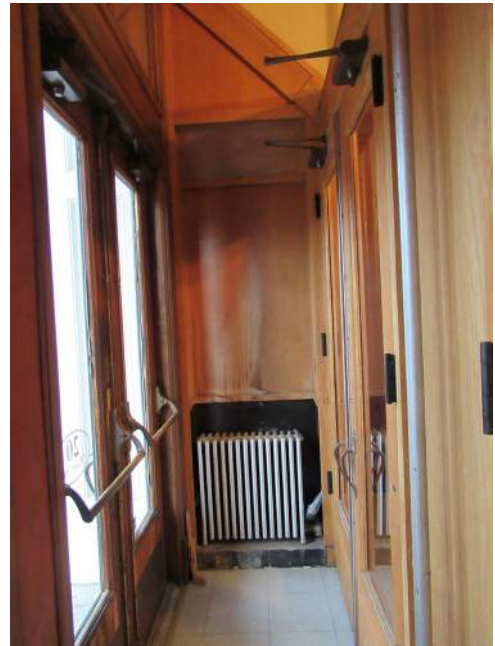
Photo 88—First floor vestibule looking north.

The main entrance for the opera house is on the west end of the first floor. Directly inside the main entrance doors is a small 3 feet wide air lock vestibule. This was part of the 1986 court house renovations. The finishes in the vestibule are in fair to poor condition.

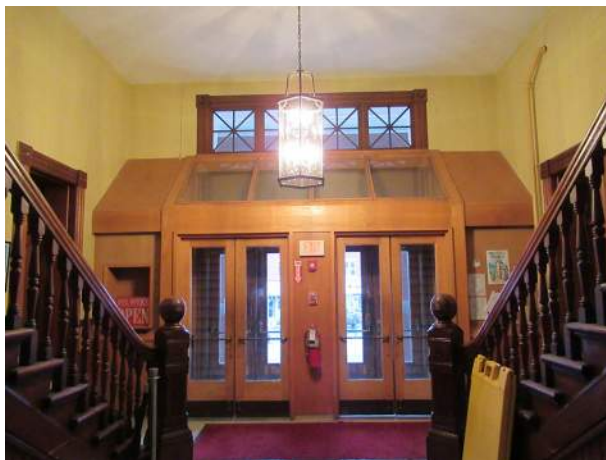
Photo 89—First floor lobby looking west at vestibule added in 1986.

building should be repaired and repainted (refinished on interior). There are 4 exterior doors (photo 32) and 4 vestibule doors (see photos 89). The hardware and weather-stripping on all of these doors should be replaced.

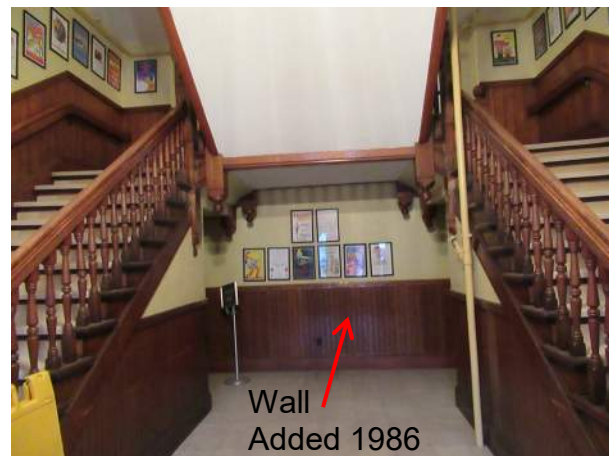
Photo 90—First floor lobby looking east.

This lobby and stair were last renovated in 2000, the walls have been repainted since then. The plaster walls and ceilings are in good condition. The woodwork at the stairway, the wood wainscoting, doors and frames are in good to fair condition. The floor tiles and stair tread coverings are in fair to poor condition.

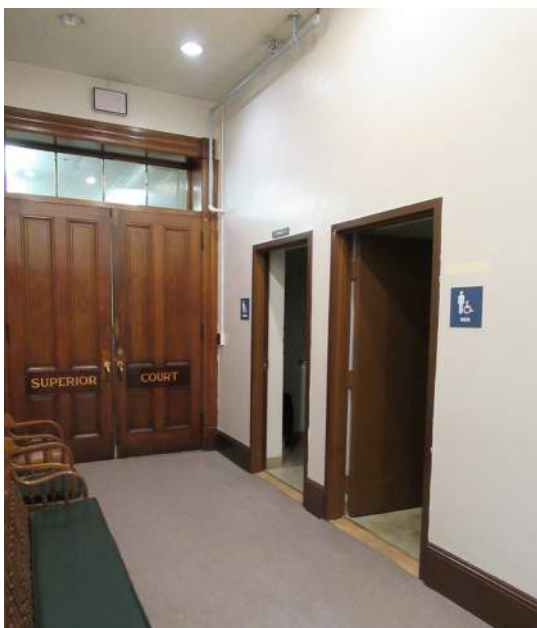
Photo 97—Interior hallway, looking west. Pair of doors are incorrectly labeled

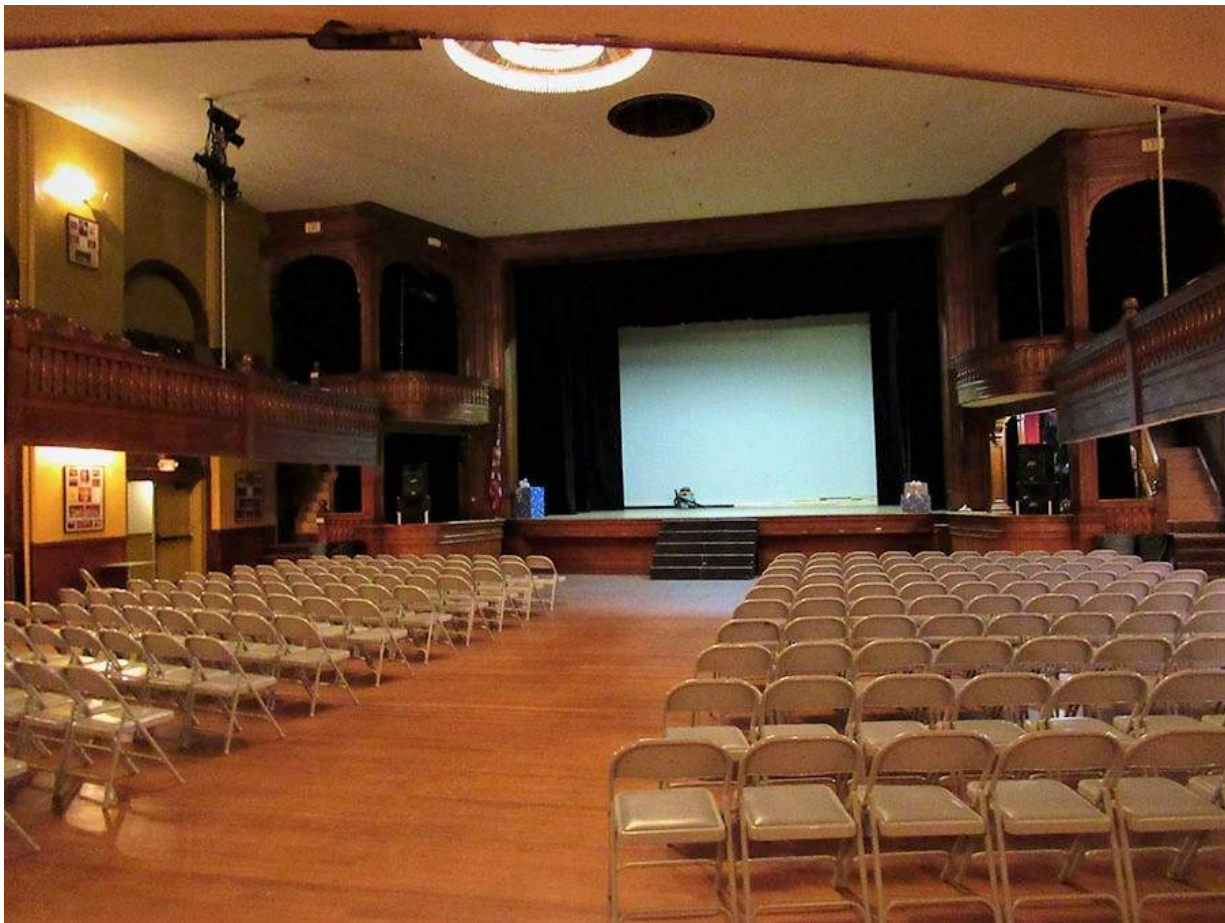
Photo 115—Opera House looking east.

The plaster walls and ceilings in the opera house were restored between 2003 and 2006, these are in good condition. Some of the woodwork including the wainscoting at the lower level were cleaned during that same time period. Other woodwork such as the window trim and the wood railing at the balcony were not cleaned at that time and have a heavy build up varnish like finish and needs to be cleaned.

The floor of the opera house is random length tongue and groove maple. The floor is poor condition. According to Ken Dennis the floor was refinished about every 5 years between 1995 and 2011. The floor was sanded to bear wood (not using a drum sander) and sealed with 3 coats of finish. In the years that it was not refinished, the floor was scuff sanded, not

down to bear wood, and three coats of sealer were applied. This process stopped in 2011 because the boards were thin to sand any further. A number of floor boards have crack in the surface of the tongue and groove edges.

- 16 - The maple flooring in the opera house and stage needs to be replaced (see photos 115, 125, 126, 127, 130, 131 & 132). We will need to determine whether to remove the existing maple floor or install over it.

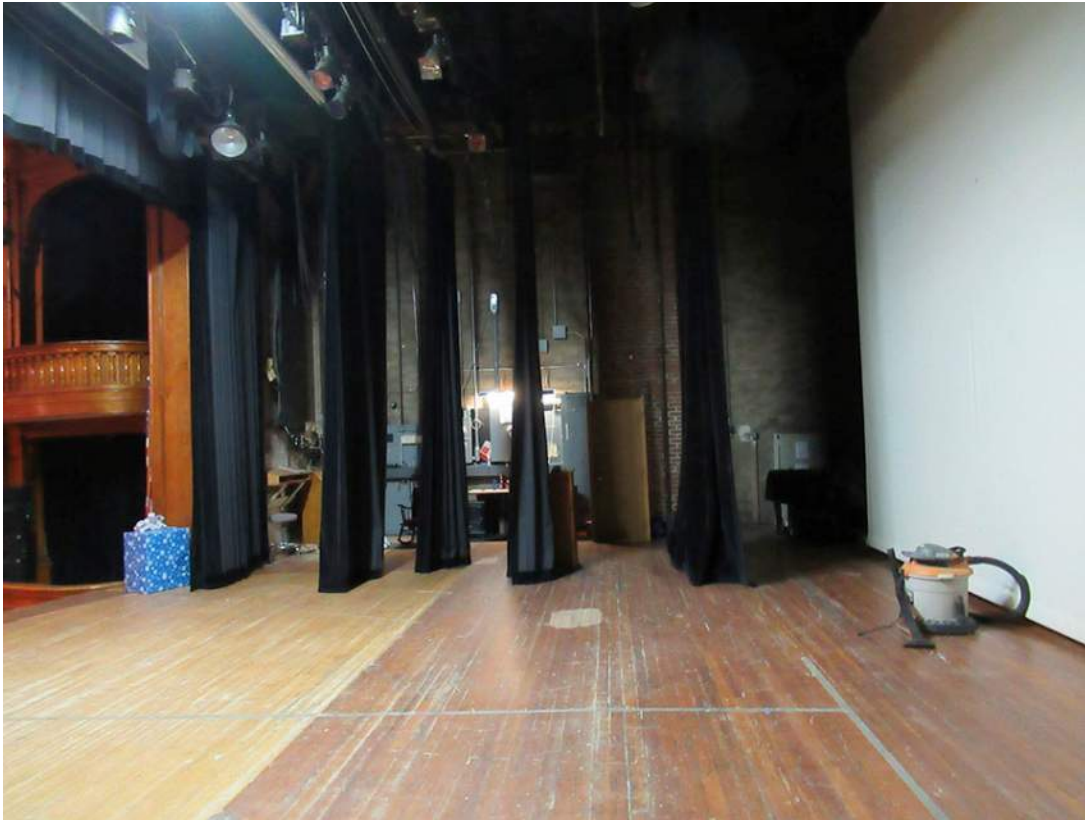
Photo 127—Stage, looking north.

The floor of the stage is a combination of the original floor (believed to be Douglas fir) and a portion along the west side of the stage that was previously replaced with maple strip flooring. The floors are in poor condition and need to be replaced.

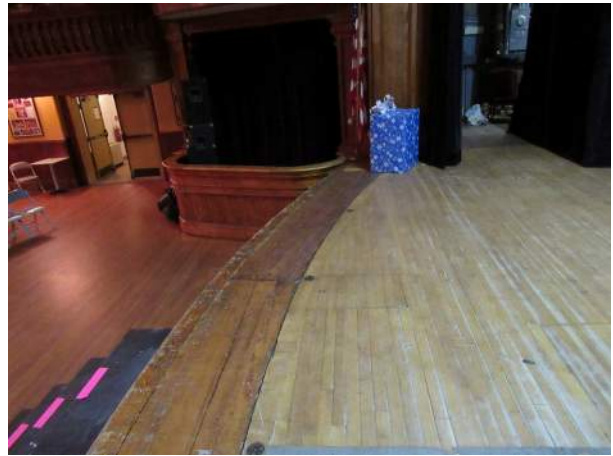
Photo 130— West edge of stage with light trough covered.

There is a recessed lighting trough along the west edge of the stage. This is covered with removable panels made of pine boards. These boards and the boards at the very edge of the stage are in poor condition. It does not appear that the lighting in this trough is functional.

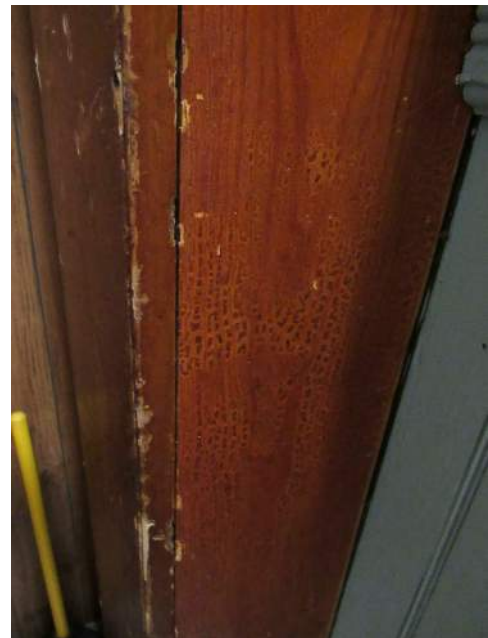
The original finish was most likely a shellac type finish, other types of finishes may have been applied over this. There are areas where the existing finish has alligatorated and some areas have crystalized.

Photo 133— Example of clear finish with has 'alligatorated'.

Some field test would need to be verify which cleaning methods work best. Assuming this is a shellac finish, these areas can be cleaned with a mild, biodegradable liquid dishwashing soap diluted in warm water. Areas that are 'alligatored' or have small cracks should be able to be repaired with denatured alcohol applied with a natural bristled brush. The alcohol should melt the surface of

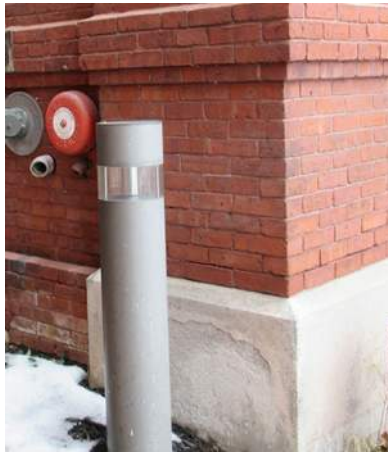
Photo 160—Limestone base at north west corner of building, looking south

- 14 – The face of some of the limestone trim and base units on the exterior of the building are deteriorating. In most conditions the face of the limestone has spalled off. If not corrected these areas will continue to deteriorate.

Based on available craftsmen, these can be repaired by consolidation, surface patching or by replacement.

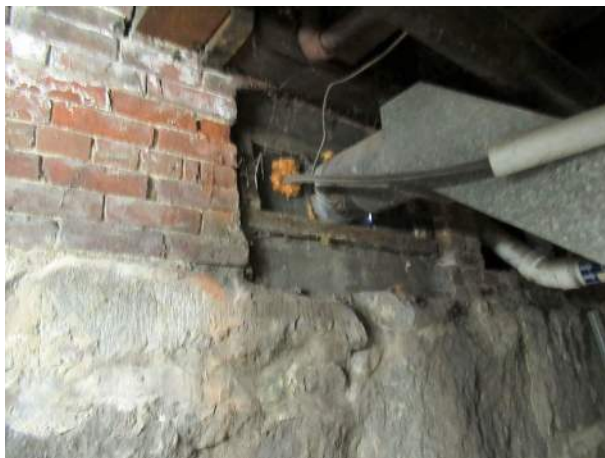
Photo 162—Top of exterior foundation wall in basement at south wall.

- 15 - There is some soft, loose or missing mortar in the brick joints at the base of the brick exterior walls. This is directly above the stone portion of the exterior foundation walls in the basement of the original portion of the building. These areas should be repointed.
