Building: Ambulance Building
 15 – 17 Meadow Road
 Newport, New Hampshire

Town of Newport, New Hampshire

Building Assessment | June 30, 2017

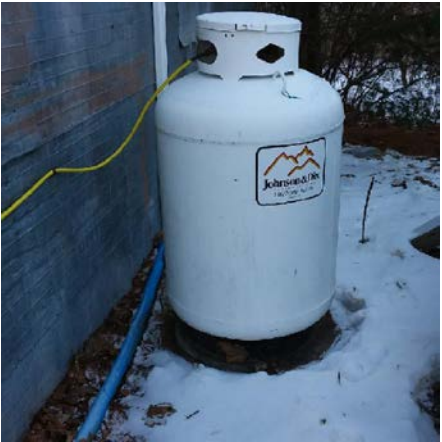
Mechanical							
Mechanical system appears to be inadequate to heat entire building due to the fact that there is electric baseboard heat in the office area. Bathrooms are adequate for current usage , however they do not meet ADA requirements.							
Equipment	Condition	Est. Remaining Service Life	Priority	Cost Estimate	Remarks & Recommendations	Photos	
169,100 pound tank Provides propane for generator.	2 Fully operational, 0-25% of life expectancy used, no issues, no concerns,

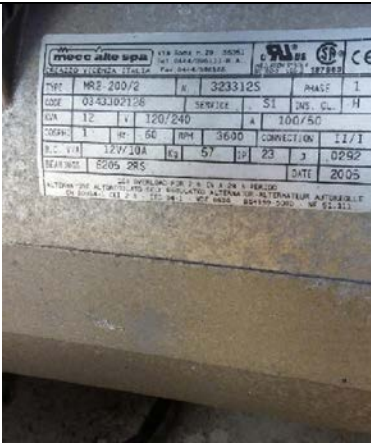
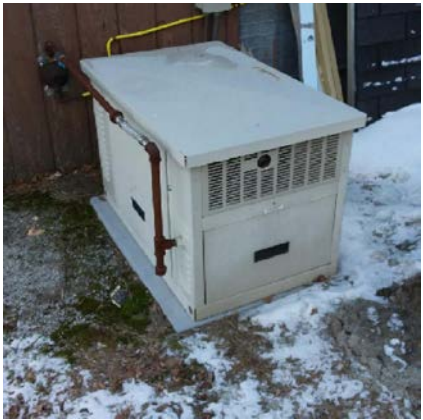
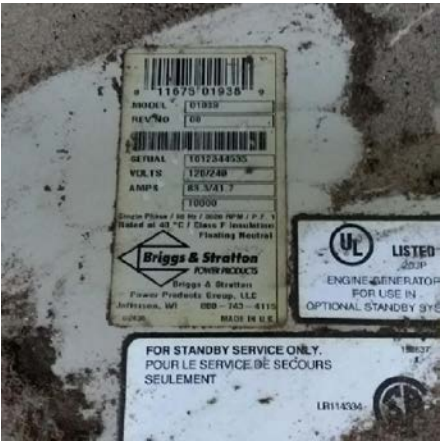
168,Briggs & Stratton 12 KW pad mounted generator Model: 01938 Installed in 2005	2 Fully operational, 0-25% of life expectancy used, no issues, no concerns,	15	10	\$8,000

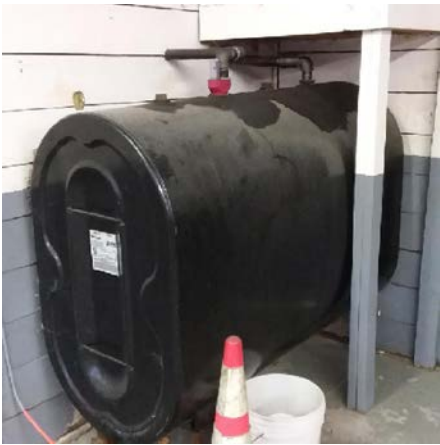
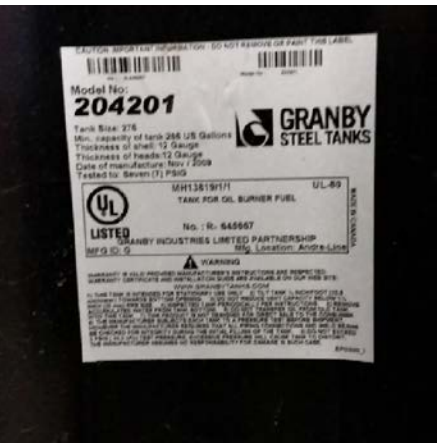
156,275 Gallon Fuel Tank	2 Fully operational, 0-25% of life expectancy used, no issues, no concerns,	15	10	\$2,000

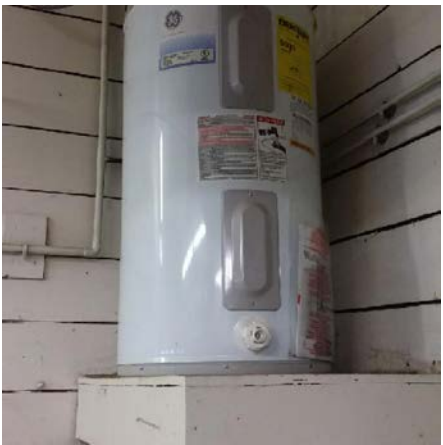
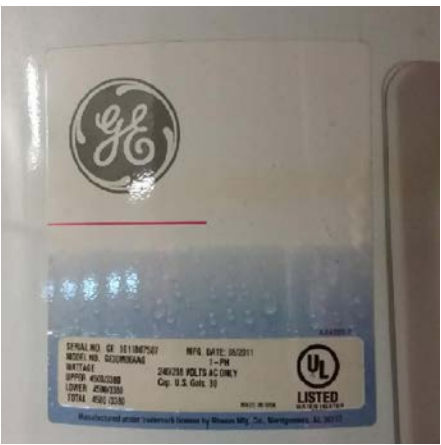
<p>155,30 Gallon Electric Water Heater</p> <p>MFG: 06/2011</p>	<p>2</p> <p>Fully operational, 0-25% of life expectancy used, no issues, no concerns,</p>	15	10	\$1,000

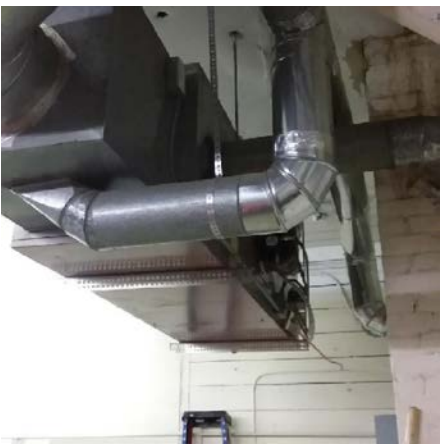
<p>154, Ceiling hung 138,000 BTU Oil-Fired Hot Air Furnace</p> <p>Make: Thermo Products</p> <p>Model: OT11-112</p>	<p>2</p> <p>Fully operational, 0-25% of life expectancy used, no issues, no concerns,</p>	15	10	\$8,000

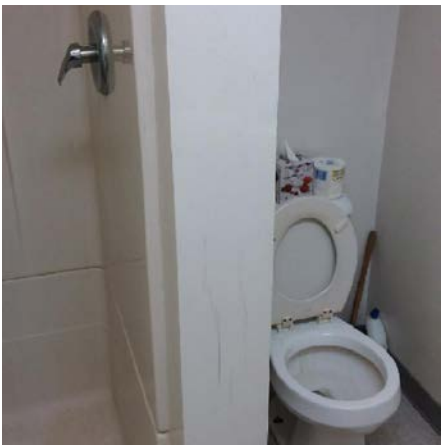
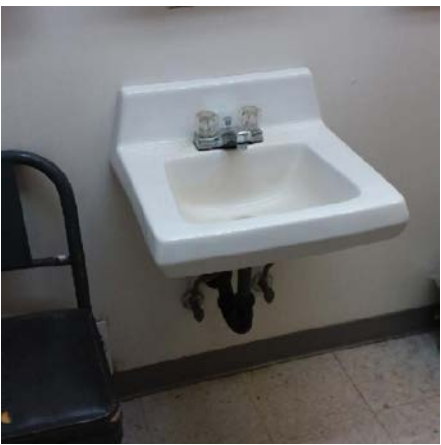
<p>157,Fixtures consist of floor mount tank type toilet and wall mount lavatory with manual dual handle faucet.</p>	<p>2</p> <p>Fully operational, 0-25% of life expectancy used, no issues, no concerns,</p>	15	10	\$1,000/ fixture

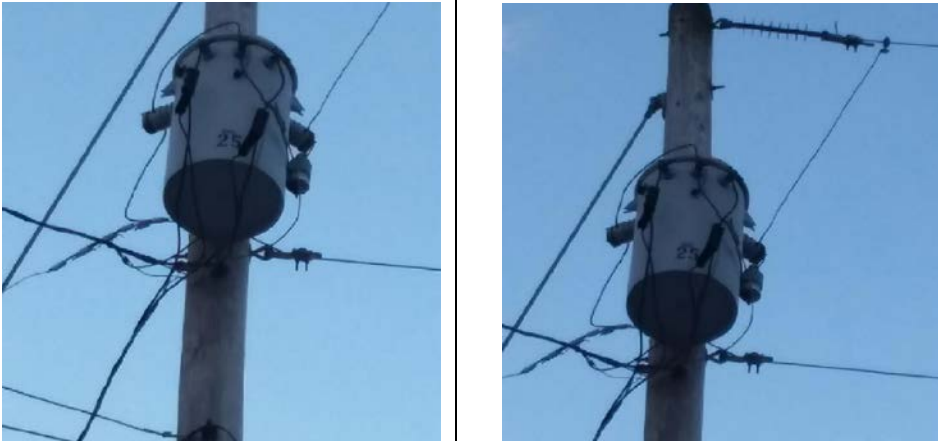
Electrical							
	Equipment	Condition	Est. Remaining Service Life	Priority	Cost Estimate	Remarks & Recommendations	Photos
	166,25 KVA pole-mounted transformer	2 Fully operational, 0-25% of life expectancy used, no issues, no concerns			By utility	Provides power to building through overhead service.

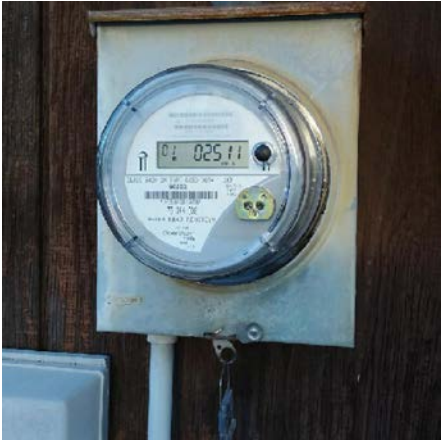
165,Meter is fed through overhead service	2 Fully operational, 0-25% of life expectancy used, no issues, no concerns,	15	10	\$250

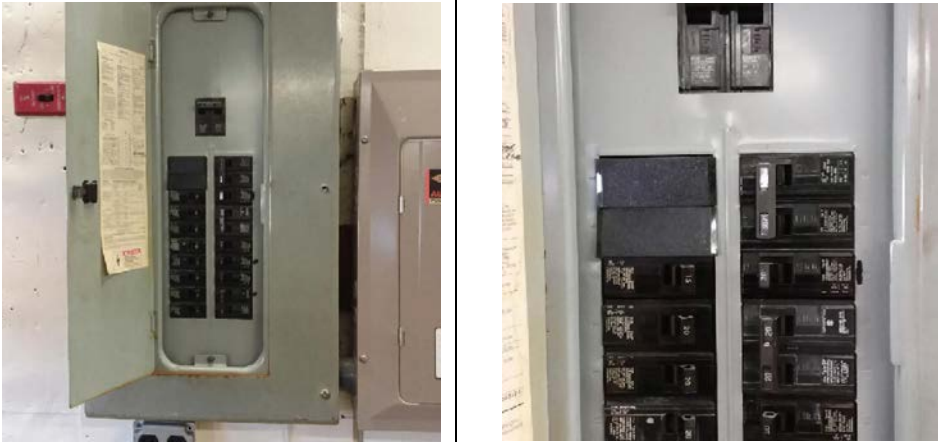
159,Electrical Panelboard – Main Distribution Panel	2 Fully operational, 0-25% of life expectancy used, no issues, no concern	15	10	\$1,000

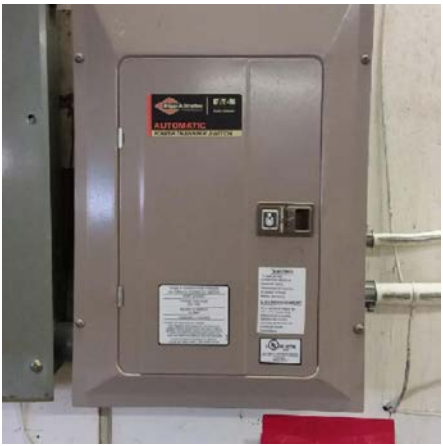
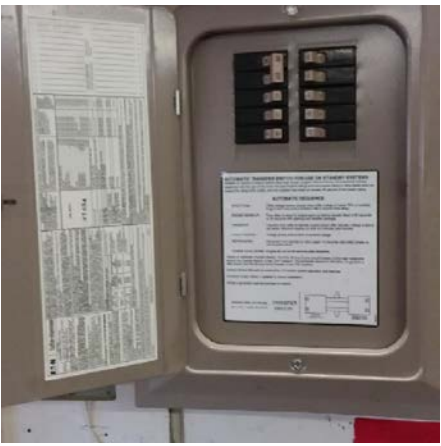
158, Generator Switchgear	2 Fully operational, 0-25% of life expectancy used, no issues, no concerns,	15	10	\$5,000
