Building: District Court
55 Main Street
Newport, New Hampshire

Town of Newport, Building Assessment July 31,2017

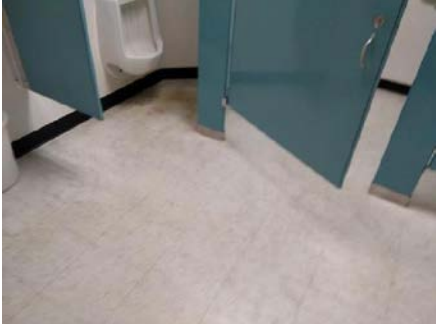
831,Floor VCT	5	0	1	\$1.45	Strip and wax all VCT.

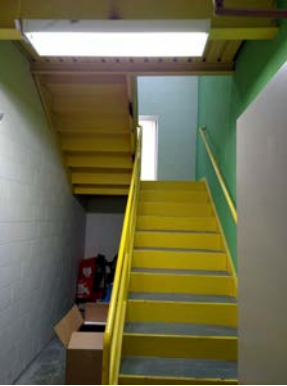
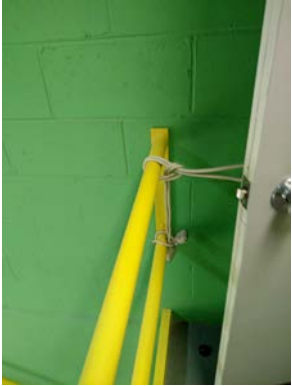
147,Code					One stair from second floor , no storage in stairwell, door should not be held open.

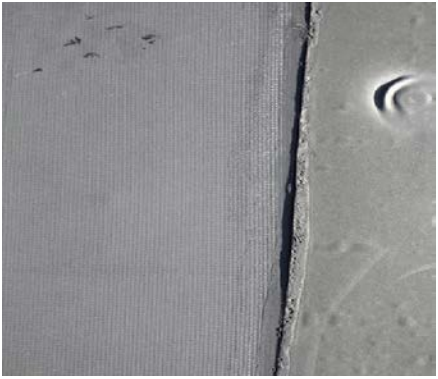
823,Rubber Roof					Remove unused rooftop equipment when replacing roof.

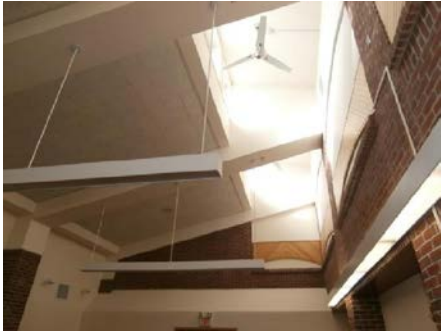
131,Composite Floor					Second floor: Cast-in- place concrete slab on cold-formed, composite steel deck, supported on structural steel framing. Typical beam spacing 7' +/- o.c. (for info only)		
	130, Rafters					One-story pitched roof area over courtroom and rear of building: Rolled steel beam rafters running down the slope with 2X10 @ 24" framing across slope. (for info only)

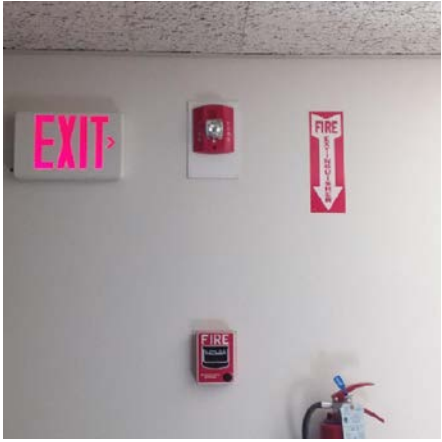
equipment	condition	Est remaining Service life	priority	cost	remarks &recommendations		
	550, Exit sign	1 Fully operational, new, recently replaced	20 Years	10	\$400 each location	Horn strobe light device, pull Station typical at all exits. Appears to be in working order.

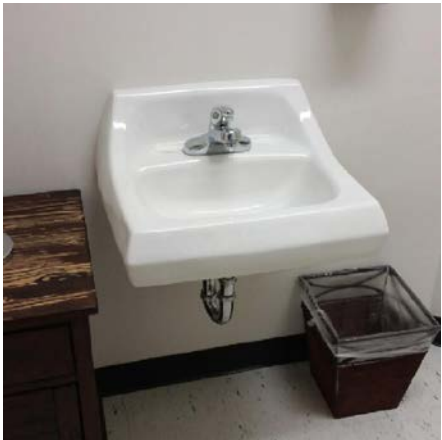
549,Floor mounted tank type toilet Wall mounted lavatory single valve faucet	3 Fully operational, 25-50% life expectancy used, periodic problems	10 Years	10	\$1,000 per fixtures	Fixtures are not the water conserve type.

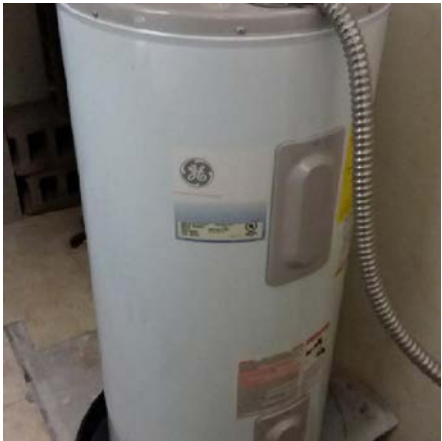
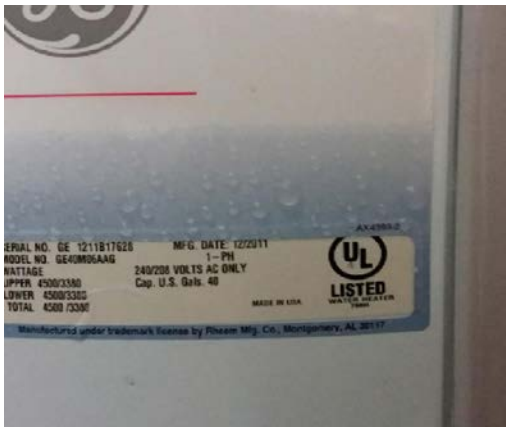
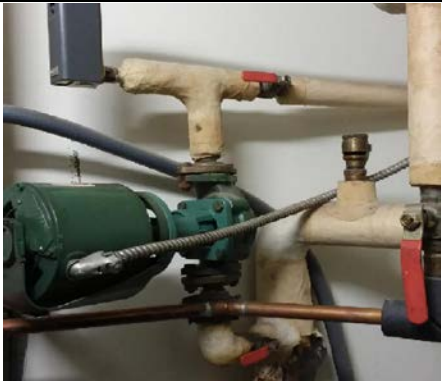
equipment	condition	Est remaining Service life	priority	cost	remarks &recommendations		
	545,40 Gallon Electric Water Heater Model GE 40068 G Installed 2011	2 Fully operational, 0-25% life expectancy used, no issues, no concerns	15 Years	10	\$1,500	Domestic hot water is recirculated through TACO inline recirculation pump.

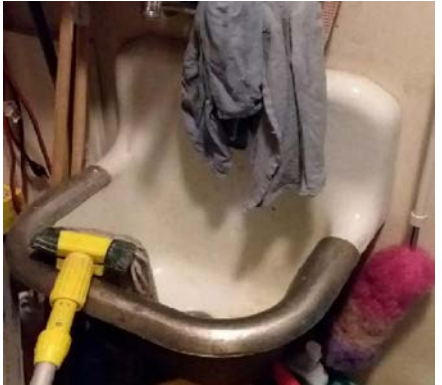
555,Wall mount slop sink typical of 2	3	10	10	\$1,000

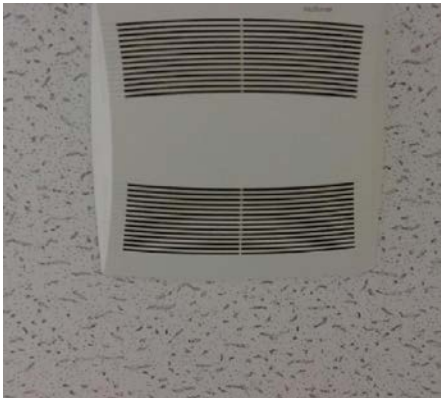
539,Ceiling-mounted NuTone bathroom exhaust fan	2 Fully operational, 0-25% life expectancy used, no issues, no concerns	15 Years	10	\$500	Vented through side wall typical for men's and women's bathroom.

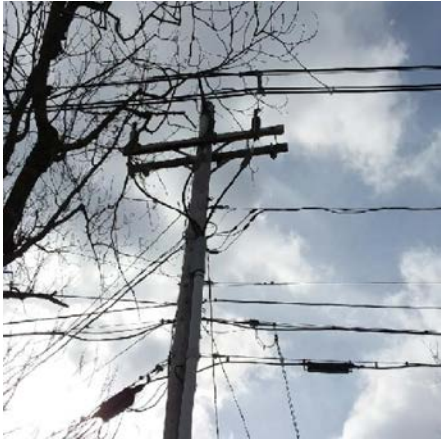
equipment	condition	Est remaining Service life	priority	cost	remarks &recommendations		
	570, 3 Phase Electrical Service underground to building	2 Fully operational, 0-25% life expectancy used, no issues, no concerns	15 Years	10	\$25,000	Transformer is interior of building.

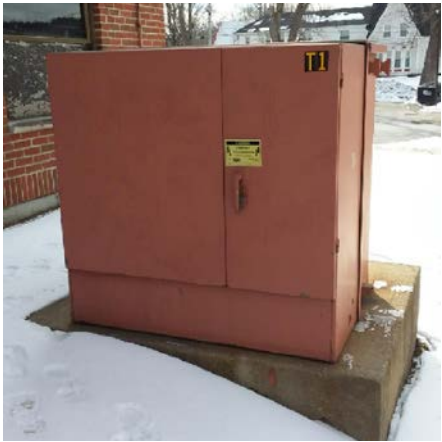
569,Pad Mount Transformer	2 Fully operational, 0-25% life expectancy used, no issues, no concerns	15 Years	10		Maintained by utility

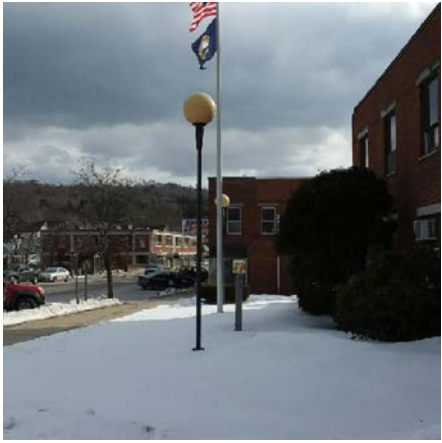
568,Exterior Lighting control by timer switches	3 Fully operational, 25-50% life expectancy used, periodic problems	10 Years	10	\$500 each	Typical on exterior of building.

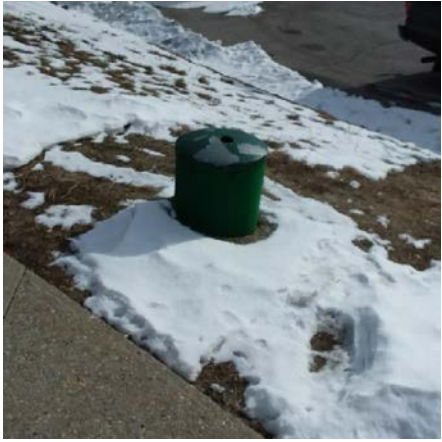
equipment	condition	Est remaining Service life	priority	cost	remarks & recommendations		
	567,1000 - Gallon buried LP tank.	2 Fully operational, 0-25% life expectancy used, no issues, no concerns	15 Years	10	\$10,000

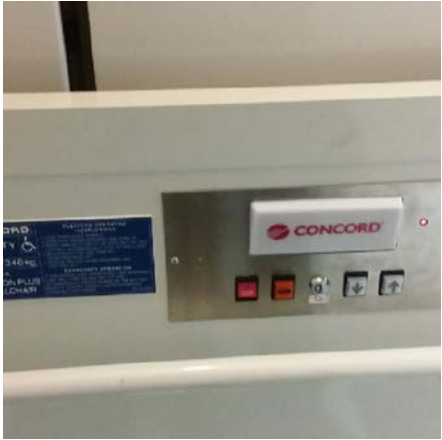
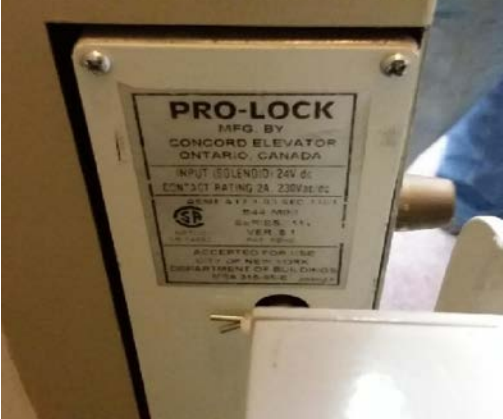
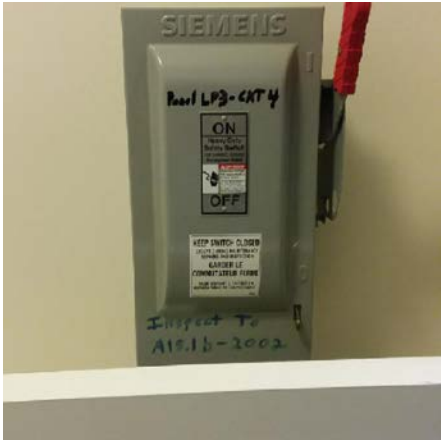
561,750 - Pound Capacity Electric wheelchair elevator	2 Fully operational, 0-25% life expectancy used, no issues, no concerns	15 Years	10		Typically renovated every 20+ years, not replaced

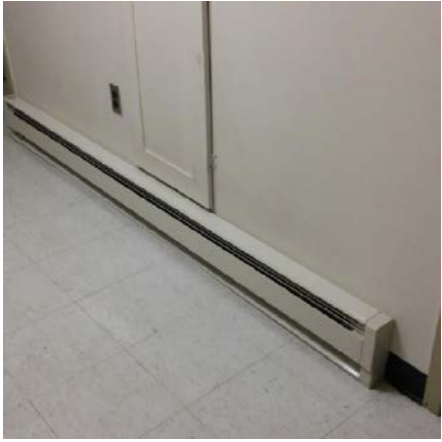
equipment	condition	Est remaining Service life	priority	cost	remarks &recommendations		
	559,544,8 - Foot and 4 – Foot strip of electrical radiation baseboard	2 Fully operational, 0-25% life expectancy used, no issues, no concerns	15 Years	10	\$600 each	Controlled by wall mounted thermostat. Typical throughout building.

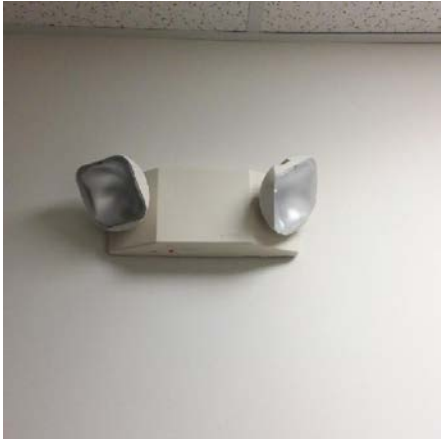
558,Wall mounted emergency lighting with battery backup	2 Fully operational, 0-25% life expectancy used, no issues, no concerns	15 Years	10	\$300 each	Typical throughout Building.

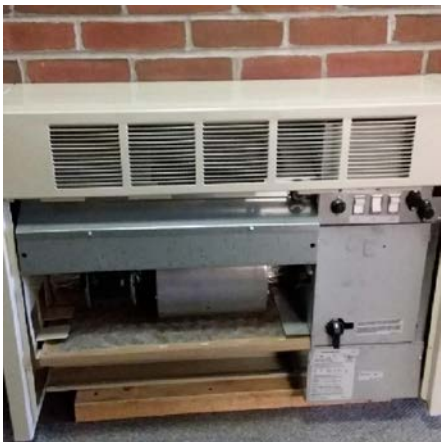
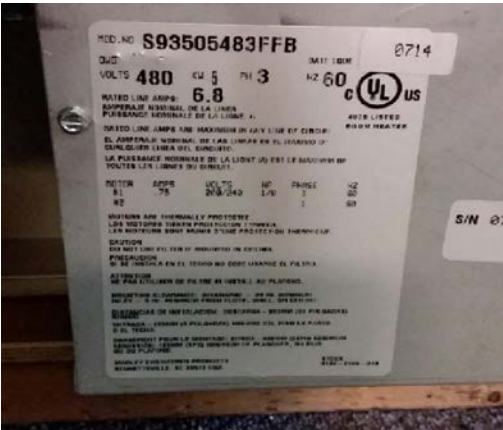
541, Floor mount 480 Volt 5 KW electric cabinet heaters	2 Fully operational, 0-25% life expectancy used, no issues, no concerns	15 Years	10	\$600	Typical of entry vestibules throughout building.

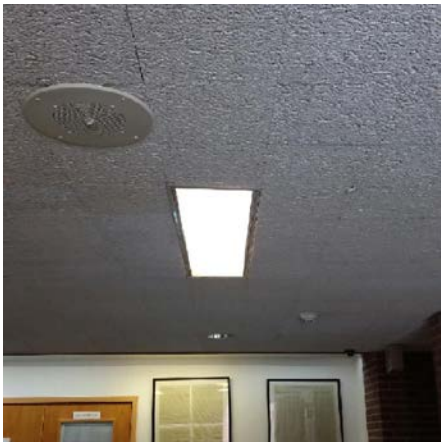
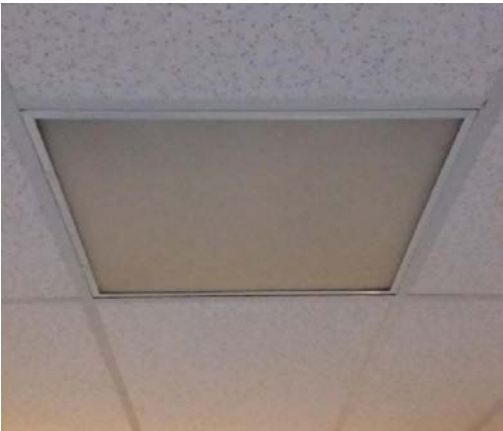
540,1x4 Foot and 2x2 Foot 277 - Volt Fluorescent lighting fixtures	3 Fully operational, 25-50% life expectancy used, periodic problems	10 Years	10	\$300 each	Typical throughout building.

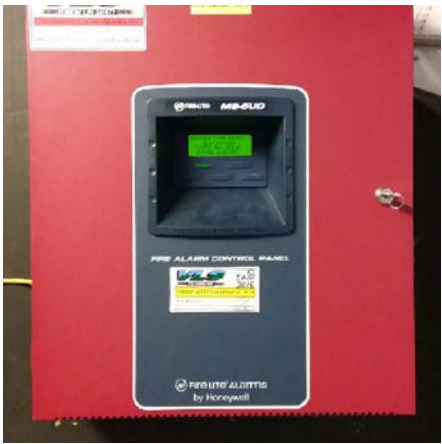
equipment	condition	Est remaining Service life	priority	cost	remarks & recommendations		
	536, Fire Alarm Control Panel	1 Fully operational, new, recently replaced	25 Years	10	\$3,000	Fire Alarm Control Panel is dispatched to the police station which is the Central Dispatch Center. Installed in 2013.
