Building: Fire Station  
11 Sunapee Street  
Newport, New Hampshire

Town of Newport, Building Assessment July 31,2017

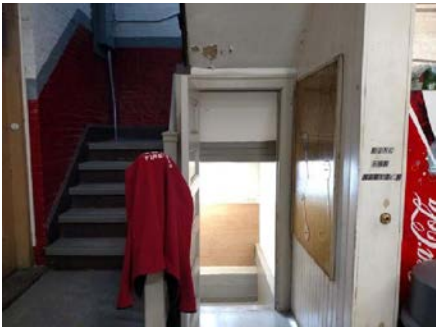
| | equipment | condition | Est remaining<br>Service life | priority | cost | remarks &recommendations | | |
|--|---|---|---|---|---|---|---|---|
| | 737,Code Issue: | 5 | | 1 | \$60,000 | Basement is accessed by<br>non-compliant fire stair<br>which is not rated. It has<br>open doors and exits into<br>the apparatus bay, with a<br>second egress up a few<br>steps and out an alley. All<br>at the same end of the hall.<br>This is not a good<br>situation for the staff and<br>there should be no public<br>meetings in this hall. | | |

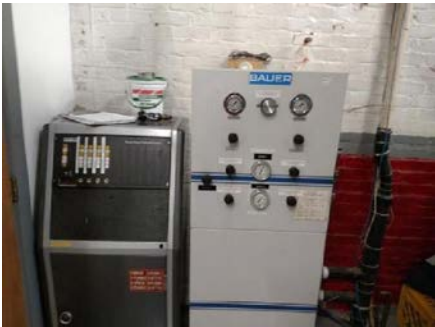
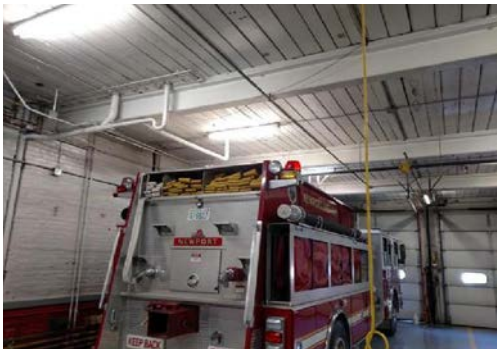
| | equipment | condition | Est remaining<br>Service life | priority | cost | remarks &recommendations | | |
|--|---|---|---|---|---|---|---|---|
| | 735,General Comment: | | | | | EXTREMELY TIGHT clearances everywhere, eventually may not be able to special order apparatus that will fit in ceiling height. Additionally, expensive equipment is in the open with exposure to damage.<br>While they have made the most of limited space, in a fire, the lack of space must hinder response time. | | |

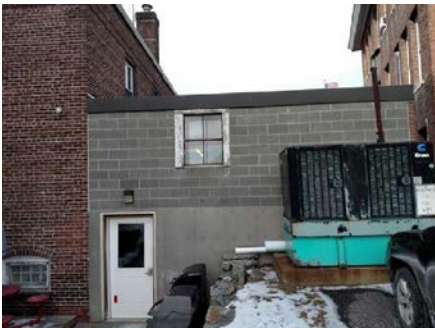
| | equipment | condition | Est remaining<br>Service life | priority | cost | remarks &recommendations | | |
|--|---|---|---|---|---|---|---|---|
| | 732,ADA | | | | | Main entrance and<br>quickest exit from stair<br>does not meet ADA<br>requirements. Only<br>ADA entrance is thru the<br>apparatus apron and then<br>there are no toilets or<br>vertical transport to the<br>second floor. | | |

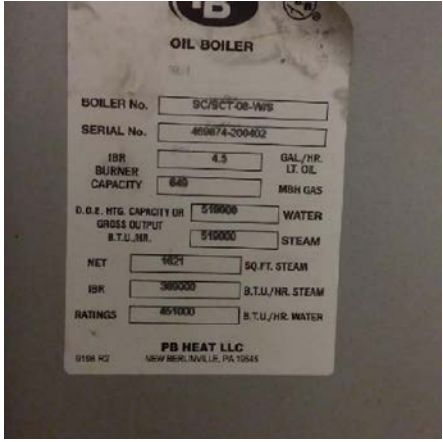
| | equipment | condition | Est remaining<br>Service life | priority | cost | remarks & recommendations | | |
|--|---|---|---|---|---|---|---|--|
| | 36, 389,000 BTU Oil Fired Boiler<br><br>Model: Kingsley SC-08 | 3<br>Fully operational, 25-50% life expectancy used, periodic problems | 10 Years | 10 | \$7,500 | Produces steam to heating terminals and domestic hot water throughout building.<br><br>Domestic hot water is circulated by 2 - TACO circulator pumps.<br><br>Boiler is atmospherically vented two adjacent chimneys.<br><br>Recommend continue annual cleaning. | | |

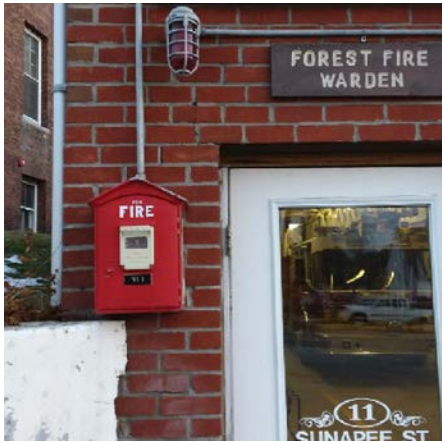
| | Equipment | Condition | Est. Remaining<br>Service Life | Priority | Cost Estimate | Remarks & Recommendations | | |
|--|---|---|---|---|---|---|---|--|
| | 58,Fire Alarm Game Well Pullstation<br><br>Box 911 | 2<br>Fully operational, 0-25% life expectancy used, no issues, no concerns | 15 Years | 10 | \$10,000 | | | |

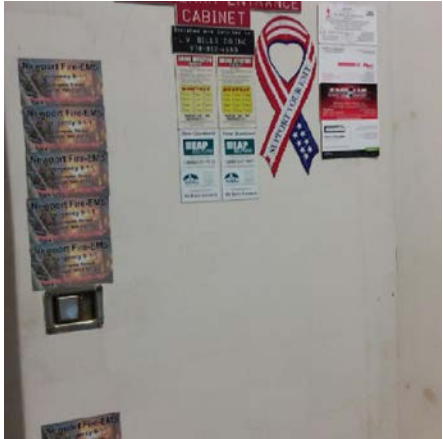
| | equipment | condition | Est remaining<br>Service life | priority | cost | remarks & recommendations | | |
|--|---|---|---|---|---|---|---|--|
| | 54, Fire Alarm Cabinet | 1<br>Fully operational,<br>new, recently<br>replaced | 20 Years | 10 | \$5000 | | | |
