Building: Horsey Bath House  
Meadow Street  
Newport, New Hampshire

Town of Newport, Building Assessment July 31,2017

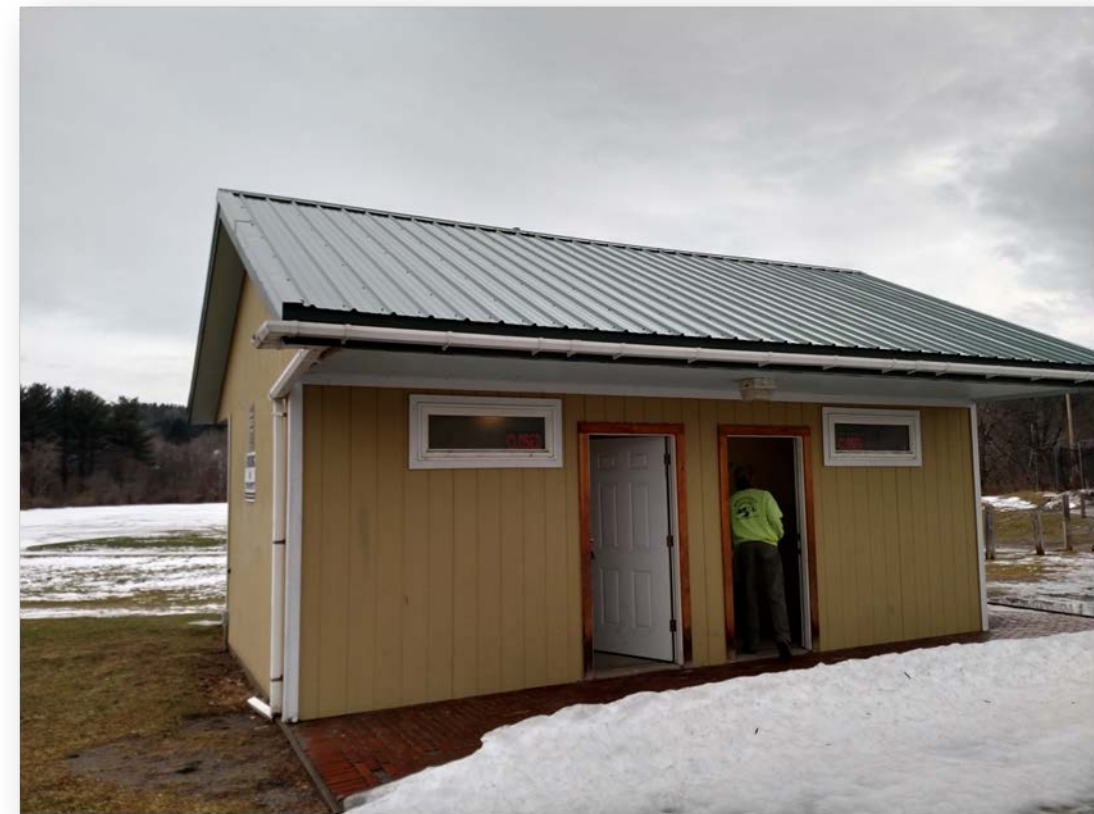
| Architectural | | | | | | | |
|---|---|---|---|---|---|---|---|
| | 682, Exterior Note: | 1 | 8 | 10 | \$2.50 Sq.ft.<br><br>\$15.00 lineal ft. For PVC skirt board | T-111 siding in good repair. Will need 12" removed eventually with the addition of synthetic surface. | |
