Town of Newport, New Hampshire
Building Assessment | July 31, 2017

Building: Opera House
 20 Main Street
 Newport, New Hampshire

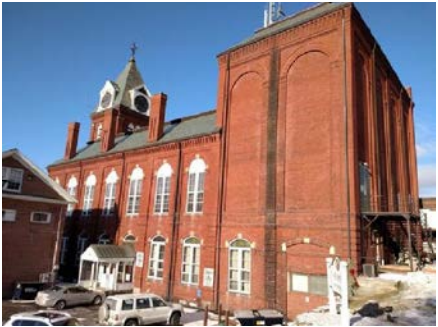
904,Brick	1	50+	9	\$1.50 sq.ft.	Brick could use a cleaning in the future.

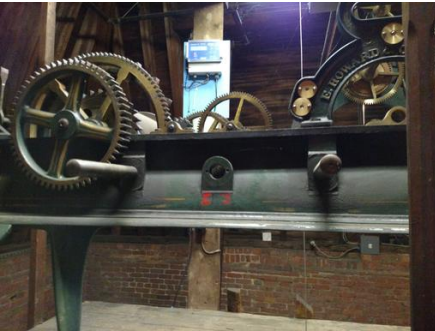
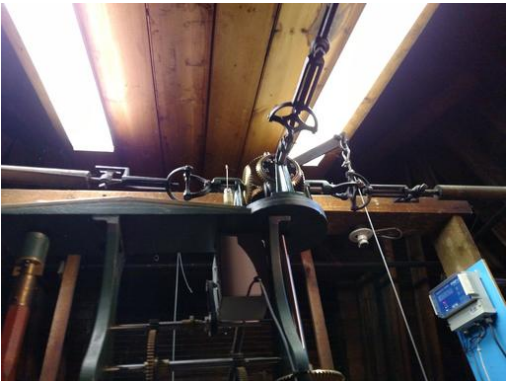
853,General Note	1	50+	10		Great clock system that has been converted to power.

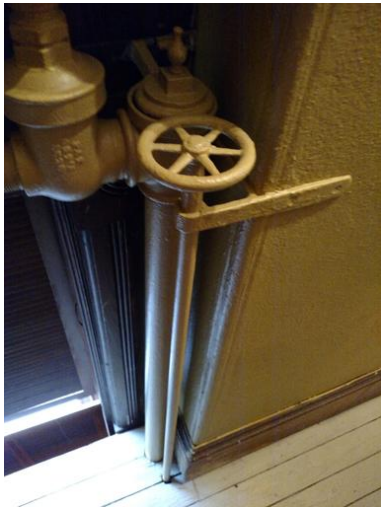
908, Item of Interest					part of the original fire hose system this wheel on the balcony traveled to the main floor and turned on the water

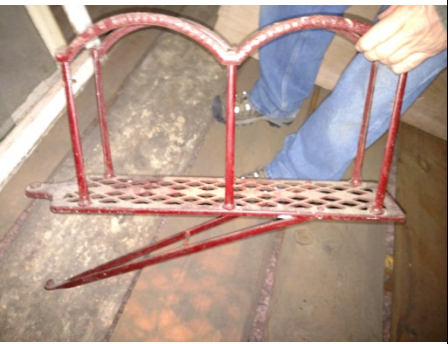
849, Salvage					Ken and staff have been good in storing original removed parts in the attic,. I cannot stress enough that this practice is important any thing removed and not needed should be archived for

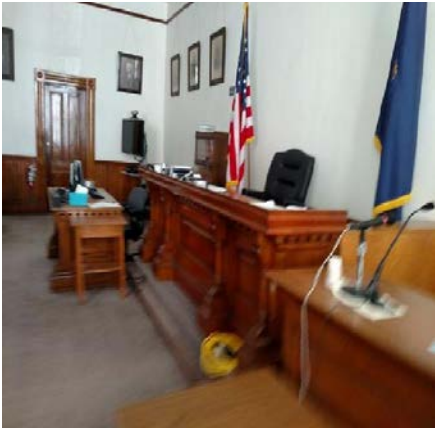
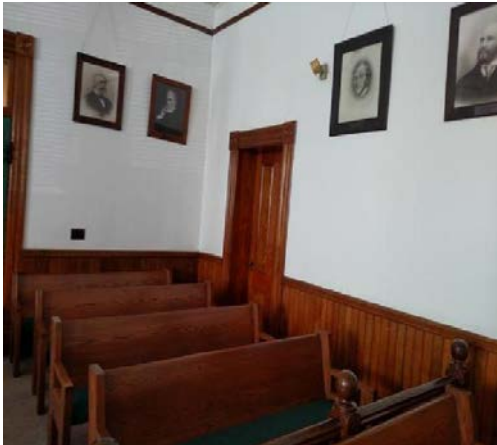
equipment	condition	Est remaining Service life	priority	cost	remarks & recommendations		
	902,General Comment:					Some really significant historical trim and furniture still remain. As mentioned elsewhere, Ken and staff have grabbed and saved parts that have been removed. Make sure this tradition is carried on if any original part, trim, door, glass or furniture, etc. is removed for modernization, store it in the attic or basement.

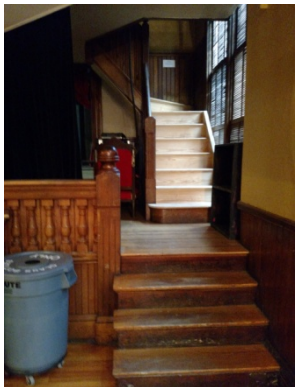
907, Stair					Kudos to Ken and team in rebuilding this stair to look exactly like the original

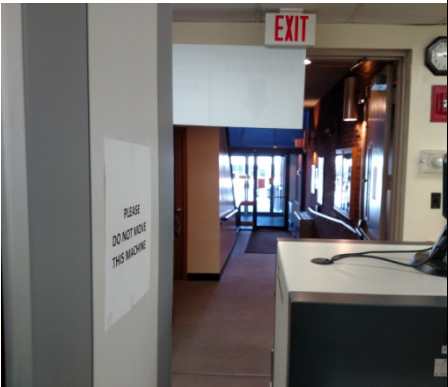
876,ADA Issues:					ADA ramp and elevator are within the superior court lease space. Potential conflict to hall for access during the day.

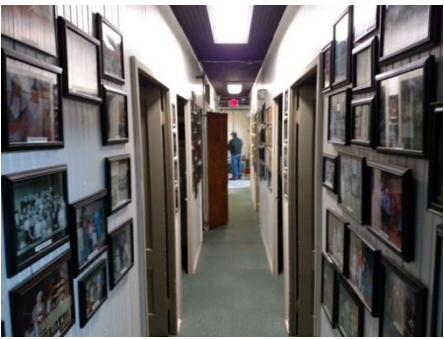
850, Law					dressing rooms do not meet ADA and potentially have longer than allowed dead end corridors, keep all emergency lighting, detectors and pull stations up to date, area overheats and suggest steam pipes that travel thru rooms be insulated for energy savings and safety

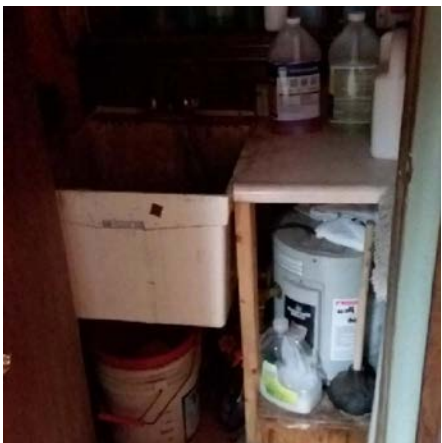
268,Slop Sink	3 Fully operational, 25-50% life expectancy used, periodic problems	15	10	\$1,000 per fixture

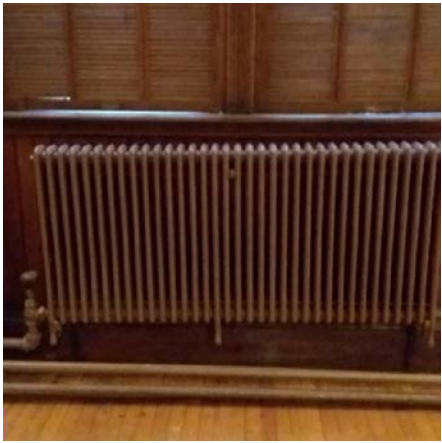
equipment	condition	Est remaining Service life	priority	cost	remarks &recommendations		
	265,266Steam Radiators	3 Fully operational, 25-50% life expectancy used, periodic problems	**			**Many more years if maintained. Floor mount steam radiators under all windows provide heat for multipurpose hall. Typical throughout building. Recommend annual inspection.

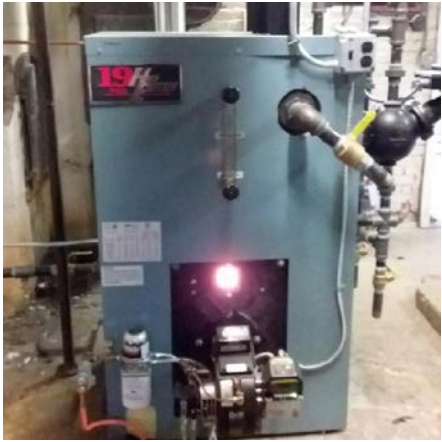
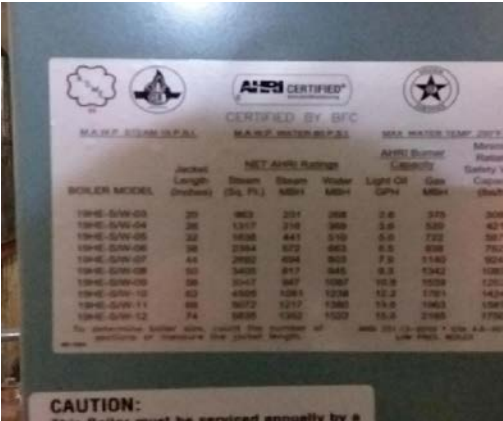
600,Smith Model# 19HE-S/W04 316,000 BTU oil fired boiler Installed 2/20/17	1 Full operational, new, recently replaced	30 Years	10	\$20,000	Final installation and commissioning was taking place during our visit.

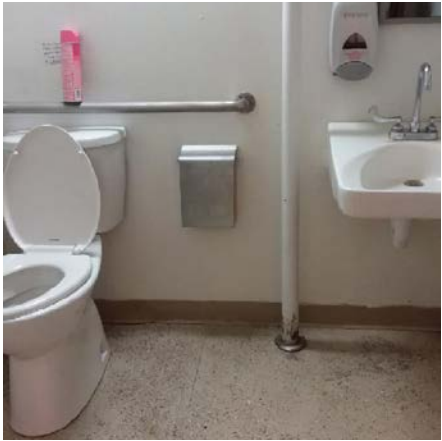
289,Floor mount tank type toilet, wall mount lavatory dual handle faucet typical	2 Fully operational, 0-25% life expectancy used, no issues, no concerns	15 Years	10	\$1,000 per fixture	This bathroom serves the public for the superior court and appears to be ADA Compliant.

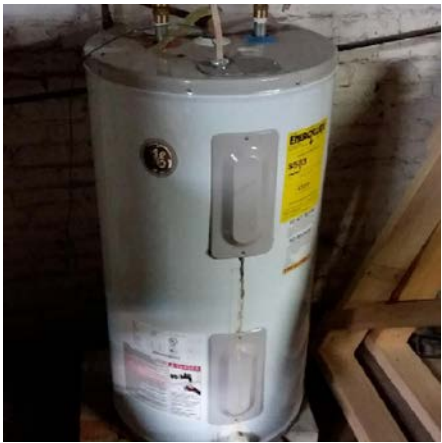
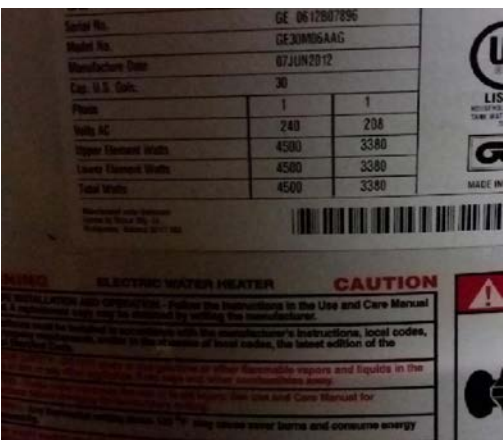
275, Model- GE30M06AAG 30 Gallon Electric water heater Installed 10/25/12	2 Fully operational, 0-25% life expectancy used, no issues, no concerns	20 Years	10	\$2,000	Provides domestic hot water throughout building except backstage dressing room area bathroom.

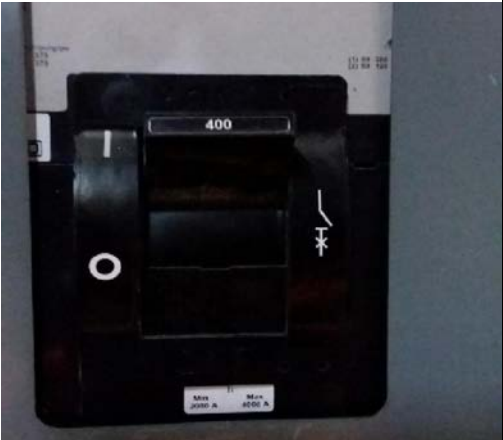
285,120 / 240 volt 400 AMP surface mount panelboard	2 Fully operational, 0-25% life expectancy used, no issues, no concerns	20 Years	10	\$8,000
