Building: Opera House
 20 Main Street
 Newport, New Hampshire

Town of Newport, Building Assessment July 31,2017

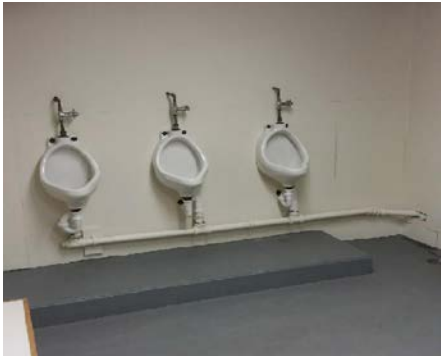
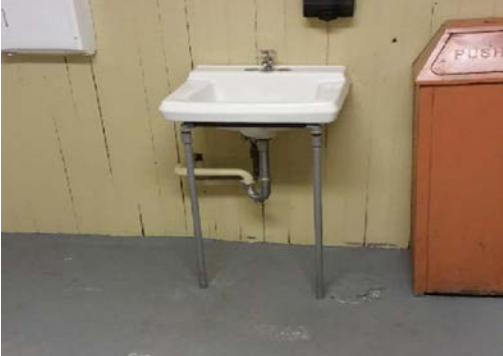
279,Floor mounted tank type toilets, wall mounted lavatories with single handle faucets, wall mounted urinals with single handle flush valves and exposed waste piping	3 Fully operational, 25-50% life expectancy used, periodic problems	5 Years	6	\$1,000 per fixture	Typical for bathrooms in lower level below multipurpose hall. Fixtures are not water conservation type.
