# Town of Newport, New Hampshire

## Building Assessment | July 31, 2017

Building: Pine Grove Cemetery  
6 Sunapee Street  
Newport, New Hampshire

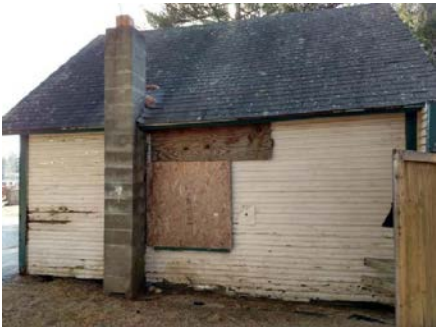
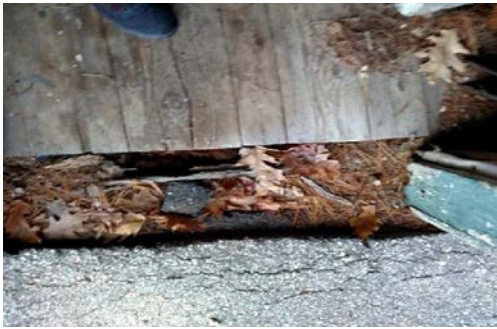
| | equipment | condition | Est remaining<br>Service life | priority | cost | remarks & recommendations | | |
|--|---|---|---|---|---|---|---|---|
| | 815,Exterior Note: | 5 | | | | Building was built on the<br>ground or stones that have<br>vanished, this can be fixed<br>but will be expensive. | | |

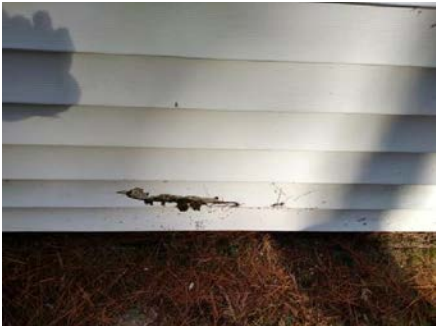
| | equipment | condition | Est remaining<br>Service life | priority | cost | remarks & recommendations | | |
|--|---|---|---|---|---|---|---|---|
| | 810, Exterior Note: | 5 | 2-5y | 6 | \$250 | Repair rot in frame. | | |

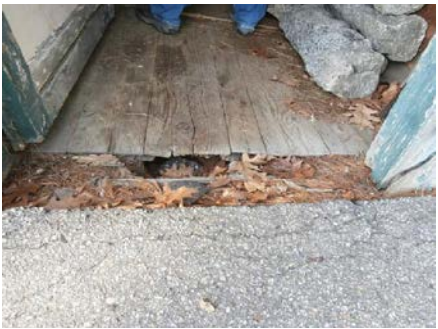
| | equipment | condition | Est remaining<br>Service life | priority | cost | remarks & recommendations | | |
|--|---|---|---|---|---|---|---|--|
| | 886,Floor Framing | | | | | Floor framing is rotted and collapsing along north wall and at east side entry door. | | |
