Building: Police Station  
59 Main Street  
Newport, New Hampshire

Town of Newport, Building Assessment July 31,2017

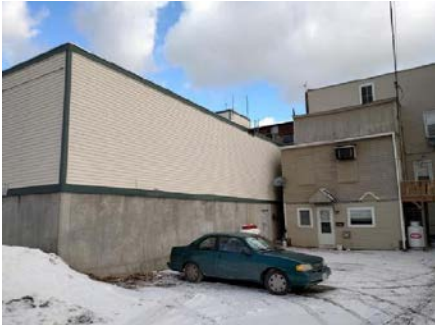
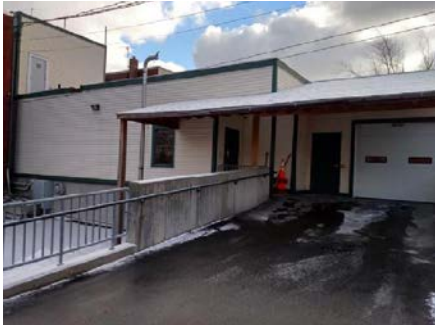
equipment	condition	Est remaining Service life	priority	cost	remarks &recommendations		
	675,Exterior Note:	1	15	10	\$5.00 Sq.ft.	Vinyl siding.

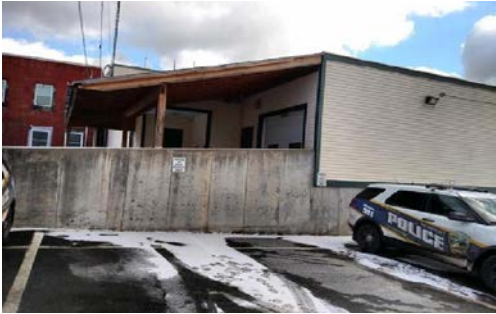
660,Exterior Note:	5		5	\$500	Complete finish on trim and siding

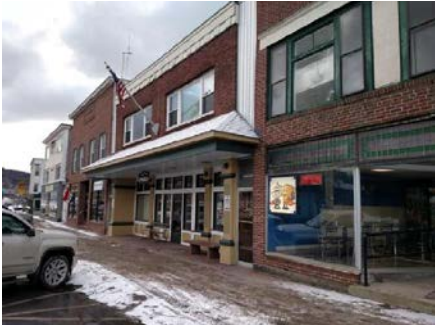
673,Exterior Note:					Brick, storefront, wood trim.

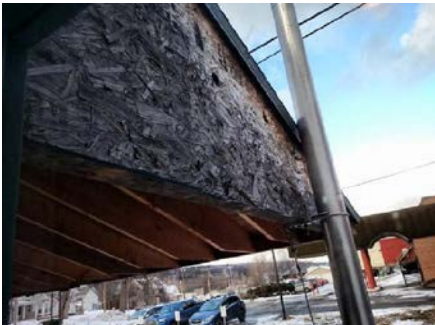
660,Exterior Note:	4	3	7	\$500	Add vinyl or aluminum wrap, material is already degrading.

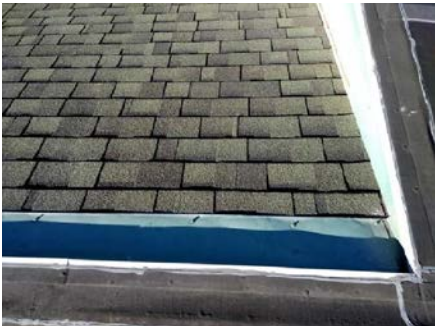
415,Asphalt Shingle	2	15	9	\$7.00	Added architectural shingle roof, some tabs broken from shoveling

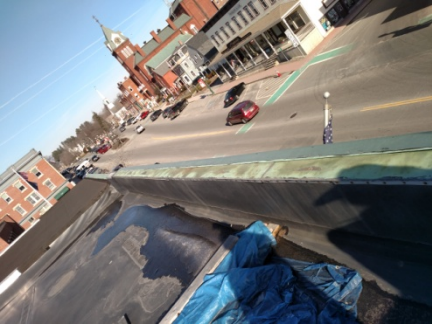
equipment	condition	Est remaining Service life	priority	cost	remarks &recommendations		
	422,Roof	3	25+	10		Copper trim , gutter and downspout on back side should be preserved

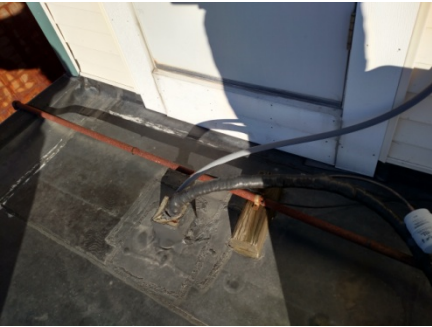
421,Roof				Correct with new roof	Door opens but barely misses pitch pocket for A/C unit, need to move around pitch pocket precisely & close to roof edge, should have guard typical.

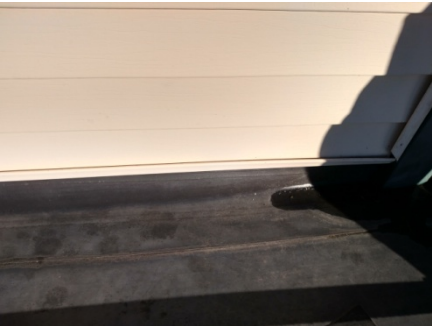
420,Roof				Correct with new roof	Vinyl siding down to 4" above roof, should be 12" minimum rubber, attachment of siding has probably pierced rubber, no walk way pads to equipment.

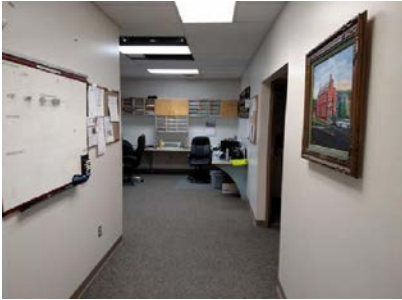
Code issue:			1	\$250	Door hardware and closer missing lower floor, fire stairs exit into elevator lobby and corridor then outside. Reinstall hardware and closer presently a fire will spread quickly.		
	Floor Carpet	3	5	4	\$.75 sq.ft.	Carpet is serviceable and could use cleaning and small repairs.

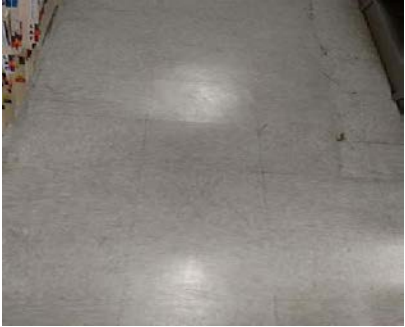
equipment	condition	Est remaining Service life	priority	cost	remarks & recommendations		
	671, Floor VCT	1	15		\$2.50 sq.ft.	VCT is in good repair

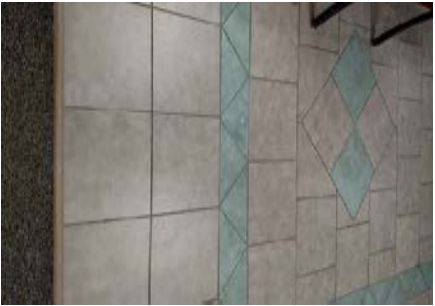
670, Ceramic Tile	1	35			Ceramic Tile is in good repair

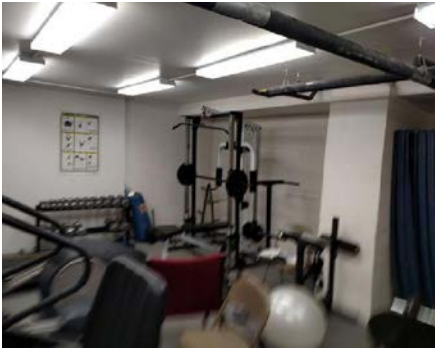
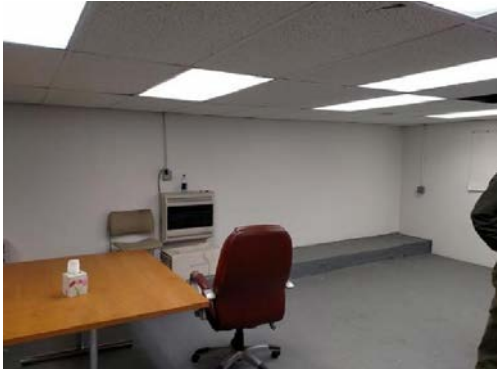
667, Code Issue:					Various areas have been finished <b>ad hoc</b> and there does not appear to be any ventilation.

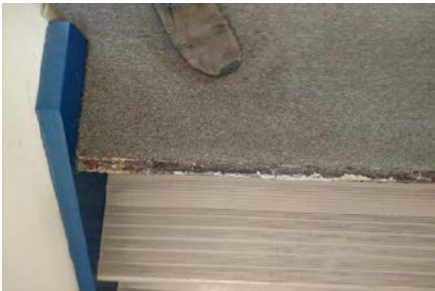
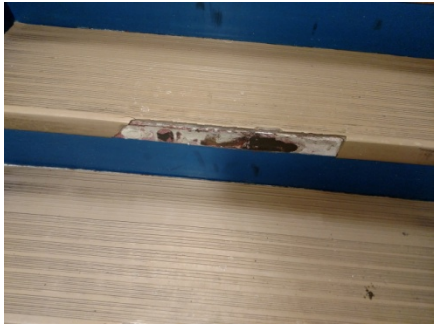
651,Flooring	4	5-10	1	\$500	Correct transition and repair or replace stair tread. Install rubber treads with epoxy at nosing if necessary

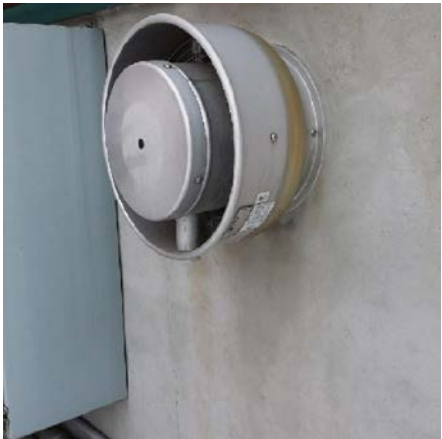
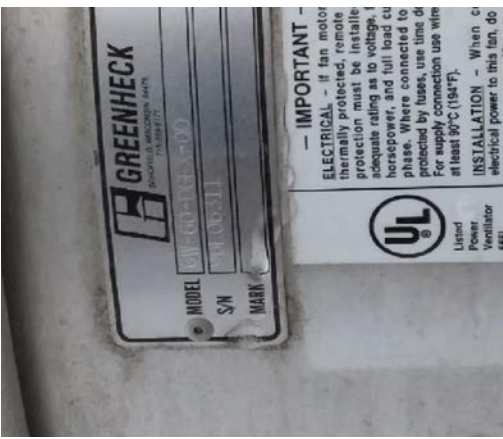
126,Exhaust Fan #2  Greenhecksidewall exhaust fan  Model: GW-60-DGEX-QD	3  Fully operations, 25-50% life expectancy used, periodic problems	10 Years	10	\$2,500	Provides exhaust for the evidence room.

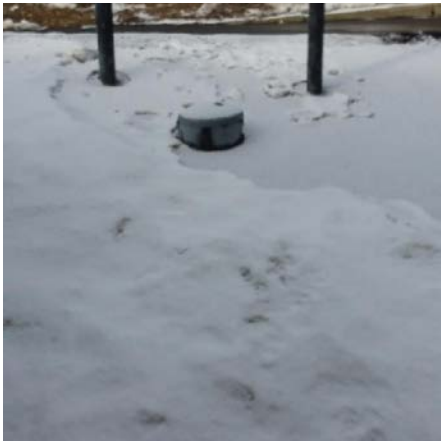
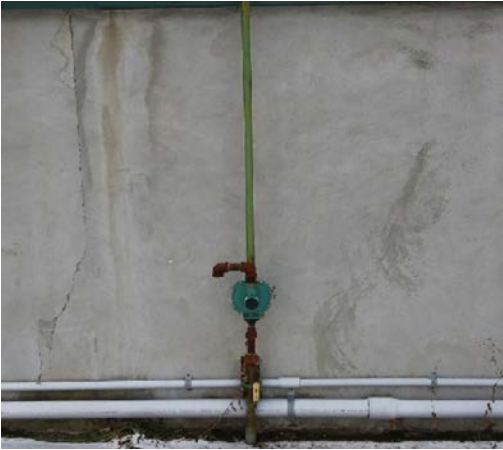
equipment	condition	Est remaining Service life	priority	cost	remarks &recommendations		
	123,1,500 Gallon LP underground fuel tank  Unknown install date					Provides fuel for rooftop heating units.

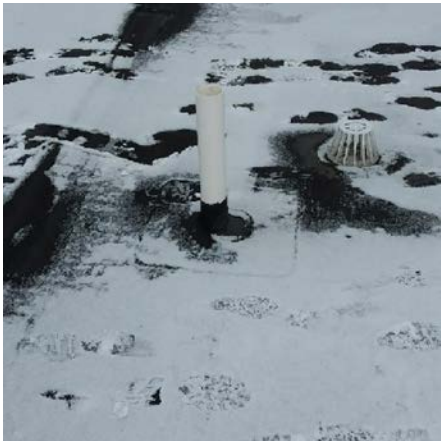
109,PVC Vent through the roof

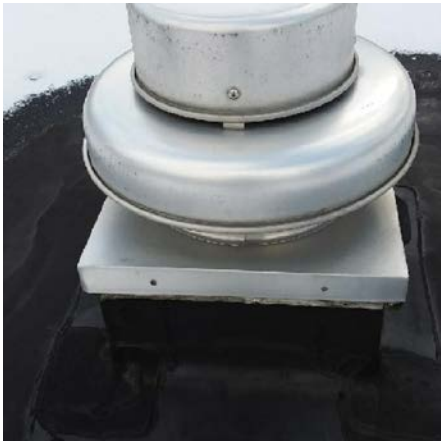
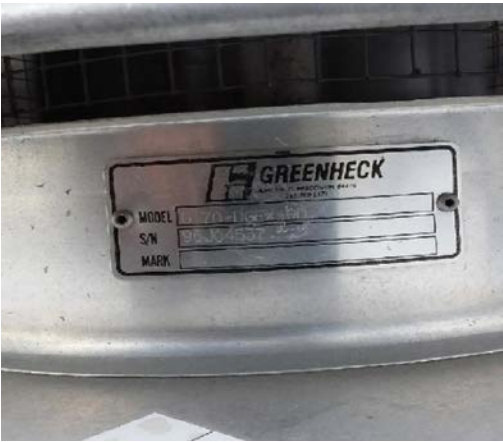
106,Exhaust Fan #3  Greenheck curb mounted exhaust fan  Model: G -70-DGEX-QD	3 Fully operational, 25-50% life expectancy used, periodic problems	10 Years	10	\$2,500	Provides exhaust for the holding cells.

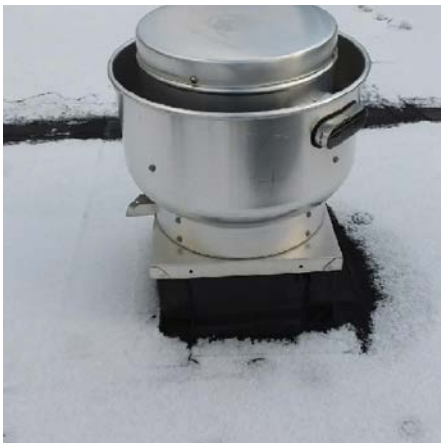
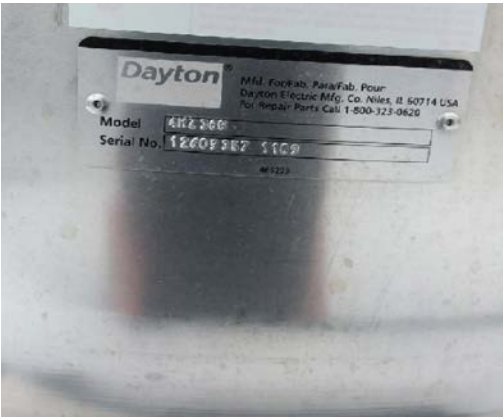
equipment	condition	Est remaining Service life	priority	cost	remarks &recommendations		
	107,Exhaust Fan #4  Dayton curb mounted upblast exhaust fan  Model: 4HZ366	2  Fully operational, 0-25% life expectancy used, no issues, no concerns	15 Years	10	\$2,500	Exhausts bathrooms on first level.

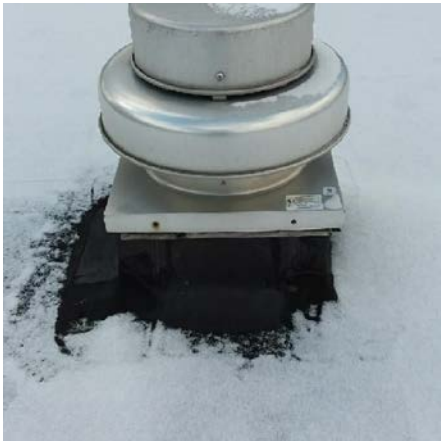
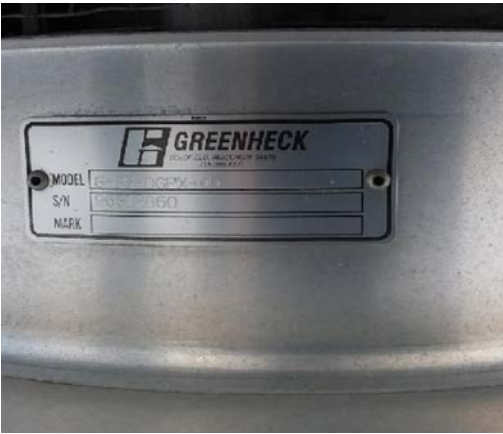
105,Exhaust Fan #5  Greenheck curb mounted exhaust fan  Model: G-85-DGFX-QD	3  Fully operational, 25-50% life expectancy used, periodic problems	10 Years	10	\$2,500	Exhausts the sallyport.

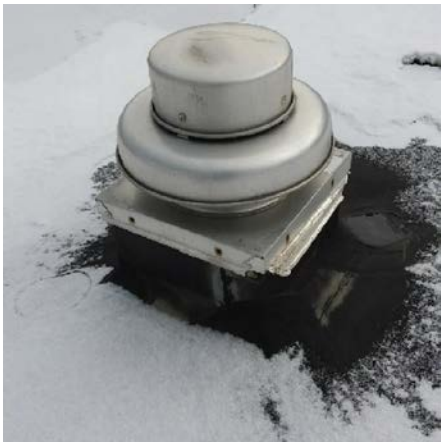
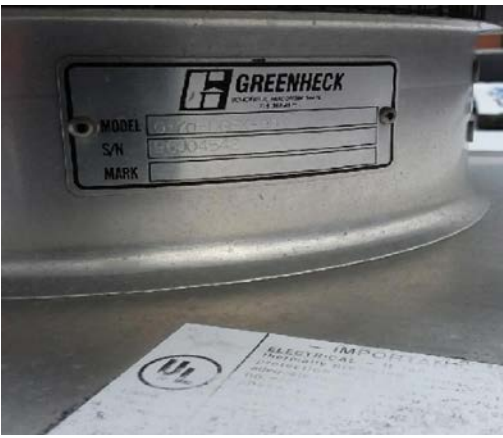
118,xhaust Fan #8  Greenheck Roof mounted exhaust fan  Model:G-70-DGEX-QD	3  Fully operational, 25-50% life expectancy used, periodic problems	10 Years	10	\$2,500	Exhausts second floor bathrooms.

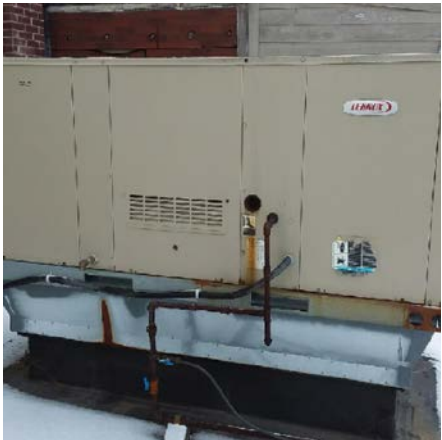
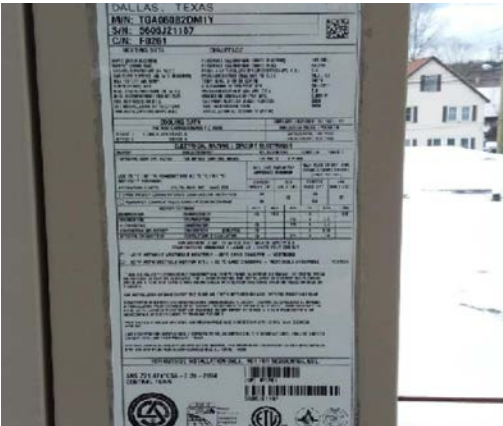
110,105,000 BTU L.P. Gas fired Lennox roof top unit  Model: TGA060B2DM1	3 Fully operational, 25-50% life expectancy used, periodic problems	10 Years	10	\$8,500	Serves the first level.

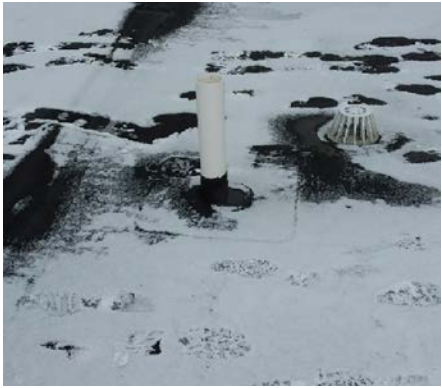
PVC Plumbing Vent	1 Fully operational, new, recently replaced	20 Years	10

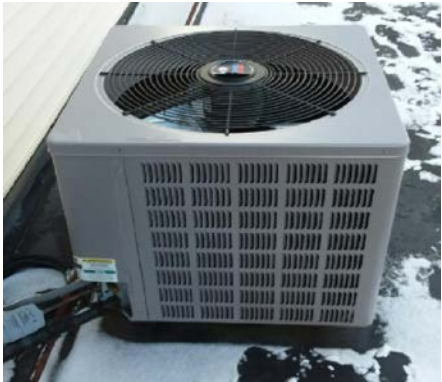
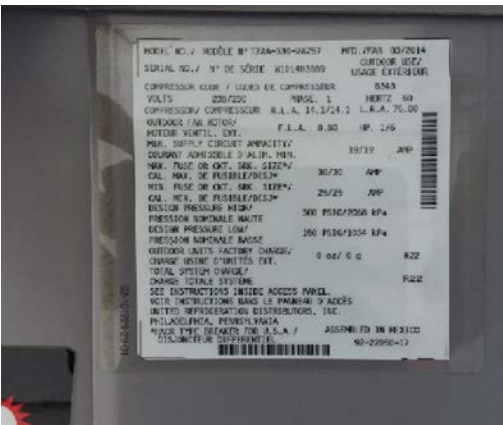
equipment	condition	Est remaining Service life	priority	cost	remarks &recommendations		
	104,Roof-mounted R-22 air conditioning condenser  Condenser was installed 2015 which replaced original.	1  Fully operational, new, recently replaced	15	10	\$5,000	Serves AH-1 which is located above ceiling on the first level.

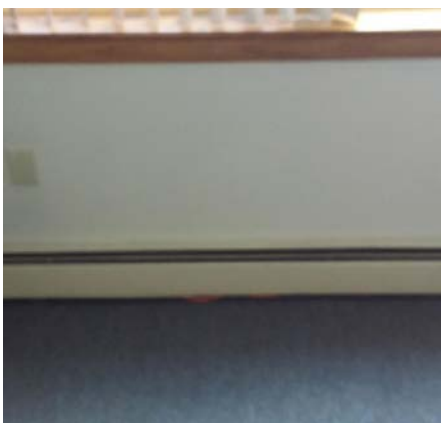
88,Fin Tube	3  Fully operational, 25-50% life expectancy used, periodic problems	10	10	\$150 per foot

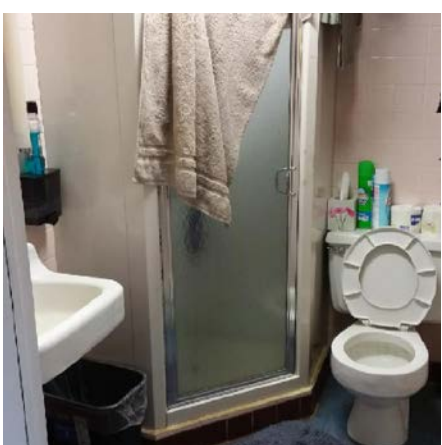
Bathroom Plumbing	3	10	8	\$1,000 per fixture

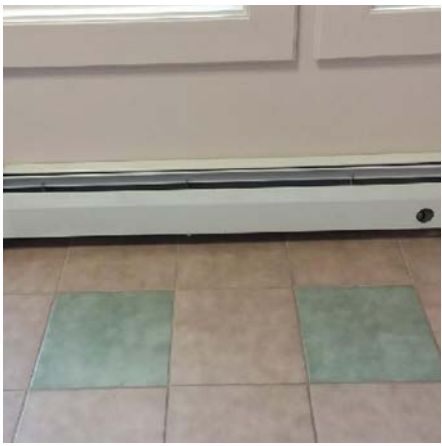
equipment	condition	Est remaining Service life	priority	cost	remarks & recommendations		
	Fin Tube	3	10	10	\$150 per foot	Fintube radiation typical throughout building

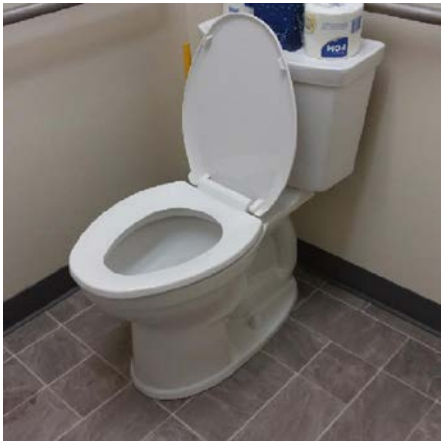
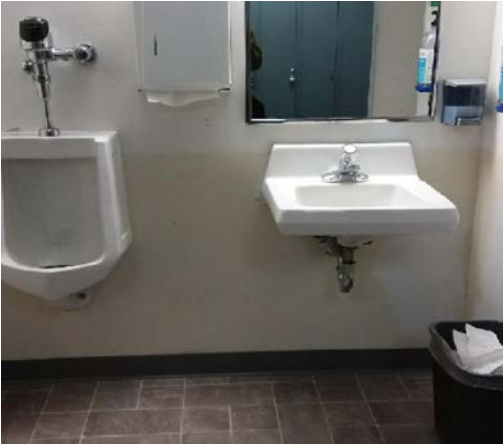
82, Wall-mounted lavatory with single handle faucet, floor mounted tank type toilets, wall mounted urinal and single handle shower faucets are typical of the building.	2 Fully operational, 0-25% life expectancy used, no issues, no concerns	15 Years	10	\$1,000 per fixture

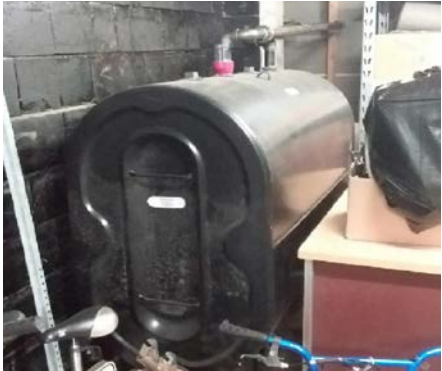
equipment	condition	Est remaining Service life	priority	cost	remarks & recommendations		
	79,275 Gallon Fuel Tank	2 Fully operational, 0-25% life expectancy used, no issues, no concerns	15 to 20 Years	10	\$2,000

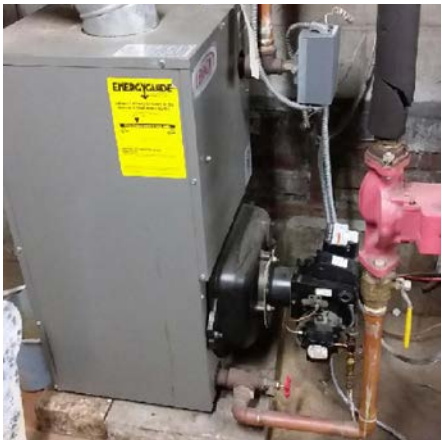
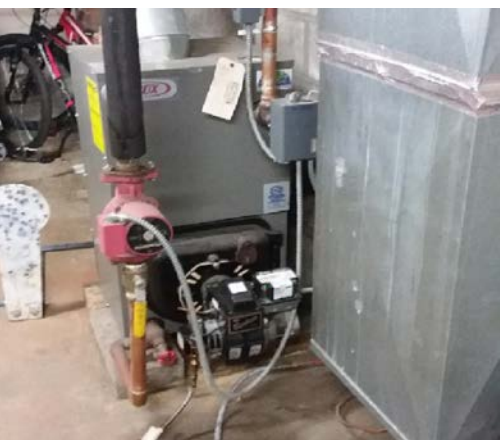
77,Lennox 210,000 BTU oil-fired boiler  Model: COWB2-4 - 1.50Z  Boiler was installed in 2010	2 Fully operational, 0-25% life expectancy used, no issues, no concerns	15 Years	10	\$10,000	Provides heating water to fin tube radiation in basement, front lobby and second floor. Boilers atmospherically vented to brick chimney.  Recommend continue annual cleaning.

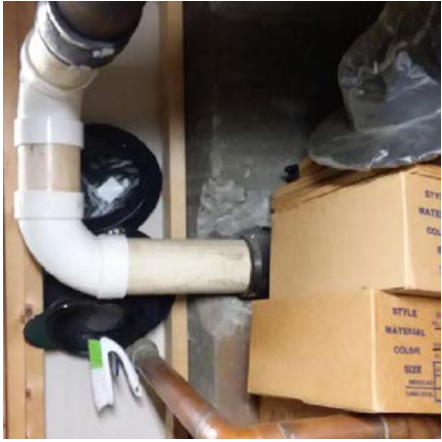
equipment	condition	Est remaining Service life	priority	cost	remarks &recommendations		
	76,Rain leader discharge piping is combination of PVC and cast iron

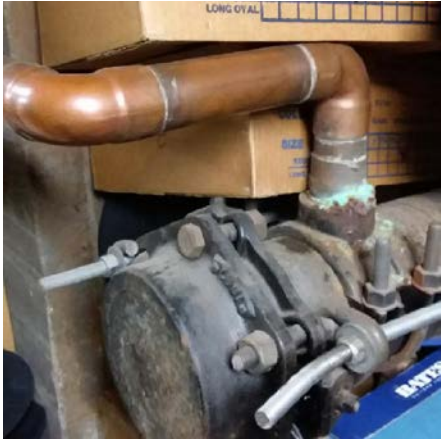
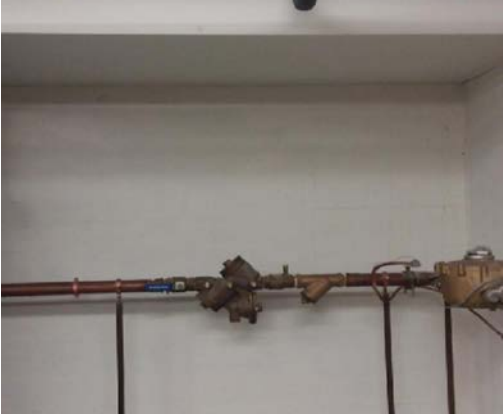
75,1" copper water entrance with remote read meter and RPZ	2	15	10	\$800	Maintained by water dept.

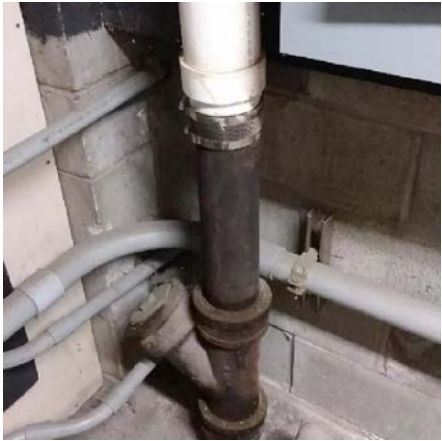
71,DWV piping is a combination of both PVC and cast iron					Appears to be in good condition.

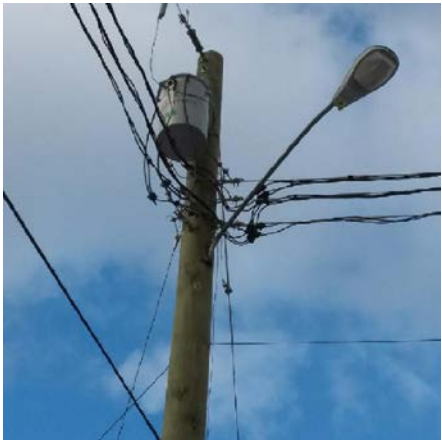
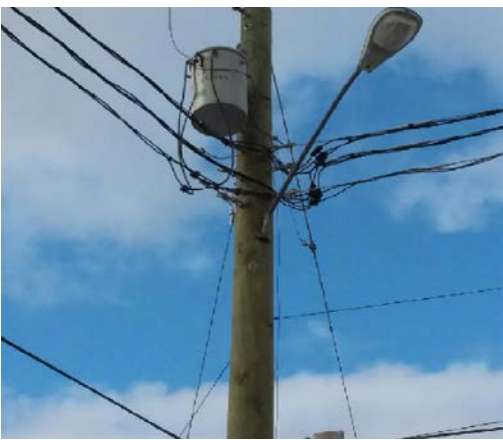
Equipment	Condition	Est. Remaining Service Life	Priority	Cost Estimate	Remarks & Recommendations			
128,One – 50 KVA pole mounted transformer	2 Fully operational, 0-25% life expectancy used, no issues, no concerns	15 Years	10		Provides power through overhead service.  Maintained by power supplier.

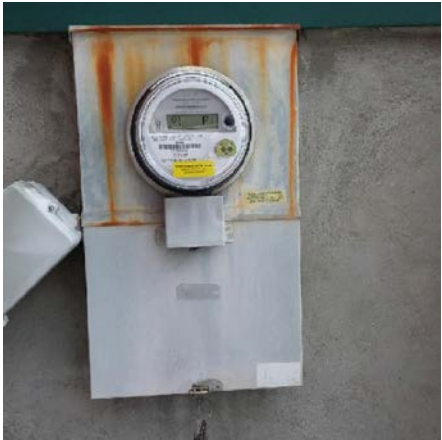
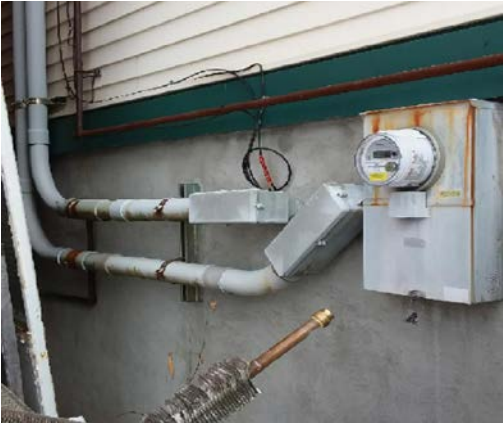
120,Conduit risers to the electrical meter from overhead service drop	2 Fully operational, 0-25% life expectancy used, no issues, no concerns	15 Years	10

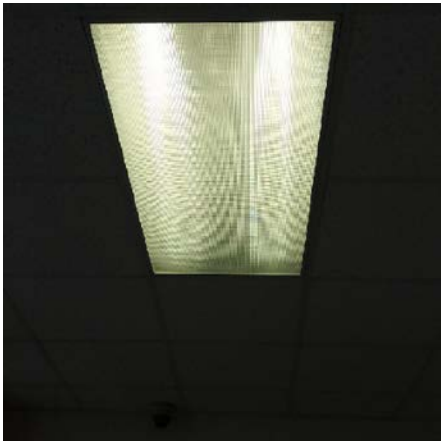
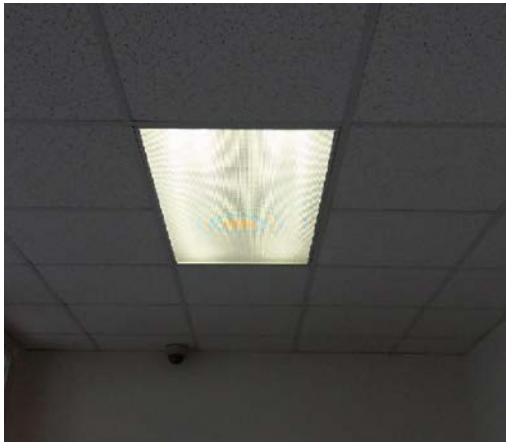
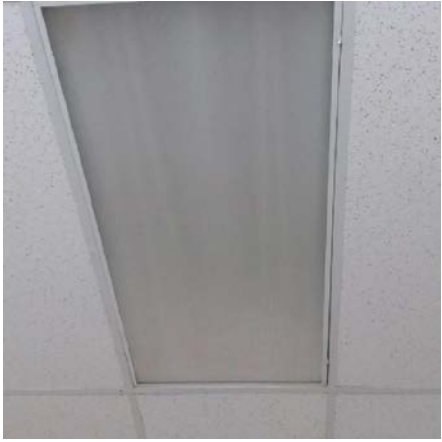
601,32 watt fluorescent lamp fixtures	3 Fully operational, 25-50% life expectancy used, periodic problems	10 Years	10		Typical throughout the building.

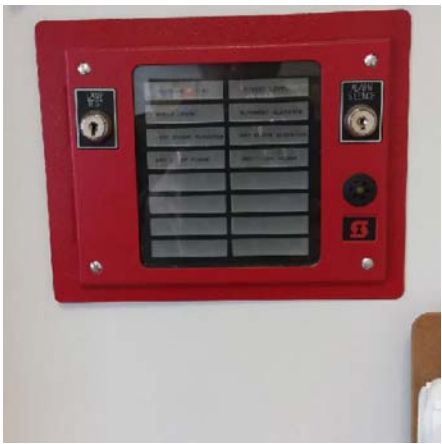
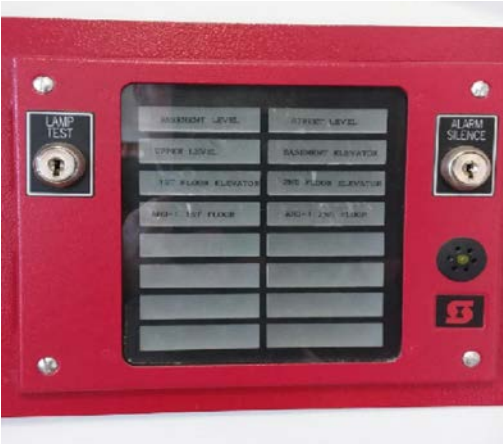
equipment	condition	Est remaining Service life	priority	cost	remarks &recommendations		
	119, Fire Alarm Annuciator	2 Fully operational, 0-25% life expectancy used, no issues, no concerns	15 Years	10	\$3,000

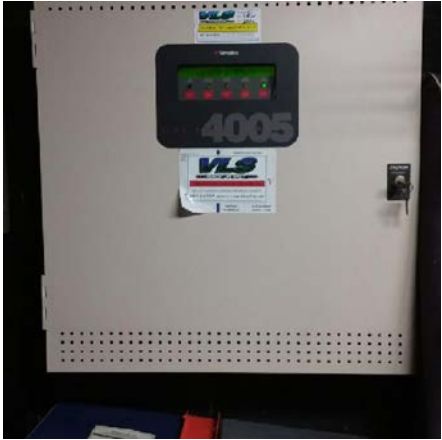
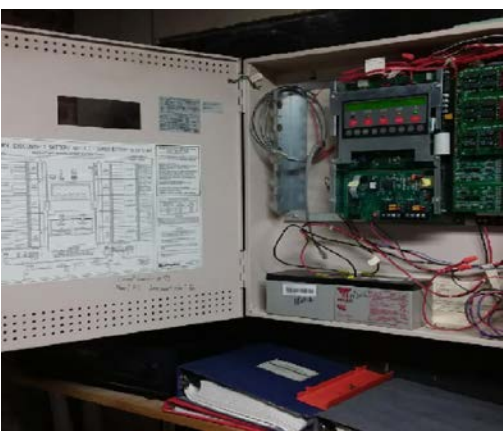
73, FACP Installed in 2013	1 Fully operational, new, recently replaced	15 to 20 Years	10	\$5,000	Dispatches to the first level of this building which is the Central Dispatch Center.

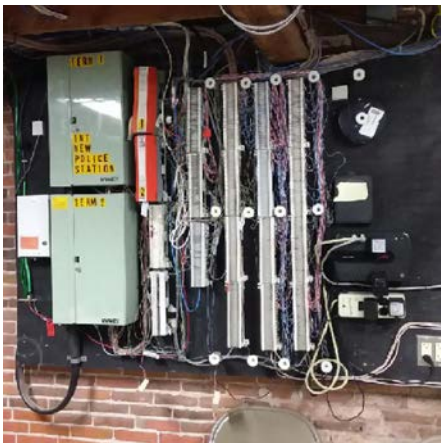
equipment	condition	Est remaining Service life	priority	cost	remarks & recommendations		
	Telephone/Data	2 Fully operational, 0-25% life expectancy used, no issues, no concerns	15 Years	10	\$3,000

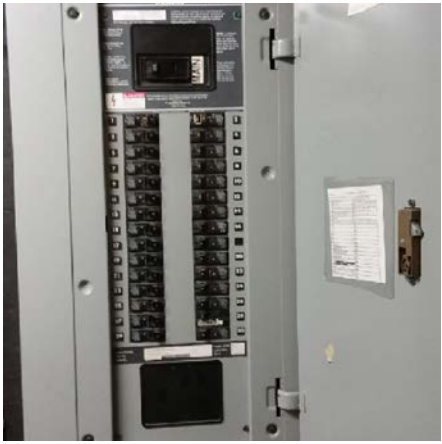
70,200 - AMP 120 /240 volt single phase surface mount panel board	2 Fully operational, 0-25% life expectancy used, no issues, no concerns	15 Years	10	\$2,000

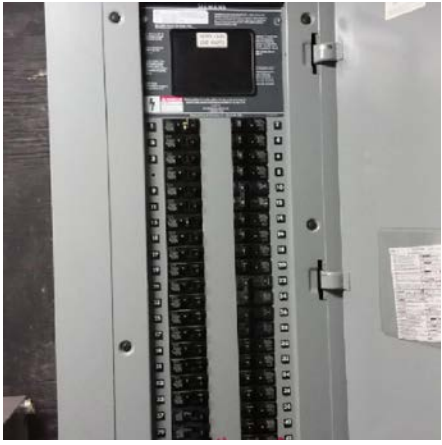
69,Electrical Panelboard P1  125 - AMP 120 / 208 volt 3 phase surface mount panel board	2 Fully operational, 0-25% life expectancy used, no issues, no concerns	15 Years	10	\$2,000

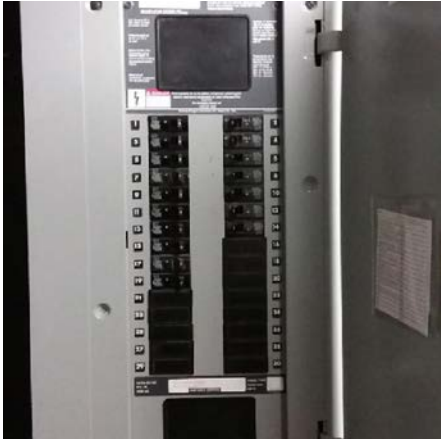
equipment	condition	Est remaining Service life	priority	cost	remarks & recommendations		
	68,Electrical Panelboard L1  125 - AMP 120 / 208 volt 3-phase surface mount panel board	2  Fully operational, 0-25% life expectancy used, no issues, no concerns	15 Years	10	\$2,000

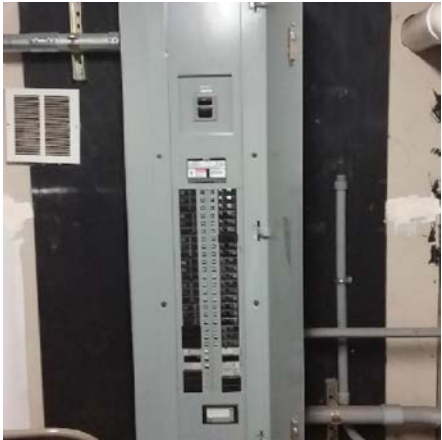
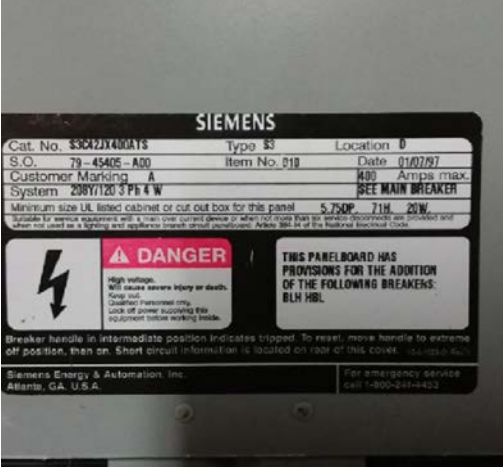
267,Electrical Panelboard MP	2  Fully operational, 0-25% life expectancy used, no issues, no concerns	15 Years	10	\$4,000

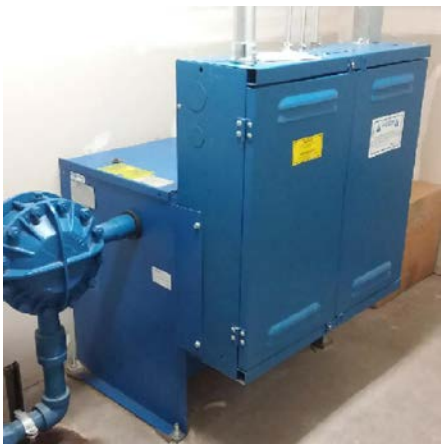
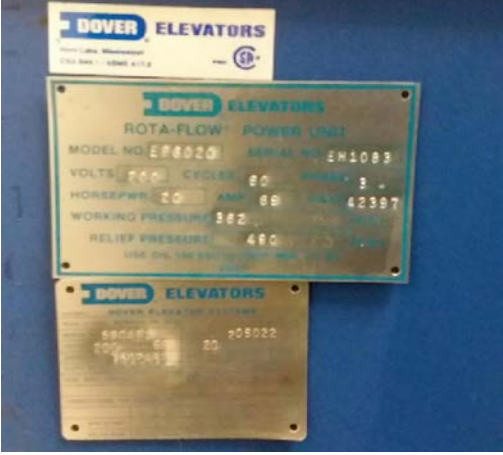
63,Elevator Power Unit	2  Fully operational, 0-25% life expectancy used, no issues, no concerns	15 Years	10

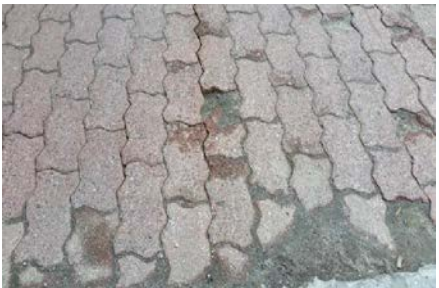
Concrete pavers at the front side of the building are worn, missing in places and have settled forming a gap along the center of the sidewalk. Curbing has shifted out of vertical in places. Pavements at the rear of the building are in relatively good condition with some transverse cracking along the access to the back lot from Main Street.

Equipment	Condition	Est. Remaining Service Life	Priority	Cost Estimate	Remarks & Recommendations	Photos	
884,Pavement	2	20	3	\$1,000	Replace and reset pavers and curb.
