Building: Pollards Well

Newport, New Hampshire

Town of Newport, Building Assessment July 31,2017

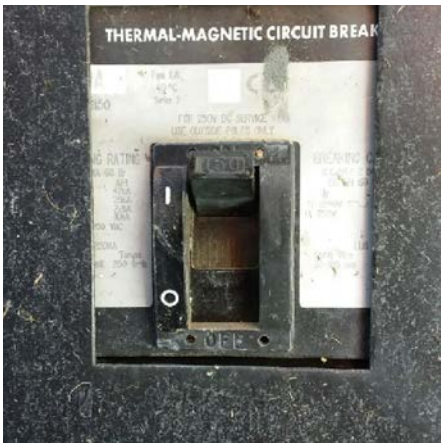
249,Electrical disconnect	1 Fully operational, new, recently replaced	25 + Years	10	\$2,000	Being installed during our visit.
