Building: Public Works Garage
449 South Main Street
Newport, New Hampshire

Architectural							
	This building was designed and built to house Public Works. Additionally, it serves as bus storage for the school system. There are immediate problems with the roof, rear CMU wall and other overdue maintenance items. If an analysis of space needs was performed; they lack adequate program space and are using every inch they can.						
	Equipment	Condition	Est. Remaining Service Life	Priority	Cost Estimate	Remarks & Recommendations	Photos

Town of Newport, Building Assessment July 31,2017

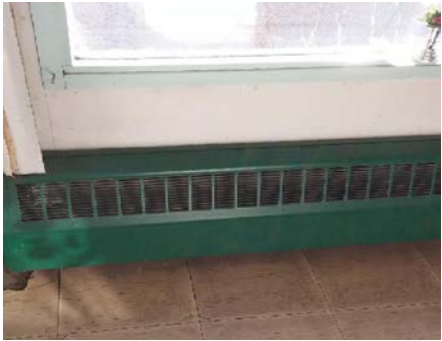
Mechanical								
	Equipment	Condition	Est. Remaining Service Life	Priority	Cost Estimate			
	413,Fintube	2 Fully operational, 0-25% life expectancy used, no issues, no concerns	15 Years	8	\$150 per ft.	Typical throughout office area.

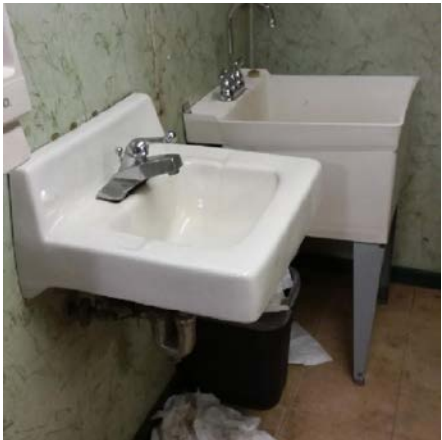
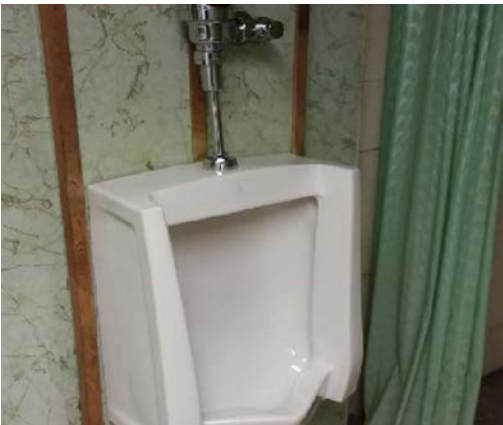
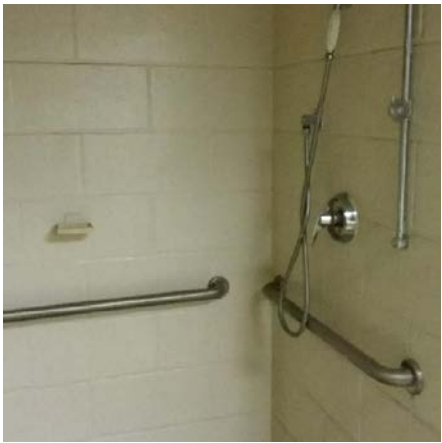
411,Shower, wall mounted urinal with flush valve and wall mounted lavatory with single handle faucet	3 Fully operational, 25-50% life expectancy used, periodic problems	10	10	\$1,000 per fixture

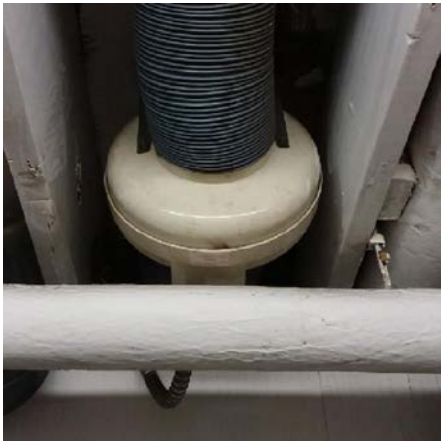
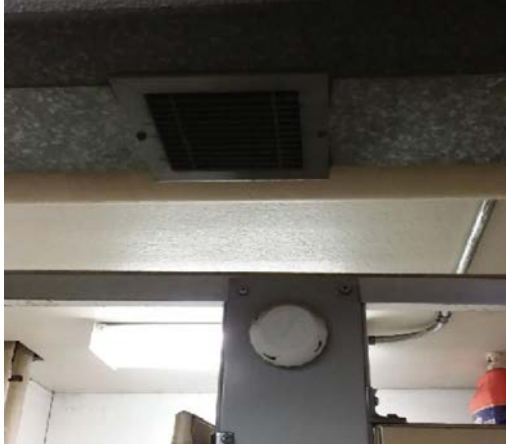
equipment	condition	Est remaining Service life	priority	cost	remarks &recommendations		
	408,Fantech - Inline exhaust fan Unable to locate name plate	2 Fully operational, 0-25% life expectancy used, no issues, no concerns	15 Years	8	\$1,200	Exhaust bathrooms and breakroom. Fan exhausts to a sidewall vent hood.

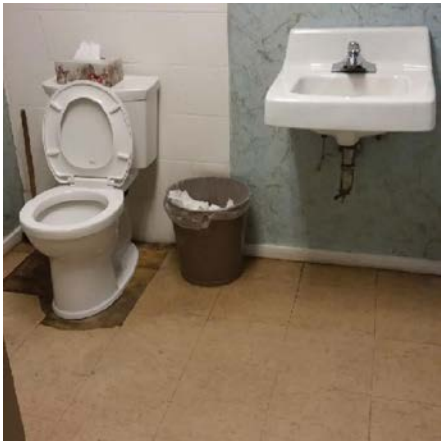
407,Floor mounted tank type toilet and wall mounted lavatory with single handle faucet.	3 Fully operational, 25-50% life expectancy used, periodic problems	10	8	\$1,000 per fixture

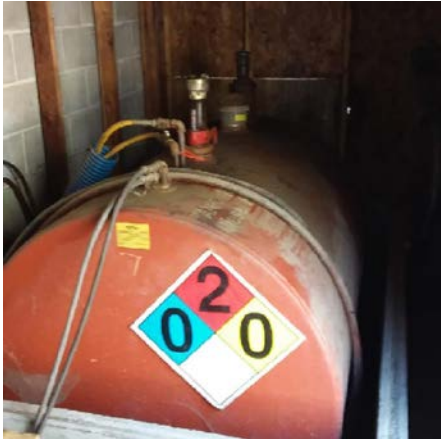
388,500 Gallon diesel fuel tank	3 Fully operational, 25-50% life expectancy used, periodic problems	10	8	\$2,500	Provides fuel for generator, not currently in operation, and boiler. Tank is located in an unconditioned building attached to the main building. Tank is installed within a containment enclosure.

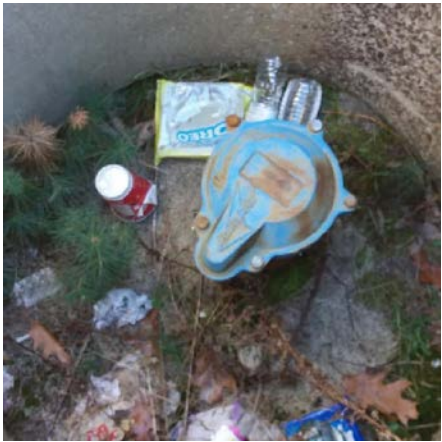
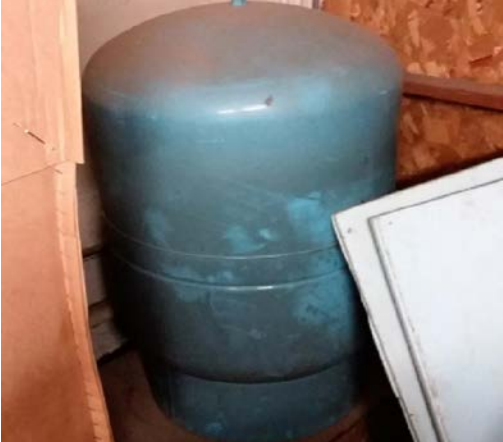
386,Well Cap	3	20	10	\$5,000-10,000	600 to 800 Foot drilled well. Well cap is approximately 75 feet away from building. Pressure tank is located on the mezzanine

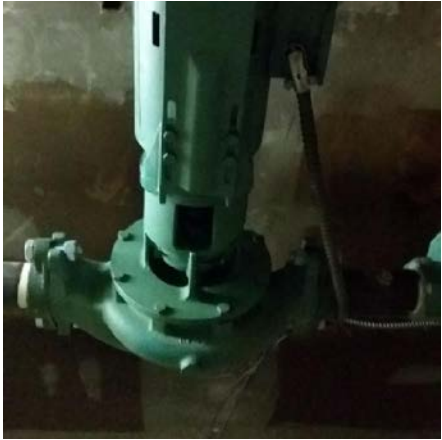
equipment	condition	Est remaining Service life	priority	cost	remarks & recommendations		
	383, TACO inline Circulation pump Installed in 2010	2 Fully operational, 0-25% life expectancy, no issues, no concerns	15 Years	8	\$2,500	Supplies heating hot water to heating terminals.

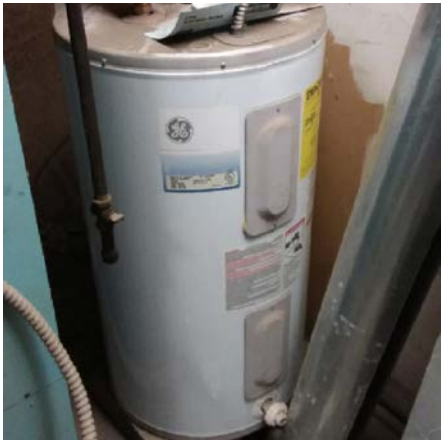
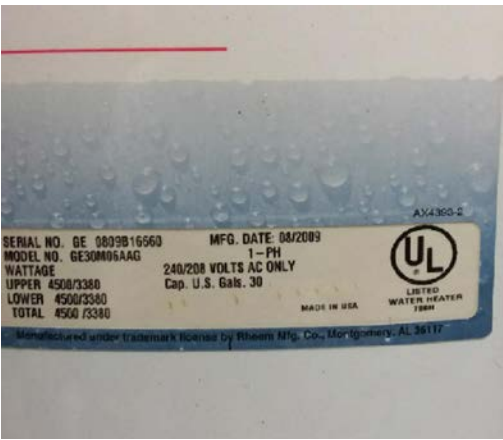
382, 30 Gallon Electric water heater GE Model : GE30M06AA6 Installed 2010	3 Fully operational, 25-50% life expectancy used, periodic problems	10 Years	6	\$2,000	Water heater provides domestic hot water throughout building.

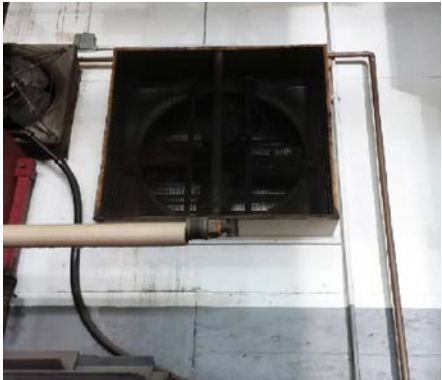
374,Sidewall Prop fan	2 Fully operational, 0-25% life expectancy used, no issues, no concerns	15 Years	8	\$3,500	Exhausts truck bay garage. Fan is operated by on/off toggle switch.

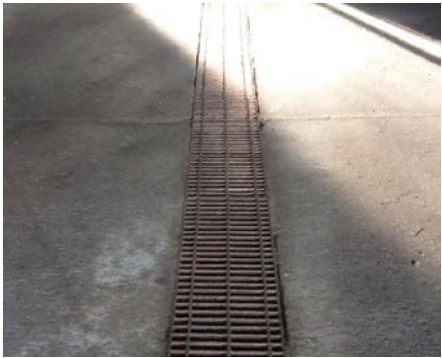
385,Trench drain is piped to 1000 Gallon underground tank					Tank is pumped annually.

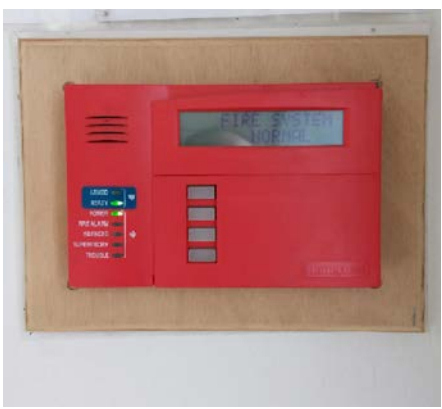
Equipment	Condition	Est. Remaining Service Life	Priority	Cost Estimate	Remarks & Recommendations		
	416,Fire alarm annunciator panel. Fire alarm system was installed in 2013	1 Fully operational, new, recently replaced	25 Years	10	\$3,000

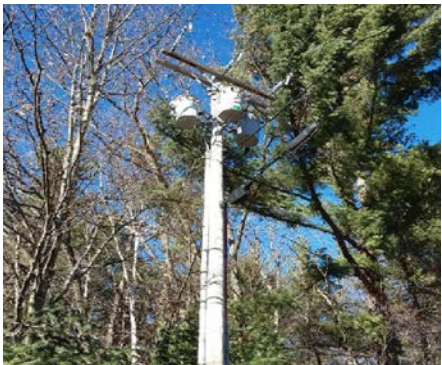
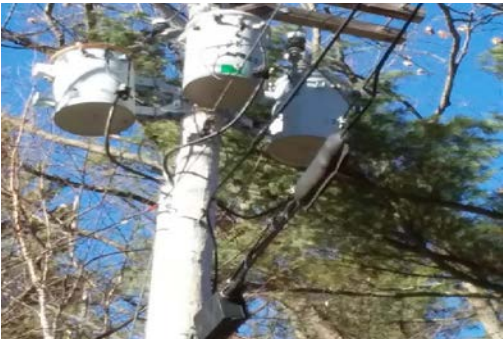
410,Three - 15 KVA pole mount transformers	2 Fully operational, 0-25% life expectancy used, no issues, no concerns	15 Years	10		Provide power to building through underground service. Maintained by power supplier.

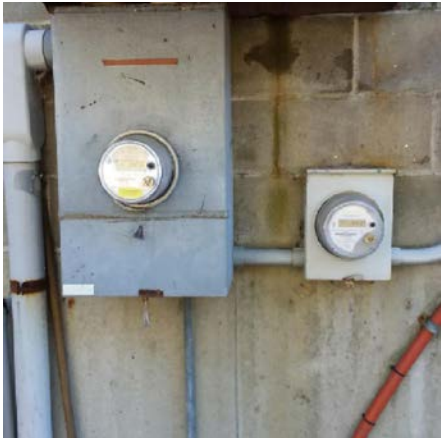
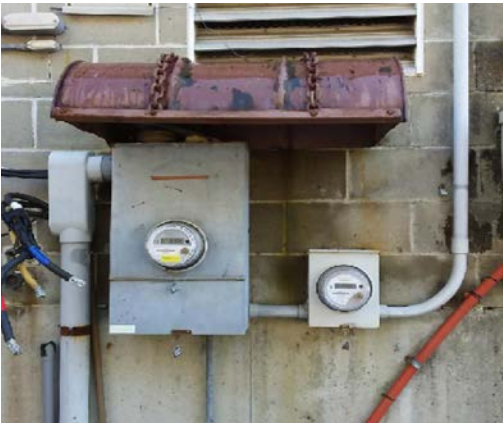
409,Electrical Meters	2 Fully operational, 0-25% life expectancy used, no issues, no concerns	15 Years	10	\$2,000	Unable to determine why there are two electrical meters. The meter on the right is directly piped to the current, although not in operation, generator. The other meter is piped to the MDP. Maintained by power supplier.

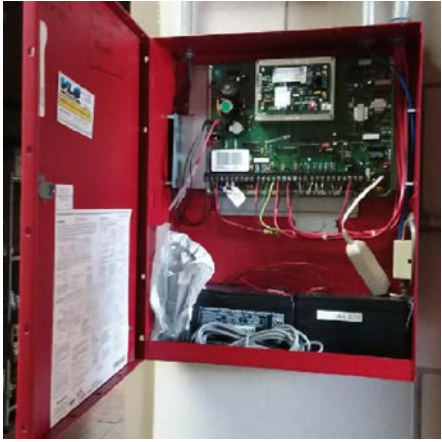
equipment	condition	Est remaining Service life	priority	cost	remarks & recommendations		
	389,Fire Alarm	1 Fully operational, new, recently replaced	25 Years	10	\$8,000	FACP. Fire alarm system was installed in 2013.

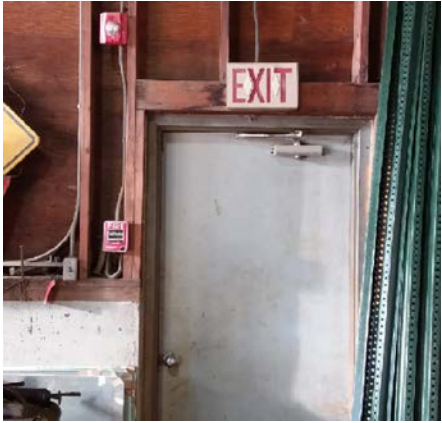
equipment	condition	Est remaining Service life	priority	cost	remarks & recommendations		
	376,Exit signs, horn strobe light and pull stations typical at all exits.	3 Fully operational, 25-50% life expectancy used, periodic problems	10 Years	10	\$600 each	All appear to be in working order. Some fixtures are in unconditioned areas.

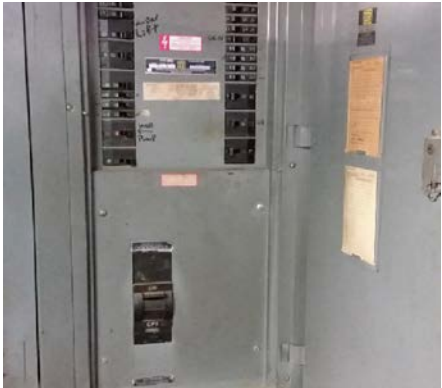
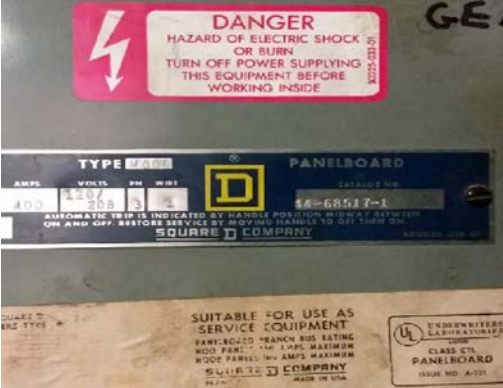
373,400 - AMP 120/ 208 Volt 3-phase surface mount panel board	3 Fully operational, 25-50% life expectancy used, periodic problems	10 Years	10	\$4,000

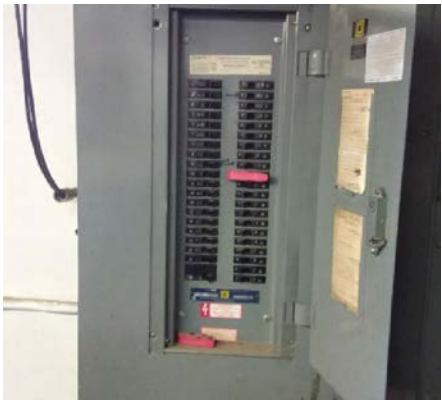
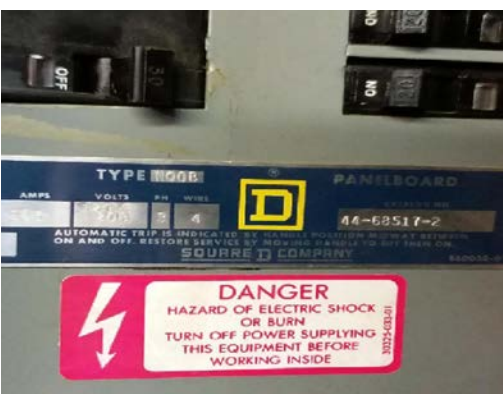
372,100 - AMP 120 /208 Volt 3-phase surface mount panel board.	3 Fully operational, 25-50% life expectancy used, periodic problems	10 Years	10	\$1,000	Panelboard is fed from 100 - AMP breaker in main distribution panel.
