Building: Recreation Building
65 Belknap Ave.
Newport, New Hampshire

Town of Newport, Building Assessment July 31,2017

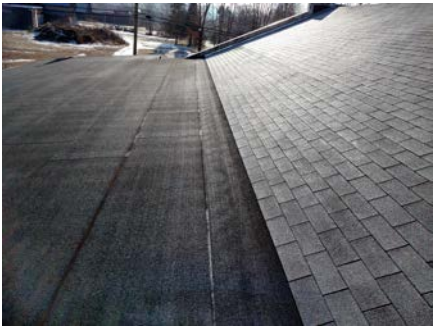
equipment	condition	Est remaining Service life	priority	cost	remarks &recommendations		
	766,Exterior Note:	2	15	10	\$7.00 sq.ft	Asphalt shingle

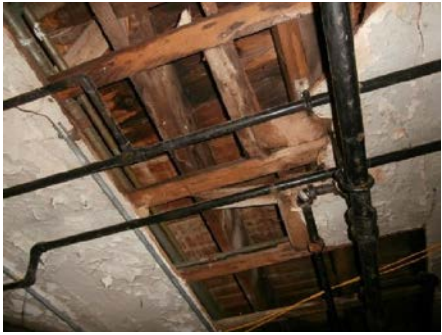
305, floor					Plaster fireproofing hole, boiler room. 2x12 @ 16 (information only).

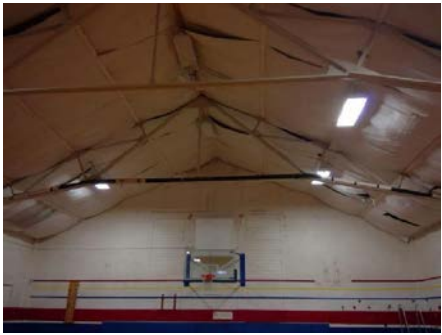
303, truss					Steel scissor trusses across center gym. Secondary framing between trusses is concealed by insulation. (information only)

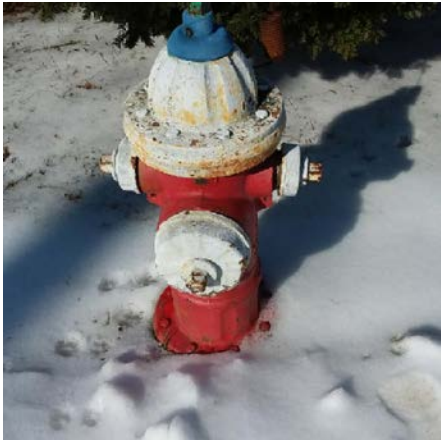
Equipment	Condition	Est. Remaining Service Life	Priority	Cost Estimate			
	509,Fire Hydrant					Located at the southwest corner of the building.

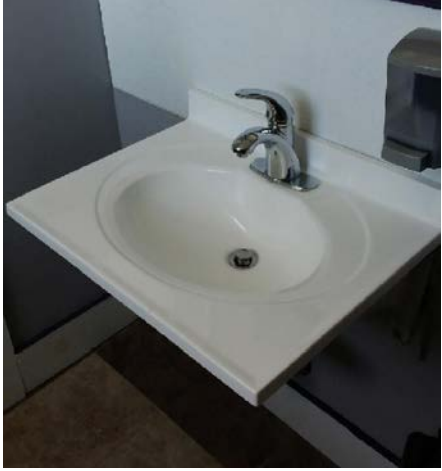
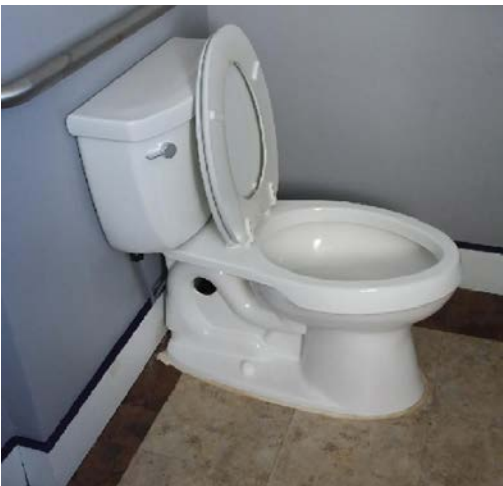
equipment	condition	Est remaining Service life	priority	cost	remarks &recommendations		
	502,Floor mount tank type toilet, wall mount lavatory with single handle faucet	2 Fully operational, 0-25% life expectancy used, no issues, no concerns	15 Years	10	\$1,000 per fixture

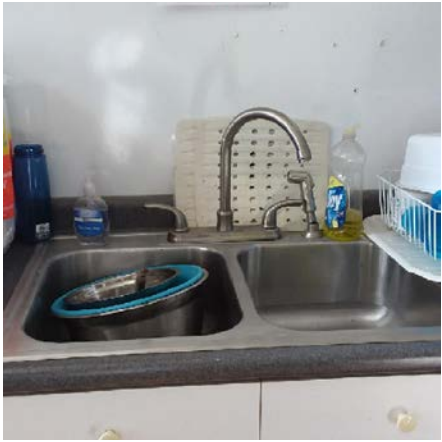
501,Double bowl S/S countertop sink with dual handle faucet	2 Fully operational, 0-25% life expectancy used, no issues, no concerns	15 Years	10	\$1,000 per fixture

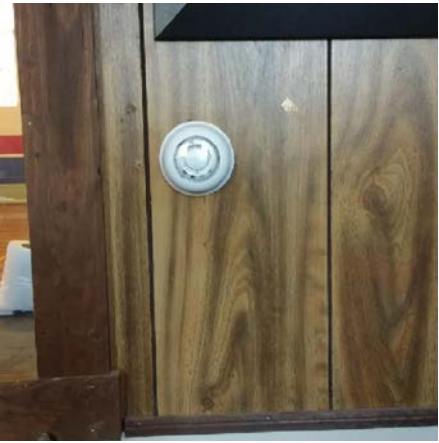
equipment	condition	Est remaining Service life	priority	cost	remarks &recommendations		
	497,Wall mount Honeywell thermostat	3 Fully operational, 25-50% life expectancy used, periodic problems	10 Years	10	\$150	This one thermostat controls heat throughout entire building.

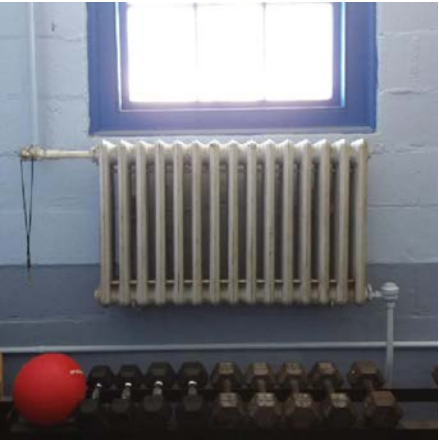
496, Wall mount steel pipe radiation under each window typical	3 Fully operational, 25-50% life expectancy used, periodic problems	10 Years	10	\$1,800 each	Recommend annual inspection.

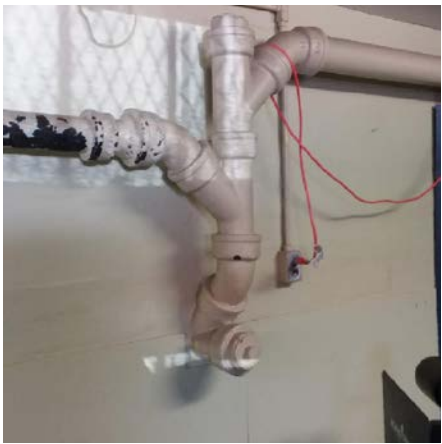
equipment	condition	Est remaining Service life	priority	cost	remarks &recommendations		
	488,4 inch cast iron Sewer discharge	2 Fully operational, 0-25% life expectancy used, no issues, no concerns	15 Years	10	\$200 per foot	Discharges to town sewer. Drain piping is exposed in the lower level.

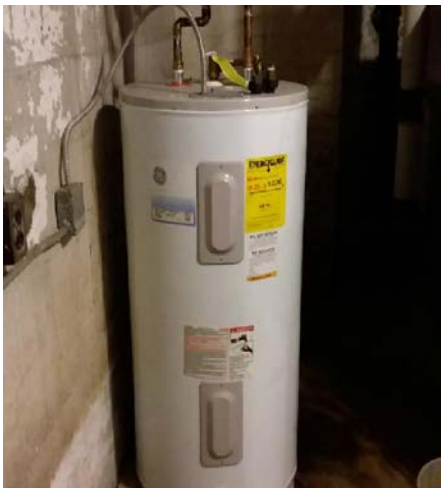
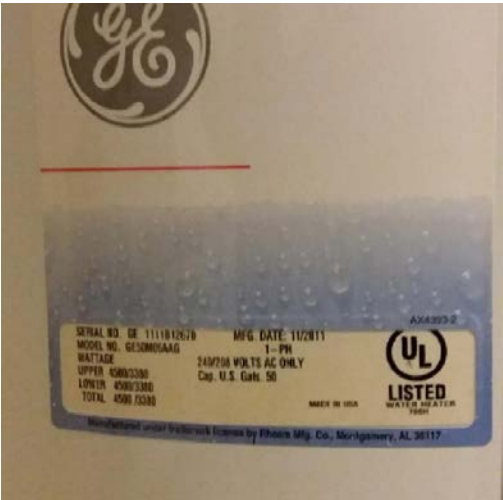
485,GE Model: GE50M06AAG 50 Gallon Electric water heater Installed 11/27/2011	2 Fully operational, 0-25% life expectancy used, no issues, no concerns	15 Years	10	\$2,000	Provides domestic hot water to the lavatories.

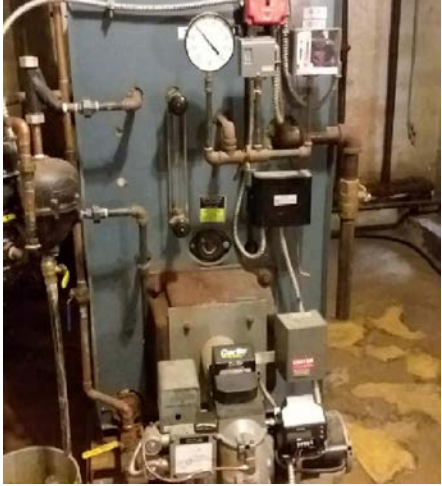
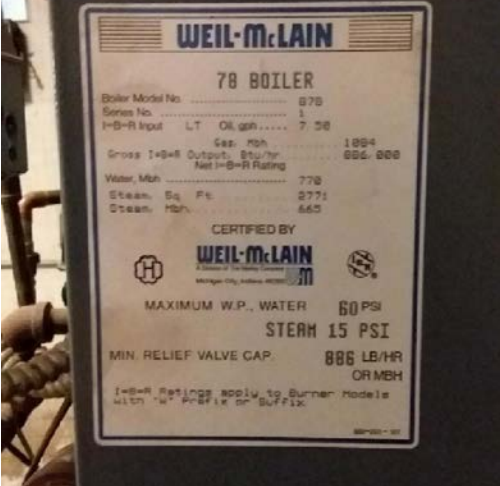
equipment	condition	Est remaining Service life	priority	cost	remarks &recommendations		
	484,WEIL McLain Model #878 886,000 BTU oil fired boiler	3 Fully operational, 25-50% life expectancy used, periodic problems	15 Years	10	\$10,000	Boiler is atmospherically vented to chimney. Generates steam for wall mounted radiation and ceiling hung unit heaters throughout building. Unknown install date.

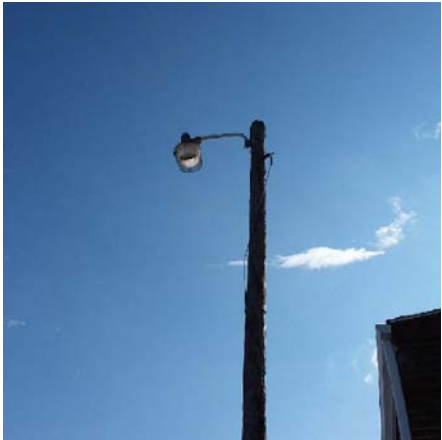
Equipment	Condition	Est. Remaining Service Life	Priority	Cost Estimate	Remarks & Recommendations		
	508,Pole mounted exterior lighting around perimeter of building	3 Fully operational, 25-50% life expectancy used, periodic problems	10 years	10	\$200

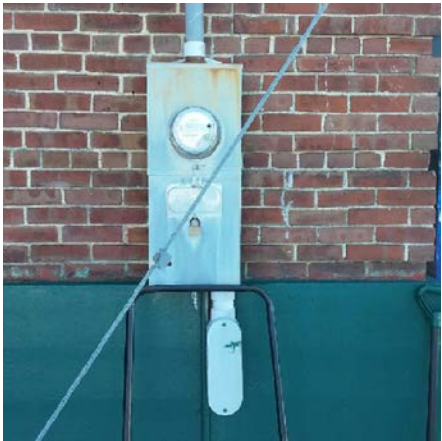
505,Wall mount electrical meter	2 Fully operational, 0-25% life expectancy used, no issues, no concerns	15 Years	10	\$1,000	Maintained by power supplier.

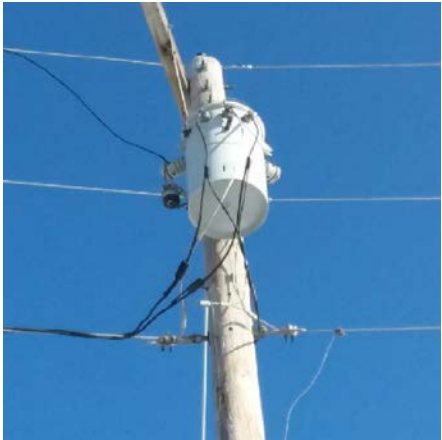
504,One - 15 KVA pole mount transformer	2 Fully operational, 0-25% life expectancy used, no issues, no concerns	15 Years	10		Provides power to building through overhead service. Maintained by power supplier.

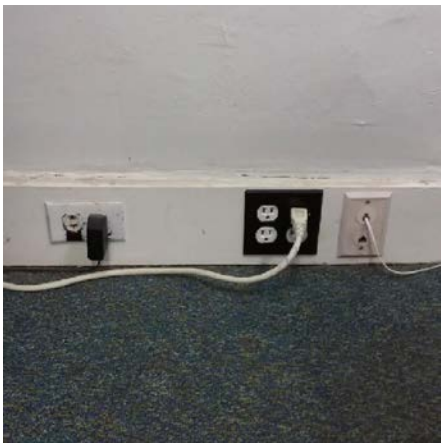
equipment	condition	Est remaining Service life	priority	cost	remarks &recommendations		
	503,Typical receptacles	2 Fully operational, 0-25% life expectancy used, no issues, no concerns	15 Years	10	\$300 each

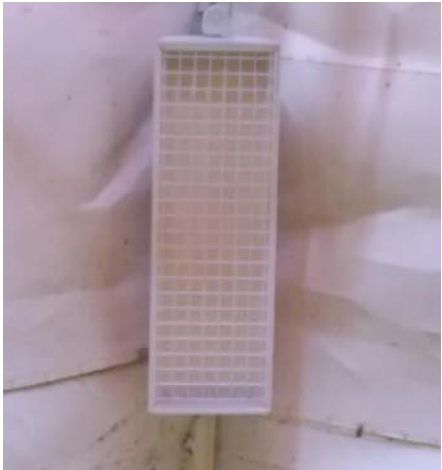
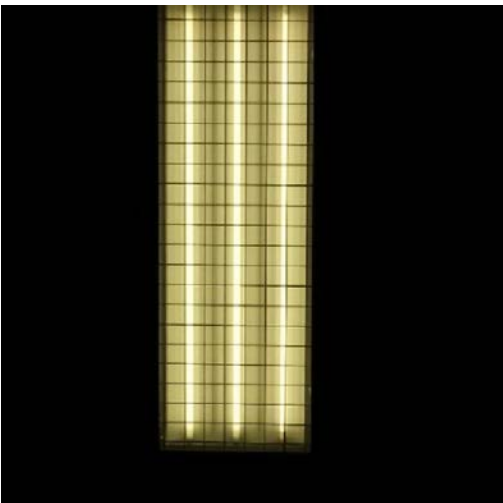
equipment	condition	Est remaining Service life	priority	cost	remarks &recommendations		
	493,T8 32 Watt 3 lamp fluorescent fixtures typical	3 Fully operational, 25-50% life expectancy used, periodic problems	10 years	10	\$500 each

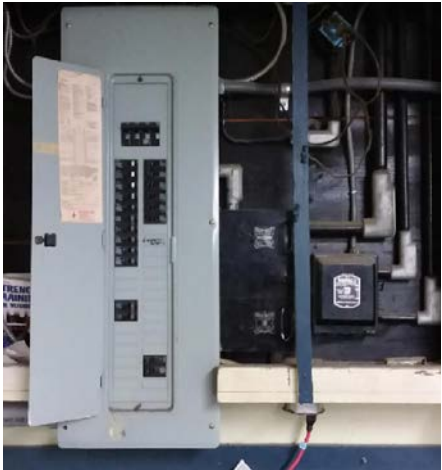
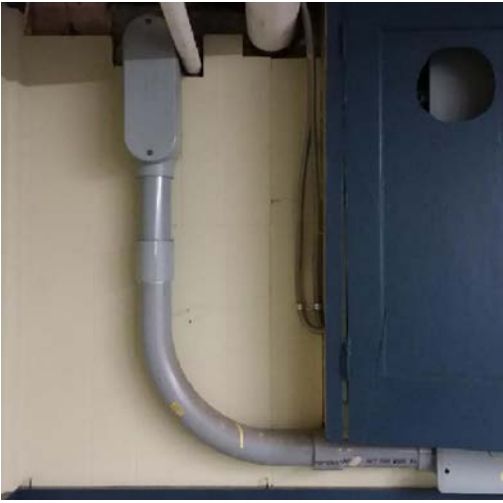
487, 120/240-volt single phase 200 – AMP surface mount panelboard	2 Fully operational, 0-25% life expectancy used, no issues, no concerns	15 Years	10	\$2,000
