Town of Newport, New Hampshire  
Building Assessment | July 31, 2017

Building: Town Hall  
20 Main Street  
Newport, New Hampshire

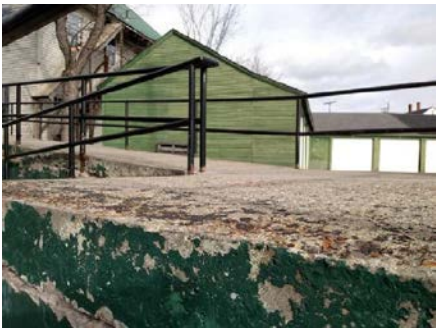
| | equipment | condition | Est remaining<br>Service life | priority | cost | remarks &recommendations | | |
|--|---|---|---|---|---|---|---|---|
| | 710, Exterior Note: | 5 | 0 | 2 | \$25,000 | HC ramp is in poor condition, rails are rusted, concrete has spalled and paint has peeled. I would suggest a comparison between repair costs and a lift be evaluated, or combine with elevator for entire building | | |

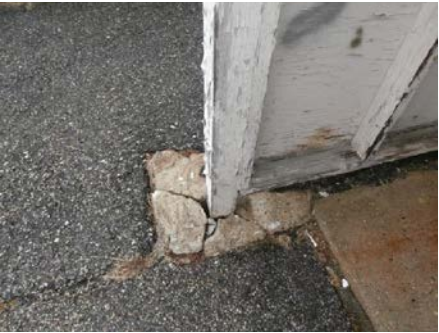
| | equipment | condition | Est remaining<br>Service life | priority | cost | remarks &recommendations | | |
|--|---|---|---|---|---|---|---|---|
| | 185,Post | 5 | 0 | 2 | \$750 | Corner post on "doghouse" entry is rotted. | | |

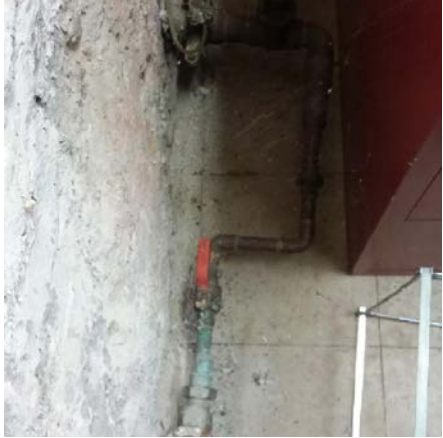
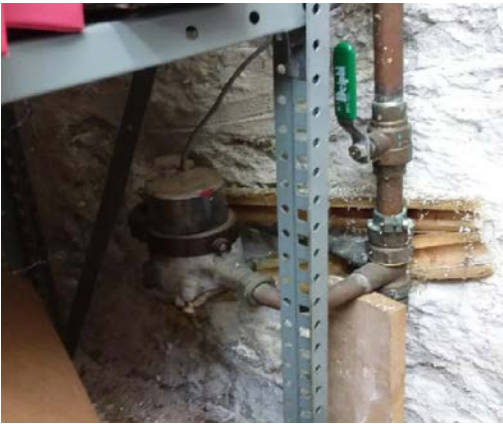
| | Equipment | Condition | Est. Remaining<br>Service Life | Priority | Cost Estimate | | | |
|--|---|---|---|---|---|---|---|---|
| | 144,1 inch copper<br>entrance with remote<br>read meter and PRV<br>valve | 3<br><br>Fully operational,<br>25-50% of life<br>expectancy used,<br>periodic<br>problems | 10 | 8 | | Maintained by water<br>dept. | | |

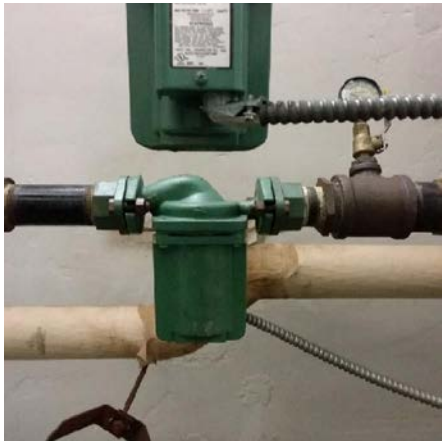
| | equipment | condition | Est remaining<br>Service life | priority | cost | remarks &recommendations | | |
|--|---|---|---|---|---|---|---|--|
| | 23, Two- TACO inline<br>Pumps | 2<br>Fully operational,<br>0-25% life<br>expectancy used,<br>no issues, no<br>concerns | 15 Years | 10 | \$2,500<br>each<br><br>\$5,000 | Circulates heating water<br>through a 2 pipe monoflo<br>system throughout the<br>building. | | |

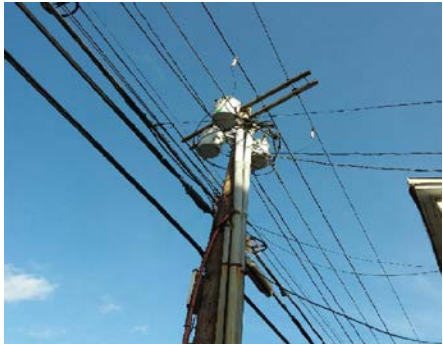
| | Equipment | Condition | Est. Remaining<br>Service Life | Priority | Cost Estimate | Remarks & Recommendations | | |
|--|---|---|---|---|---|---|---|---|
| | 224,Three – 25 KVA<br>pole mounted<br>transformers | 2<br>Fully operational,<br>0-25% life<br>expectancy used,<br>no issues, no<br>concerns | 15 Years | 10 | | Feed underground<br>service to building.<br><br>Maintained by power<br>supplier. | | |

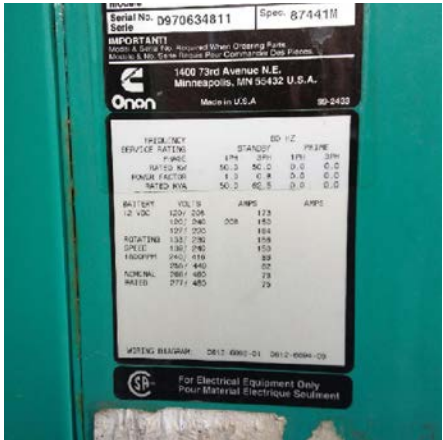
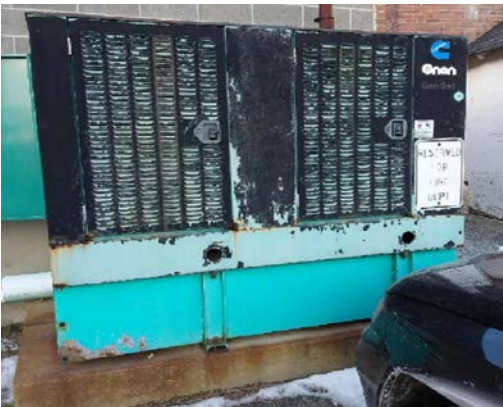
| | Equipment | Condition | Est. Remaining<br>Service Life | Priority | Cost Estimate | Remarks & Recommendations | | |
|--|---|---|---|---|---|---|---|---|
| | 11,50 KW diesel<br>generator<br><br>Make: Onan<br><br>Model: 50DGCA<br><br>Serial: B970634811.<br><br>Unknown install date | 2<br>Fully operational,<br>0-25% life<br>expectancy used,<br>no issues, no<br>concerns | 15 Years | 10 | \$32,500 | Provides power to the<br>town office building, fire<br>department and Opera<br>House. Transfer<br>switch gear for all<br>buildings powered by this<br>generator is located in<br>the town office basement. | | |

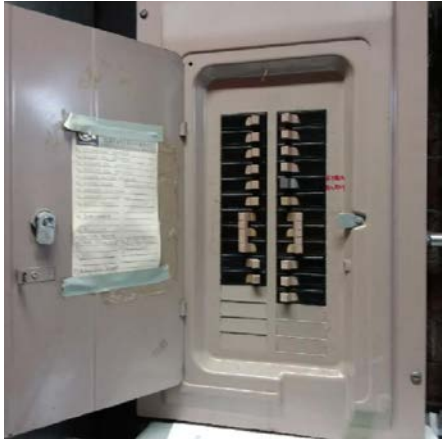
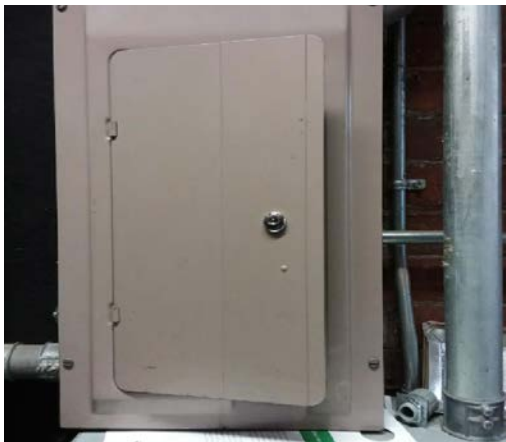
| | equipment | condition | Est remaining<br>Service life | priority | cost | remarks & recommendations | | |
|--|---|---|---|---|---|---|---|---|
| | 17,Panel A | 2<br>Fully operational,<br>0-25% life<br>expectancy used,<br>no issues, no<br>concerns | 15 Years | 10 | \$2,000 | | | |

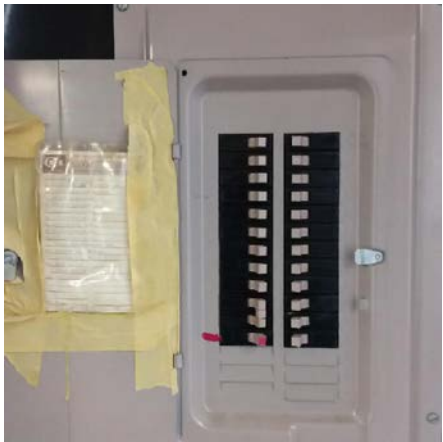
| | equipment | condition | Est remaining<br>Service life | priority | cost | remarks & recommendations | | |
|--|---|---|---|---|---|---|---|---|
| | 34,Electric Panelboard<br>A2 | 2<br>Fully operational,<br>0-25% life<br>expectancy used,<br>no issues, no<br>concerns | 15 Years | 10 | \$2,000 | | | |

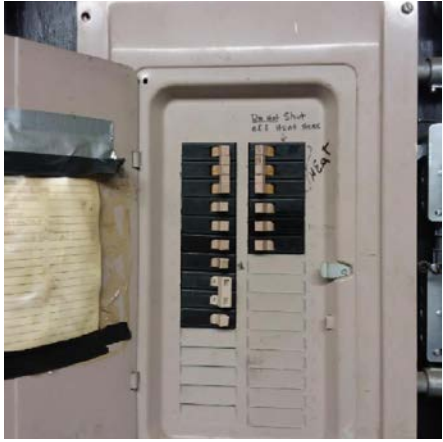
| | equipment | condition | Est remaining<br>Service life | priority | cost | remarks & recommendations | | |
|--|---|---|---|---|---|---|---|--|
| | 22,Electric Panelboard<br>B<br><br>220 Volt | 2<br>Fully operational,<br>0-25% life<br>expectancy used,<br>no issues, no<br>concerns | 15 Years | 10 | \$2,000 | | | |

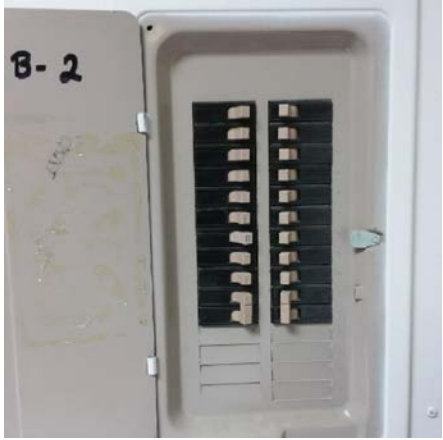
| | equipment | condition | Est remaining<br>Service life | priority | cost | remarks & recommendations | | |
|--|---|---|---|---|---|---|---|--|
| | 35, Electric Panelboard<br>B2 | 2<br>Fully operational,<br>0-25% life<br>expectancy used,<br>no issues, no<br>concerns | 15 Years | 10 | \$2,000 | | | |

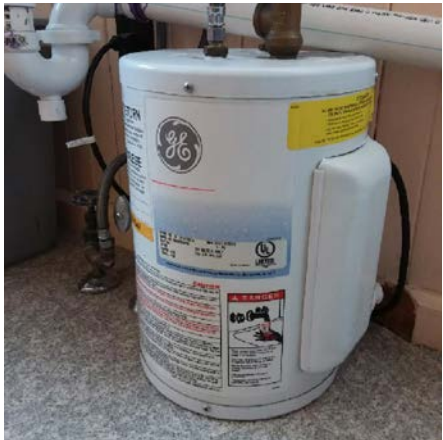
| | equipment | condition | Est remaining<br>Service life | priority | cost | remarks & recommendations | | |
|--|---|---|---|---|---|---|---|--|
| | 33, GE 2.5 Gallon<br>capacity Electric water<br>heater<br><br>Installed in 2011 | 1<br>Fully operational,<br>new, recently<br>replaced | 20 Years | 10 | \$1,000 | Provides domestic hot<br>water for this lavatory<br>only. | | |

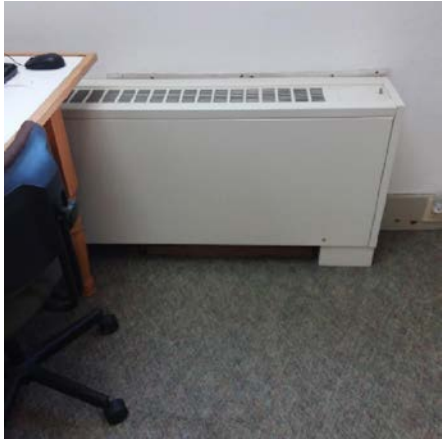
| | equipment | condition | Est remaining<br>Service life | priority | cost | remarks & recommendations | | |
|--|---|---|---|---|---|---|---|--|
| | 28,Fan Coil Unit | 2<br>Fully operational,<br>0-25% life<br>expectancy used,<br>no issues, no<br>concerns | 15 Years | 10 | \$2,500<br>each | Floor mounted fan coil<br>unit provides heat to<br>entryway, typical of 2. | | |

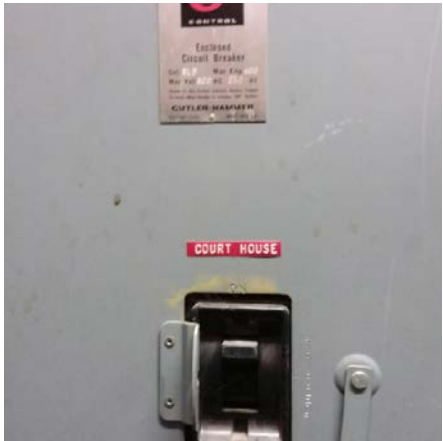
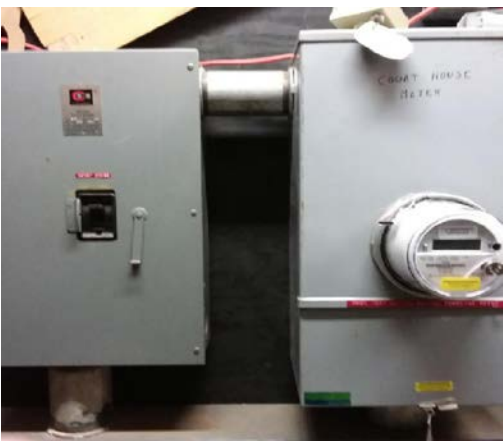
| | equipment | condition | Est remaining<br>Service life | priority | cost | remarks & recommendations | | |
|--|---|---|---|---|---|---|---|--|
| | 19,400 - AMP circuit<br>breaker for courthouse | 3<br>Fully operational,<br>25-50% life<br>expectancy used,<br>periodic<br>problems | 10 Years | 10 | \$1,000 | | | |

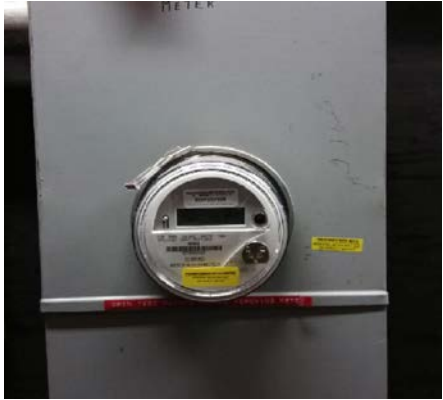
| | equipment | condition | Est remaining<br>Service life | priority | cost | remarks &recommendations | | |
|--|---|---|---|---|---|---|---|--|
| | 15,Electric Meter | 2<br>Fully operational,<br>0-25% life<br>expectancy used,<br>no issues, no<br>concerns | 15 Years | 10 | \$4,000 | Meter powers for the<br>courthouse restaurant<br>and museum.<br><br>Maintained by power<br>supplier. | | |

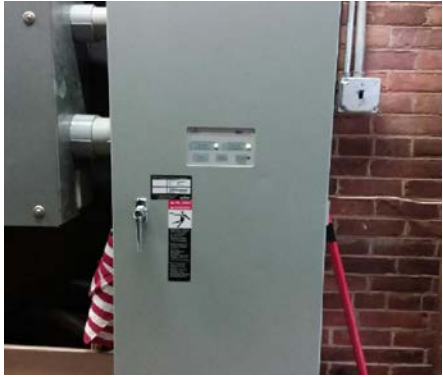
| | equipment | condition | Est remaining<br>Service life | priority | cost | remarks &recommendations | | |
|--|---|---|---|---|---|---|---|--|
| | 16,Generator<br>Switchgear | 1<br>Fully operational,<br>new, recently<br>replaced | 25 Years | 10 | \$2,000 | This switchgear serves<br>town office, opera house<br>and the fire department. | | |

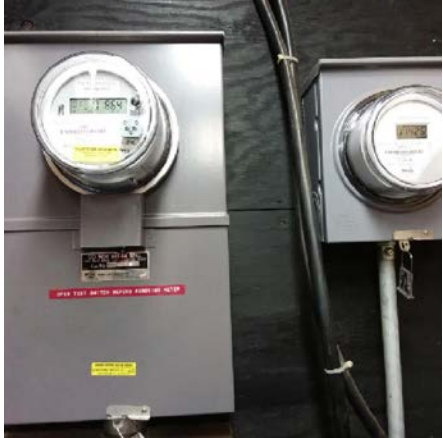
| | equipment | condition | Est remaining<br>Service life | priority | cost | remarks &recommendations | | |
|--|---|---|---|---|---|---|---|--|
| | 18Electric Meters | 2<br>Fully operational,<br>0-25% life<br>expectancy used,<br>no issues, no<br>concerns | 15 Years | 10 | \$1,000 | One meter is for the<br>courthouse and the other<br>meter is for the town<br>office building.<br><br>Maintained by power<br>supplier. | | |

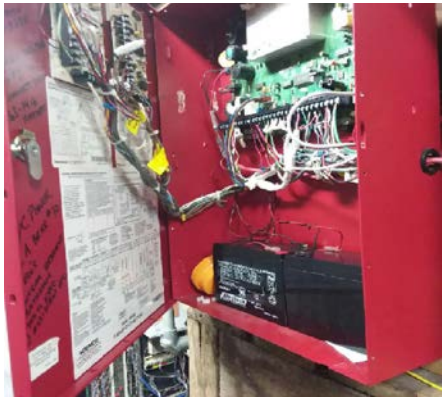
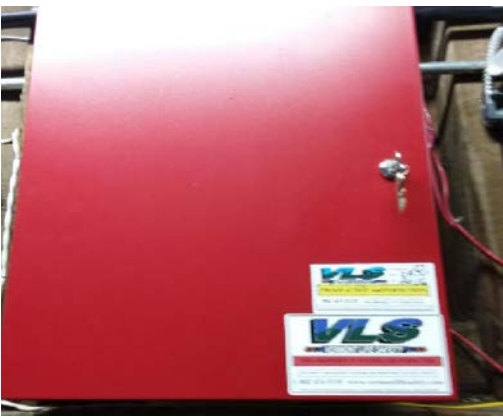
| | equipment | condition | Est remaining<br>Service life | priority | cost | remarks &recommendations | | |
|--|---|---|---|---|---|---|---|--|
| | 14,FACP<br><br>System was installed in<br>2013 | 1<br>Fully operational,<br>new, recently<br>replaced | 25 Years | 10 | \$4,000 | Alarm activations alert to<br>a Dispatch Center. | | |
