Building: Wastewater Treatment Facility  
20 Putnam Road  
Newport, New Hampshire

Town of Newport, Building Assessment July 31,2017

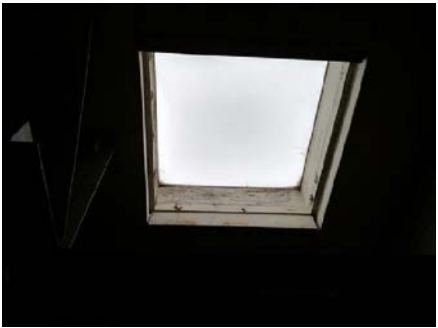
equipment	condition	Est remaining Service life	priority	cost	remarks &recommendations		
	709,Paint Surface	4	4	7	\$300	Scrape, sand, prime and paint with high performance paint.

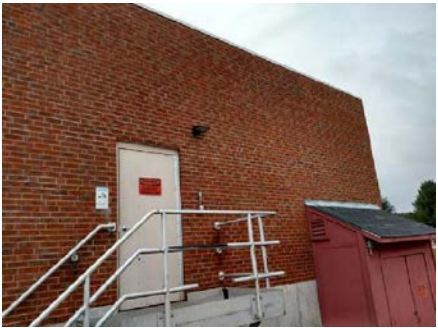
708,Asphalt Shingle	5	0	1	\$ 7.00 sq.ft.  \$500	Replace asphalt shingle roof and other shed roofs at the same time as the main building.

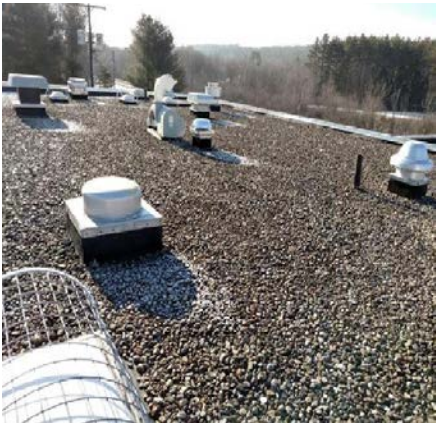
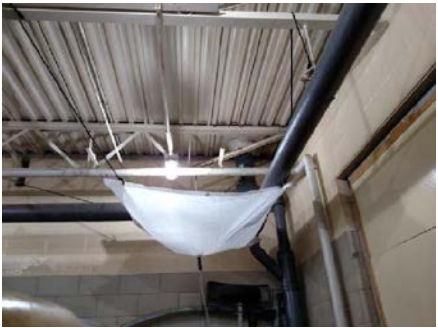
707,Rubber Roof	5	0	1	\$ 18/sq.ft  6905 Sq.ft.  \$124,290	Rubber roof has been a constant problem with leaking. Roof is ballasted stone roof which is difficult to trace leaks from as the stone hides pathways. Suggest this roof be replaced with an adhered membrane roof with additional insulation. Verify with structural engineer quantity of allowed insulation.

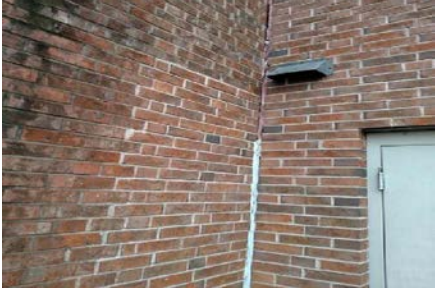
equipment	condition	Est remaining Service life	priority	cost	remarks &recommendations		
	706,Caulking	4	2	2	\$ 7.00 lineal ft.	Building is well maintained but could use exterior caulking.

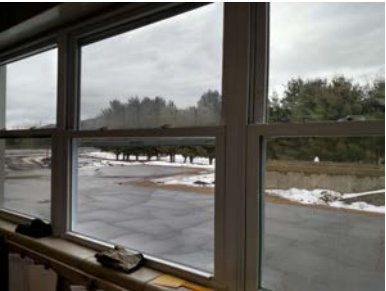
705,Window Newer	2	20+	10	\$800 Per window	Windows were replaced in 2009, no work needed.

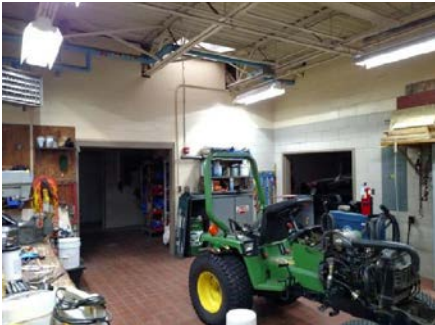
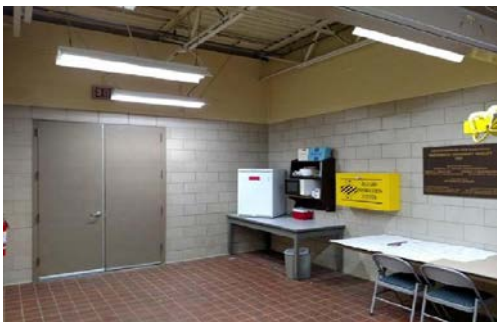
704,Flooring	2	20+	10	\$12.00/sq. ft.	All interior finishes are in very good condition.

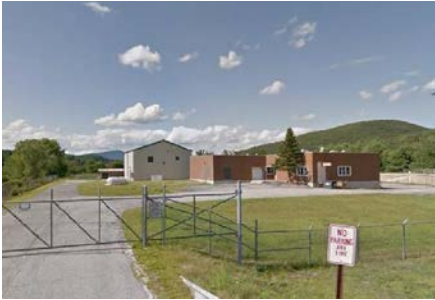
703,ADA Issues:					Front entrance is not ADA, side entrance is.

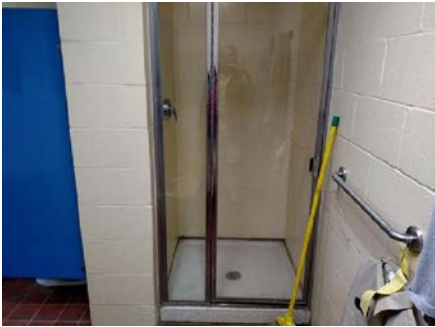
702,ADA Issues:					Bathrooms are not ADA compliant.

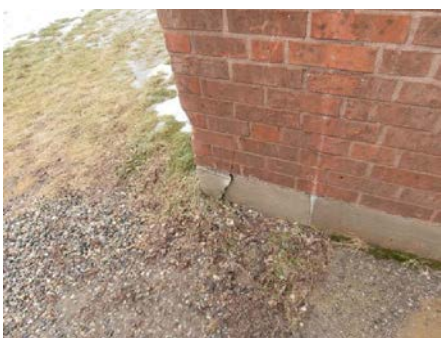
equipment	condition	Est remaining Service life	priority	cost	remarks &recommendations		
	442, Foundation					Top of foundation wall is chipped at corner of building.

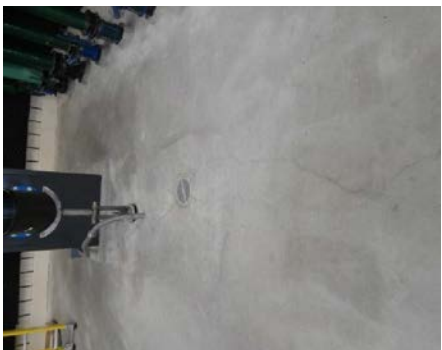
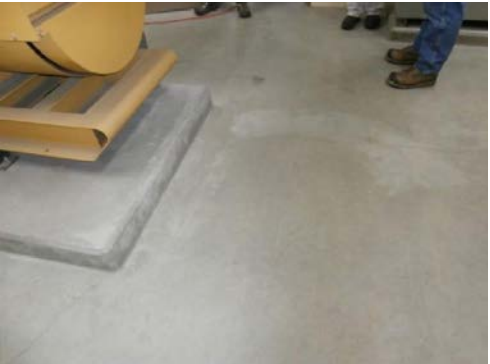
443,Slab on grade floor -					Some cracking from floor drains and from housekeeping pads due to absence of control Joints.

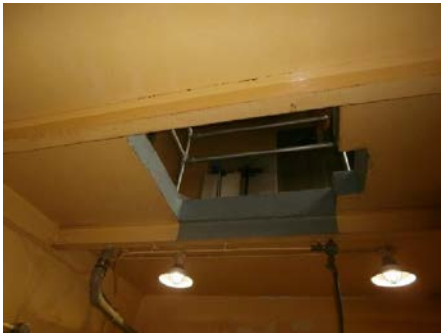
440, Bearing Wall					Exterior walls of original building are 4" brick, 8" CMU, load bearing masonry - typ. (info only)		
	439,Foundation					Lower Level - influ room and pump room - reinforced concrete construction. (info only)		
	438,Floor Framing					Floor framing over Lower Level at S end of original building: Cast in place 10" concrete flat slab on steel Framing.

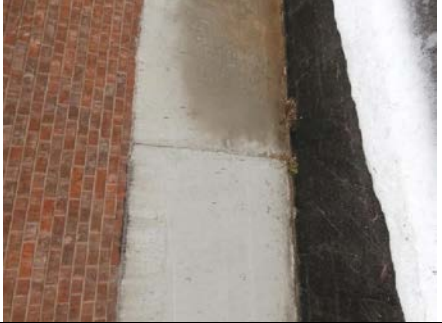
equipment	condition	Est remaining Service life	priority	cost	remarks &recommendations		
	445,Foundation	5	0	4	\$10 lineal ft.	Full height vertical crack in foundation wall - should be routed out and sealed.

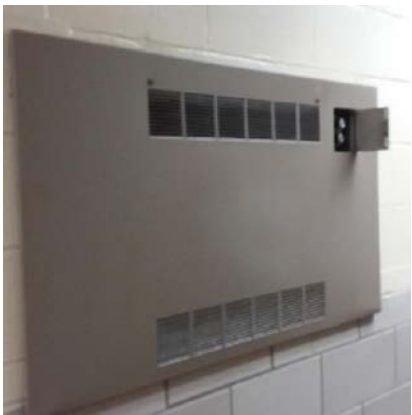
equipment	condition	Est remaining Service life	priority	cost	remarks &recommendations		
	336,Wall mount fan coil unit heater	3 Fully operational, 25-50% life expectancy used, periodic problems	10 Years	10	\$2500	Provides heat in common corridor area. E 113

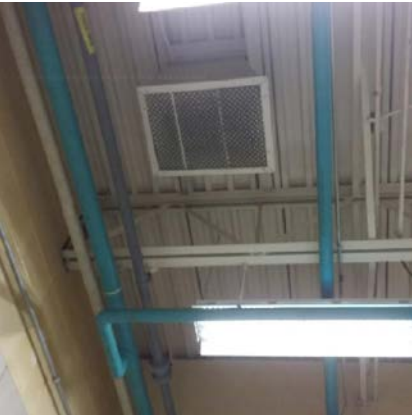
335,Rooftop exhaust fan	1 Fully operational, new, recently replaced	20 Years	10	\$2,500	Replaced within the last 5 years.  No visible nameplate.  Exhausts garage area.

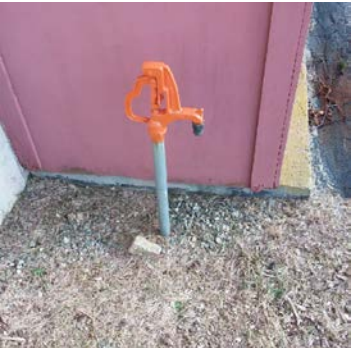
451,Hose bib					Frost proof outside Grit building

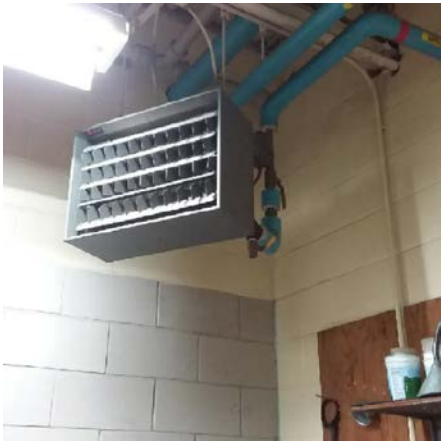
315,TRANE ceiling hung hot water unit heater	3 Fully operational, 25-50% life expectancy used, periodic problems	10 Years	10	\$3,500	Provides heat to the pump room.

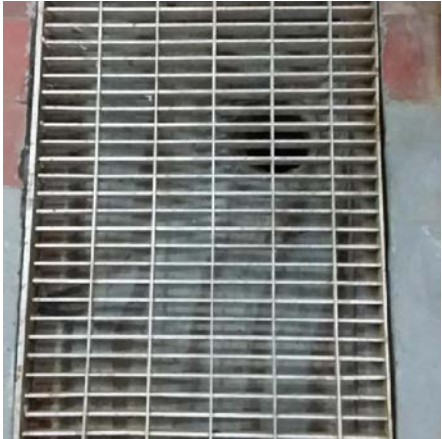
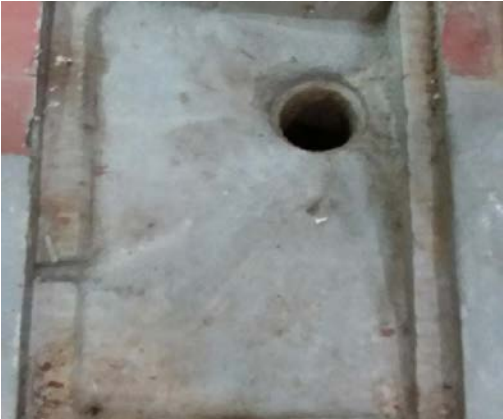
329,Trench Drain					There are many trench drains throughout this building.

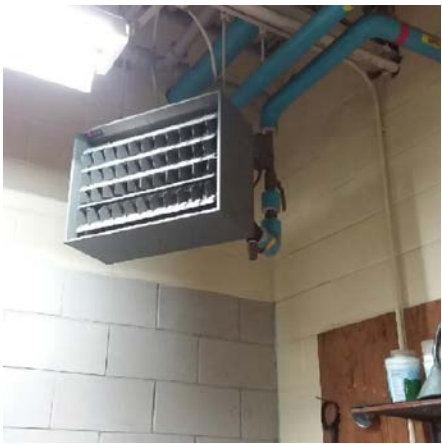
equipment	condition	Est remaining Service life	priority	cost	remarks &recommendations		
	330,Ceiling hung hot water unit heater	3 Fully operational, 25-50% life expectancy used, periodic problems	10	10	\$3500	Provides heat to filter room

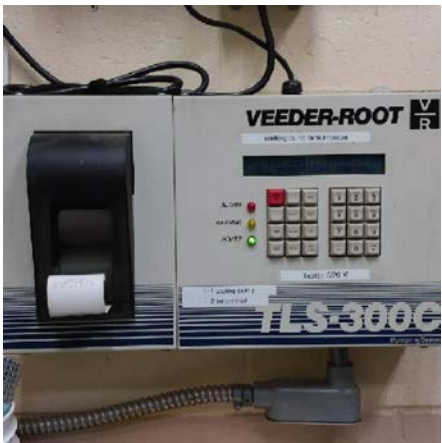
358,Oil tank monitor for underground tank	2 Fully operational, 0-25% life expectancy used, no issues, no concerns	15	10	\$3,000	Appears to be in working order. Boiler room.

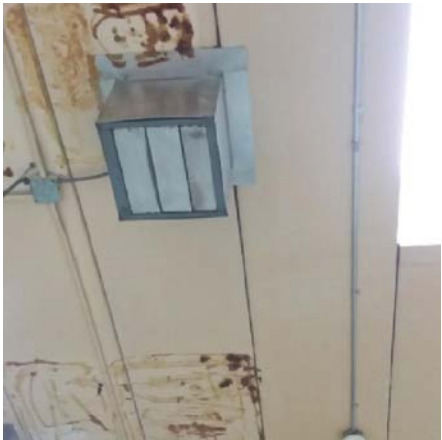
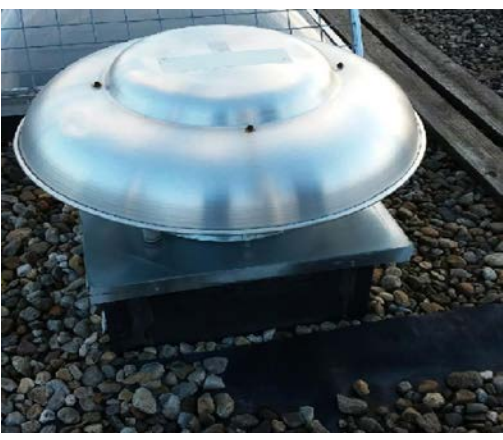
equipment	condition	Est remaining Service life	priority	cost	remarks &recommendations		
	325,Rooftop exhaust fan  Unable to visualize nameplate	1 Fully operational, new, recently replaced	20 Years	10	\$2,500	Replaced within the last 5 years.  Serves to exhaust blower room.

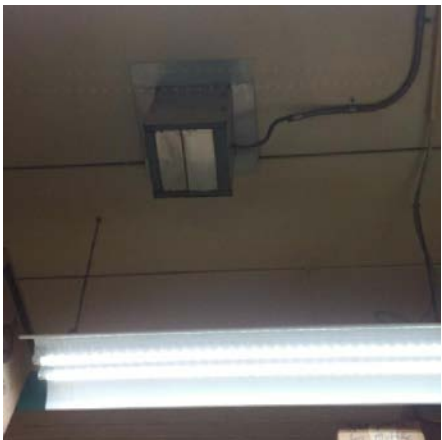
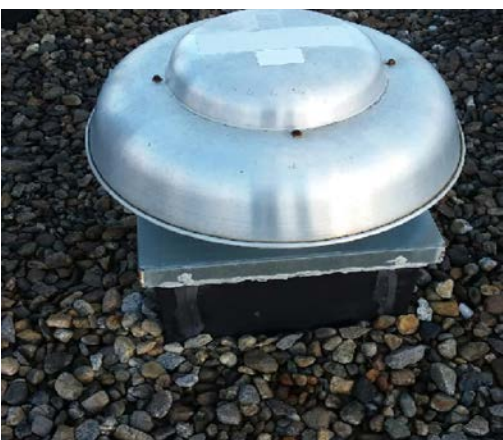
324, Rooftop exhaust fan  Unable to visualize nameplate	1 Fully operational, new, recently replaced	20 Years	10	\$2,500	Replaced within the last 5 Years.  Serves to exhaust storage room.A102

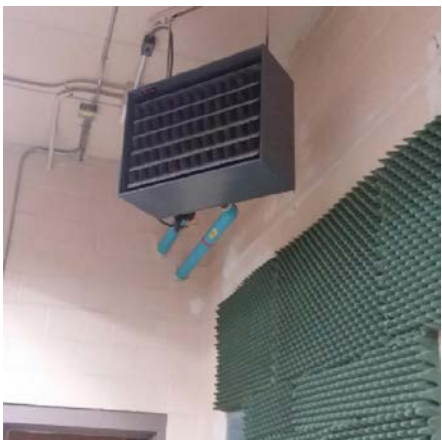
334,Ceiling hung hot water Unit heater	3 Fully operational, 25-50% life expectancy used, periodic problems	10 Years	10	\$3,500	Provides heat for garage

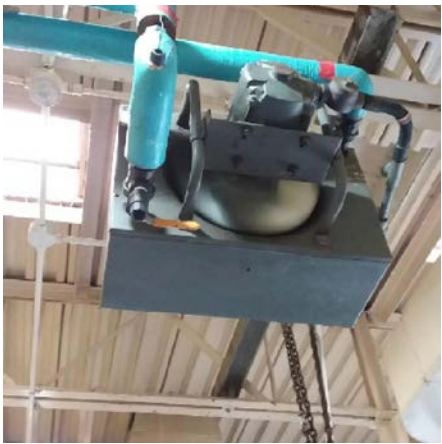
equipment	condition	Est remaining Service life	priority	cost	remarks &recommendations		
	364,Hot water Unit heater provided with explosion motor for corrosive Atmosphere	3 Fully operational, 25-50% life expectancy used, periodic problems	10 Years	10	\$3,500	Provides heat for screen room.

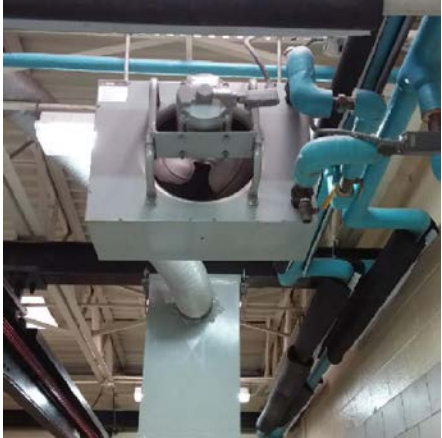
362,Ceiling hung Hot water Unit heater provided with explosion-proof motor for corrosive atmosphere	3 Fully operational, 25-50% life expectancy used, periodic problems	10 Years	10	\$3,500	Provides heat for de-chlorination system room.

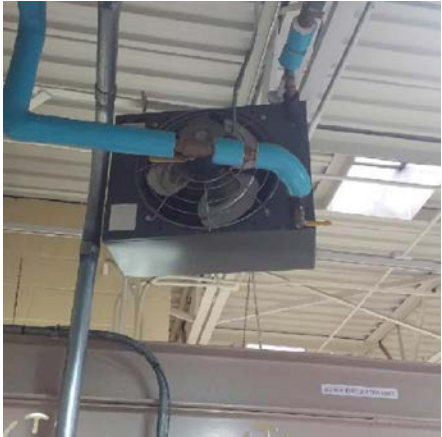
360,Ceiling hung Hot water Unit heater	3 Fully operational, 25-50% life expectancy used, periodic problems	10 Years	10	\$3,500	Provides heat for storage room.E115

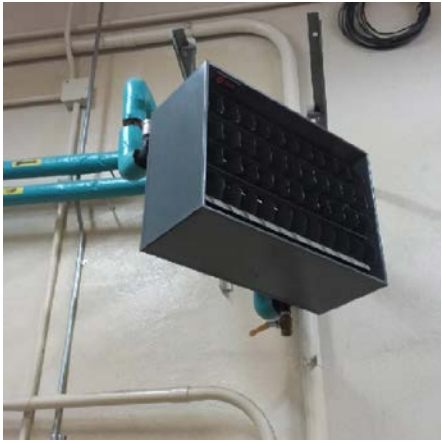
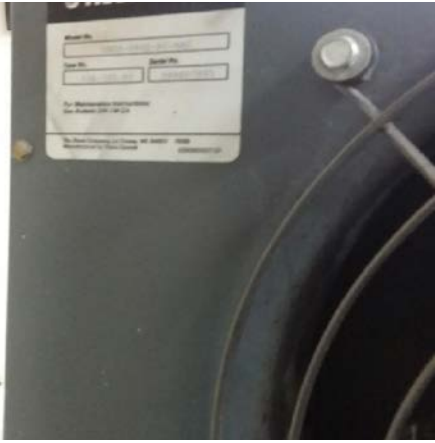
315,Trane fan powered Hot water unit heater	3 Fully operational, 25-50% life expectancy used, periodic problems	10 Years	10	\$3,500	Provides heat to pump room on the lower level.

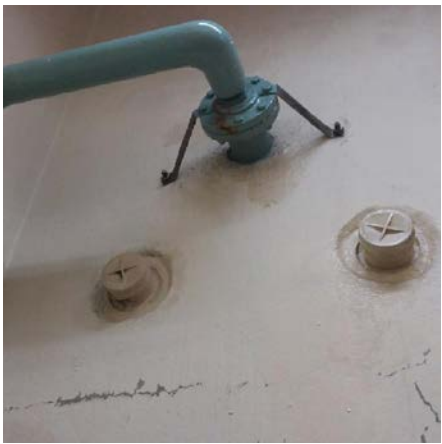
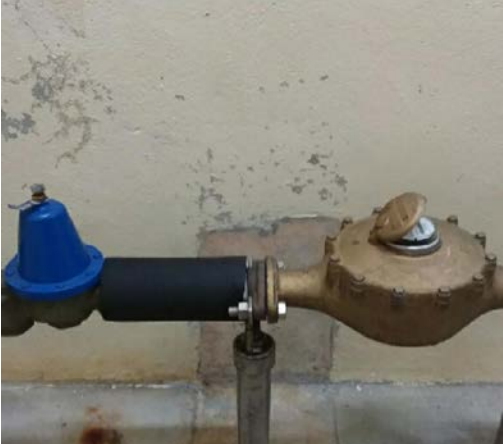
314, 2" copper pipe with RPZ					Maintained by water dept.

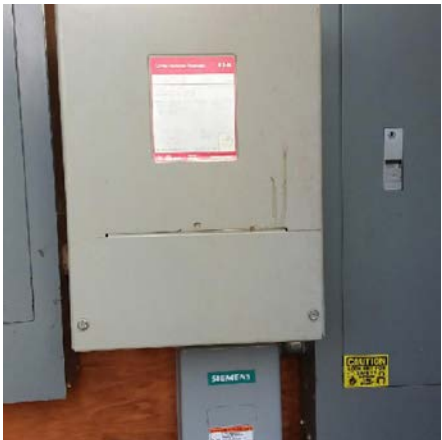
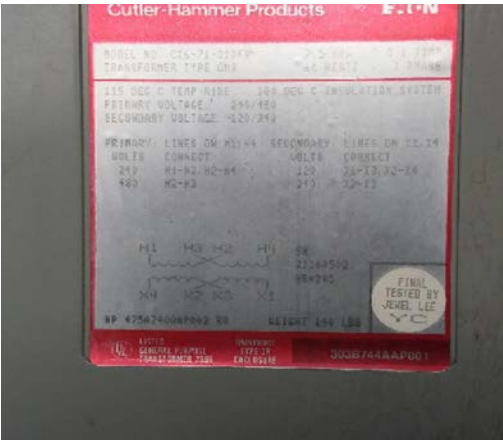
Equipment	Condition	Est. Remaining Service Life	Priority	Cost Estimate	Remarks & Recommendations		
	456,7.5 KVA wall mounted Transformer	2 Fully operational, 0-25% life expectancy used, no issues, no concerns	15 Years	10	\$1,000	Transformer is housed in a wooden enclosure attached to the GRIT building.

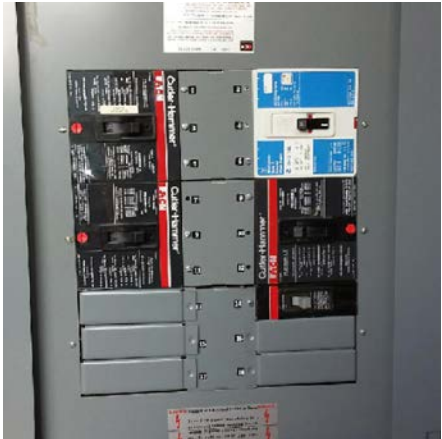
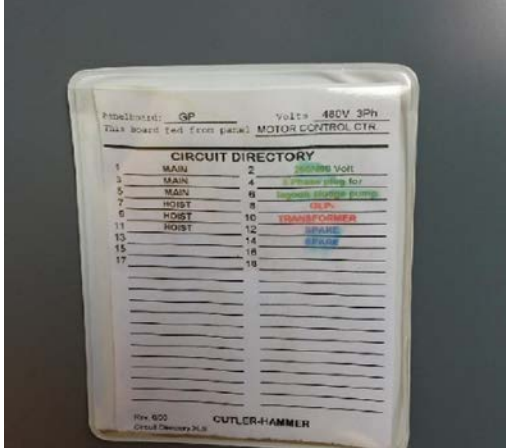
equipment	condition	Est remaining Service life	priority	cost	remarks &recommendations		
	453,480 Volt 3 phase panelboard	2 Fully operational, 0-25% life expectancy used, no issues, no concerns	15 Years	10	\$6,000	Panelboard is housed in a wooden enclosure attached to the GRIT building.

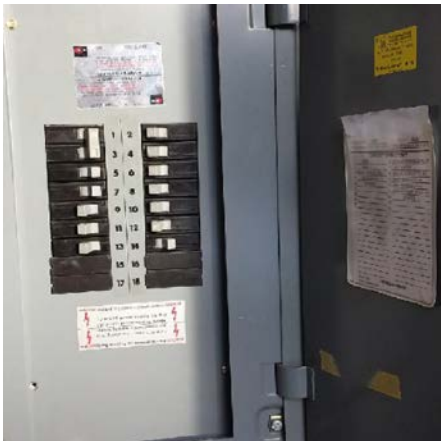
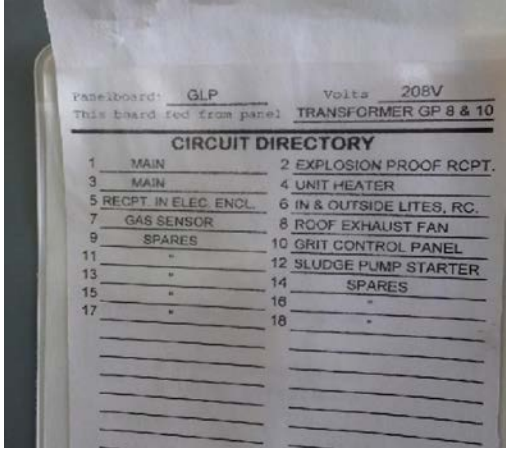
452,208 Volt panelboard	2 Fully operational, 0-25% life expectancy used, no issues, no concerns	15 Years	10	\$4,000	Panel board is housed in a wooden enclosure attached to the GRIT building.

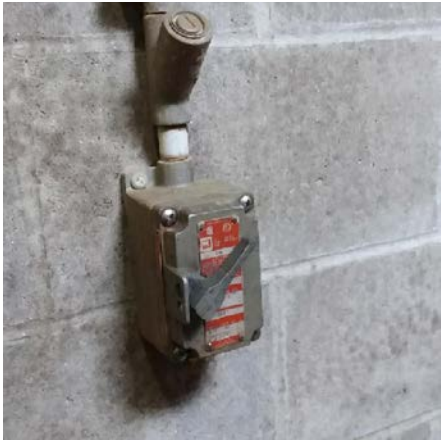
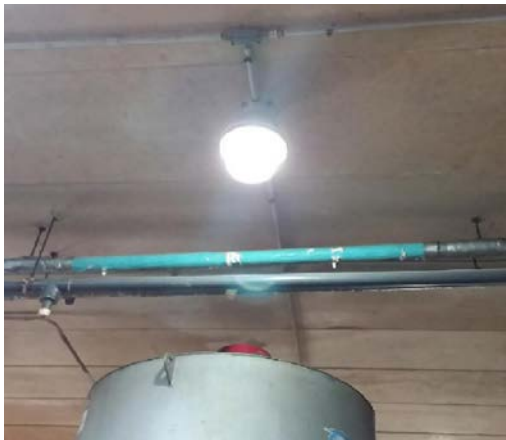
450,Explosion-proof type devices throughout building	2 Fully operational, 0-25% life expectancy used, no issues, no concerns	15 Years	10	\$3,000	These devices are located in the GRIT building.

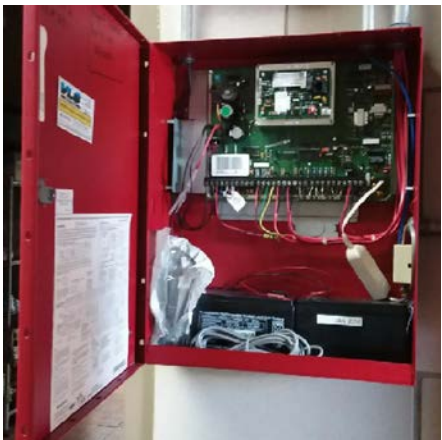
367, FACP Installed 2013	1 Fully operational, new, recently replaced	20 Years	10	\$6,000	Control panel is dispatched to the police department which is the Central Dispatch Center.

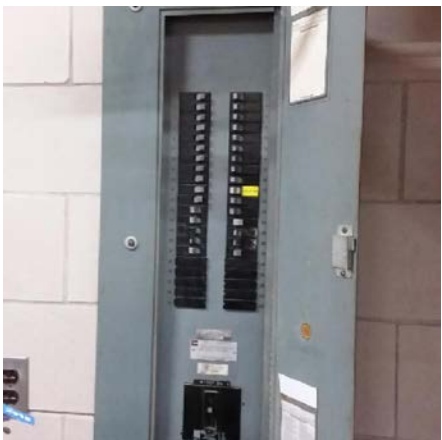
327, 120/ 208 3 phase flush mount panelboard ELP 2	2 Fully operational, 0-25% life expectancy used, no issues, no concerns	15 Years	10	\$4,000

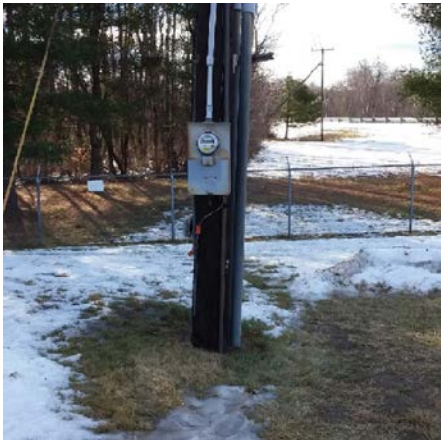
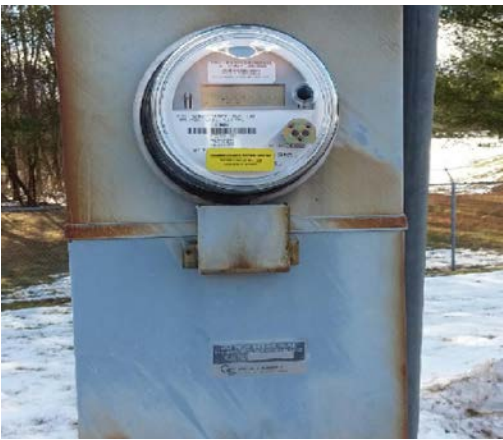
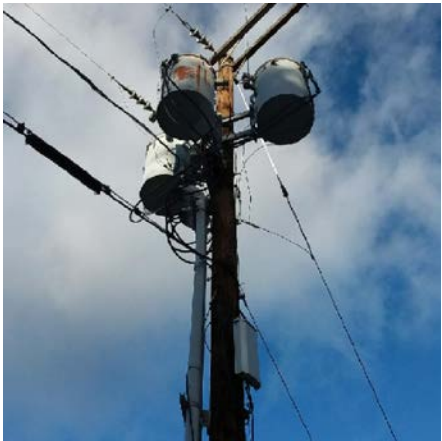
equipment	condition	Est remaining Service life	priority	cost	remarks &recommendations		
	365,Three - 100 KVA pole-mounted transformers	2 Fully operational, 0-25% life expectancy used, no issues, no concerns	15 Years	10		Provides power to building through underground service.  Electric meter is also pole mounted.  Maintained by power supplier.

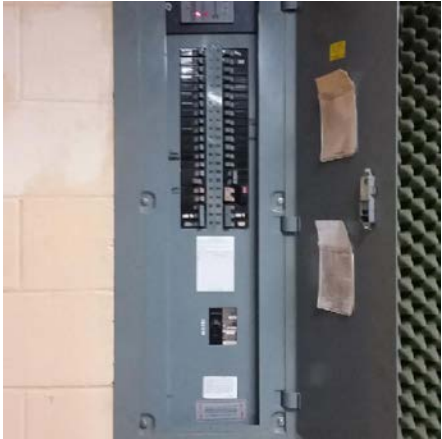
323, 208 Volt 3 phase flush mount panelboard PP	2 Fully operational, 0-25% life expectancy used, no issues, no concerns	15 Years	10	\$4,000

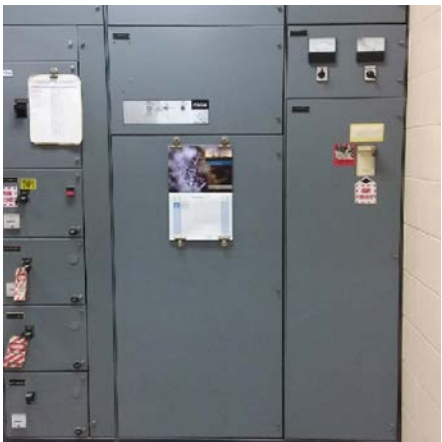
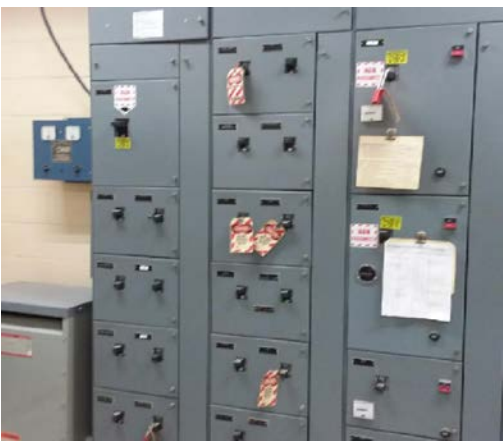
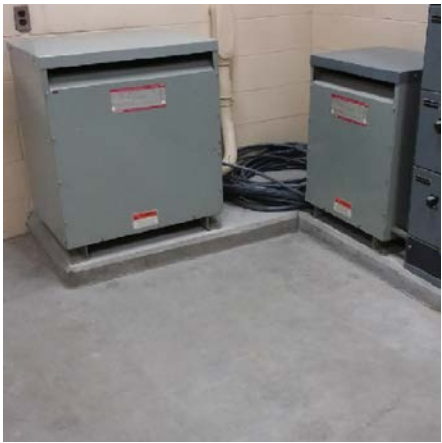
equipment	condition	Est remaining Service life	priority	cost	remarks & recommendations		
	321, 321,480 Volt 3 phase entrance, MDP and two floor mount transformers	2 Fully operational, 0-25% life expectancy used, no issues, no concerns	15 Years	10	\$15,000	Generator room

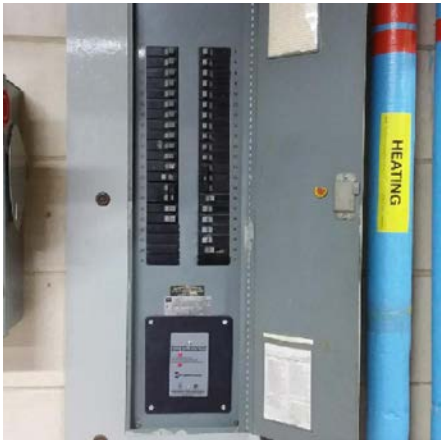
equipment	condition	Est remaining Service life	priority	cost	remarks &recommendations		
	319, Electrical Panelboard  ELP-1 225 AMP - 120/208 3 phase	2 Fully operational, 0-25% life expectancy used, no issues, no concerns	15 Years	10	\$4,000

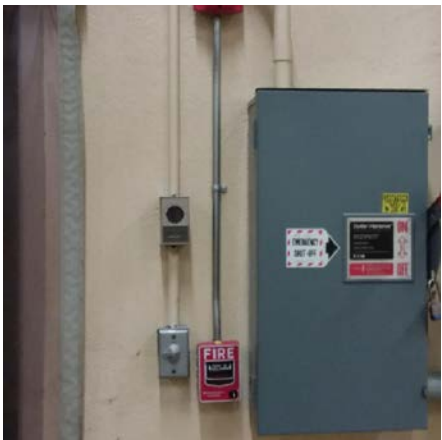
316,Pull station and horn strobe	2 Fully operational, 0-25% life expectancy used, no issues, no concerns	15 Years	10	\$250	Typical at exits of building.

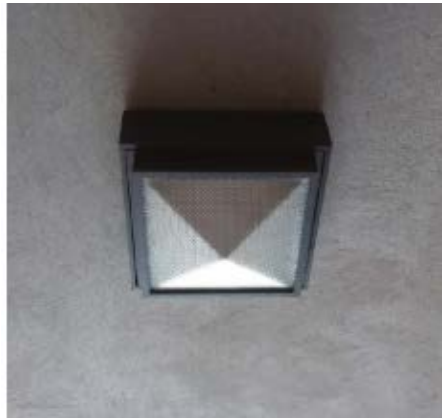
363,outdoor lighting	4 Operational, 50- 75% life expectancy used, occasional problems, frequent repairs needed	5	5	\$500 each	Outside chlorination room

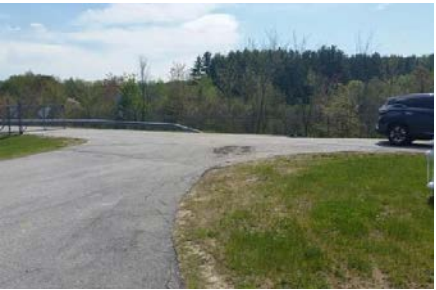
Site								
	<p>The building is paved on south and east sides, with a grassed area to the west. Pavement appears to be from at least 2 separate placements with the oldest one (dating from late 1970's or early 1980's) placed around the building, and a second placement (late 1980's or early 1990's) on the access road section parallel with the building and in a small parking area in front of the building.</p> <p>Pavement in the older section is characterized by alligator cracking in the areas near the front gate, longitudinal/transverse cracking in the section in front of, and to the east side of the building. A few of these longitudinal cracks have become eroded and widened over time. Given the appearance of the alligator cracking, it appears that this may result from the bituminous pavement applied directly over the subgrade soils, or upon a base course layer that was not thick enough. The longitudinal cracks are likely resulting from reflective cracks from the underlying asphalt layer.</p>

Equipment	Condition	Est. Remaining Service Life	Priority	Cost Estimate	Remarks & Recommendations	Photos	
	860, Pavement	4	2	4	PT \$2.80 sq.ft.  28,000 sq.ft  \$78,400	Photo - View towards entrance gate of the Sewer Treatment Plant.
