Minutes of the Airport R. Kelsea Advisory Board Meeting Held 17 October 2023

Report on Pavement Condition Evaluation
September 2023

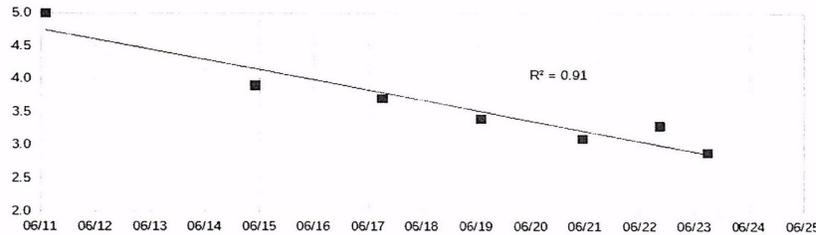
Pavement condition was evaluated on the late afternoon of Wednesday, September 6, 2023 using the evaluation method described in FAA Advisory Circular 150/5320-17A, Appendix A, *Pavement Surface Evaluation and Rating Asphalt Airfield Pavements*. The Advisory Circular (AC) provides guidelines for assigning rating values (5-excellent through 1-failed). Although examples of objective criteria are identified in the AC, as a practical matter, the act of evaluating each runway segment and assigning a rating value requires some judgement, thus the rating values are semi-quantitative. Nevertheless, by applying the same evaluation methods and techniques, conducted by the same people, over the entire evaluation period (2010 to present) we achieve reasonably consistent results as reflected in the statistical coefficient of variation ($R^2 = 0.91$) and the accompanying graph.

The current results show a continuing deterioration of the runway. This deterioration is a normal and expected condition in the pavement lifecycle. All pavements wear out and fail, eventually becoming hazardous, unsafe, and unsuitable for use by aircraft whether taxiing, taking off, or landing. As a baseline for comparison, the PASER index was 2.6 in 2010 before the runway was repaved in 2011.
